EMERGENCY REHABILITATION OF BROWNSBARN BRIDGE

V.PAKRASHI¹, J.KELLY¹, J.HARKIN² & S.NANUKUTTAN²

¹Roughan & O'Donovan Consulting Engineers, Dublin, Ireland

This paper outlines the repair methodology of Brownsbarn Bridge situated over the N7 near Dublin. The repair strategy was formulated following impact damage to the soffit from a low-loader carrying an excavator passing underneath the bridge. Significant damage was observed to one of the beams. The repairs were carried out as emergency works over a bank holiday weekend in Ireland successfully. The rehabilitation methodology is based on preloading the bridge before repair followed by a removal of load to ensure the reestablishment of some of the lost prestress. This paper outlines the various stages of rehabilitation and establishes the timelines of significant events along with practical discussions on the execution of the rehabilitation methodology. The bridge was continuously monitored throughout the refurbishment process. This case study is expected to be of topical interest to researchers, practicing engineers, bridge owners and end-users alike.

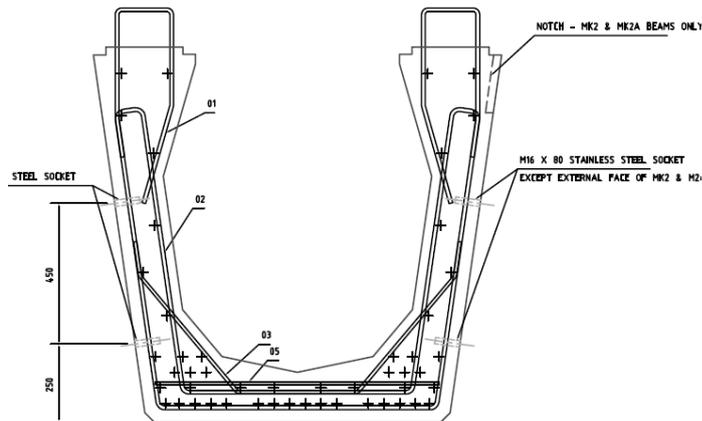
detailed repair of both beams including the introduction of some of the lost prestress into the damaged location of the inner beam. Although one of the prestressing strands was severed on the outer beam, it was computed that apart from this isolated severing of a strand, the prestressing tendons are essentially unaffected in both of the damaged beams. Under these circumstances, it was not envisaged that the damaged prestressing strand will be replaced.

Figure 1 – As Manufactured Tendon Arrangement

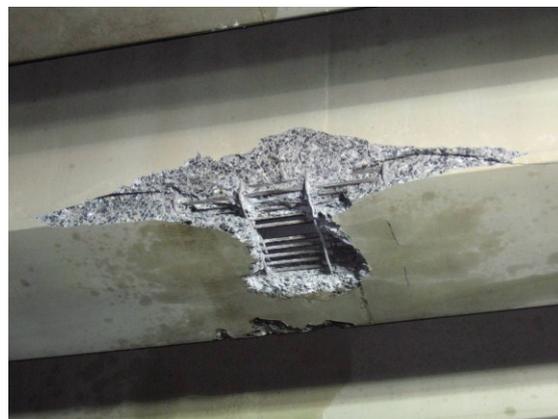
The impact damage affected two of the prestressed U8 beams the bridge consists of. The edge of the outer beam was damaged in a relatively benign fashion than a more extensively damaged inner beam. The main requirements of the rehabilitation involved

The damage extent was assessed and estimated by a number of techniques including an initial visual, photographic and hammer tapping condition survey. The extent was further investigated by incorporating an impact echo test (Tinkey et.al, 2005). In addition, a 3-D visualization was made available through laser scanning. Figure 2 and Figure 3 show the impact damage photograph and the 3-D visualization respectively. Significant damage was established to be extending at least 1.5m on either side of the visually apparent damage.

Figure 2 – Photograph of Impact Damage

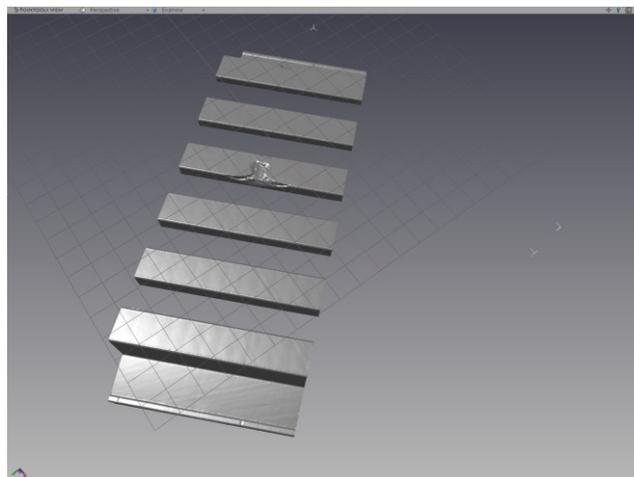
Figure 3 – 3-D Laser Scanning Visualisation made Available by Coastway Ltd.

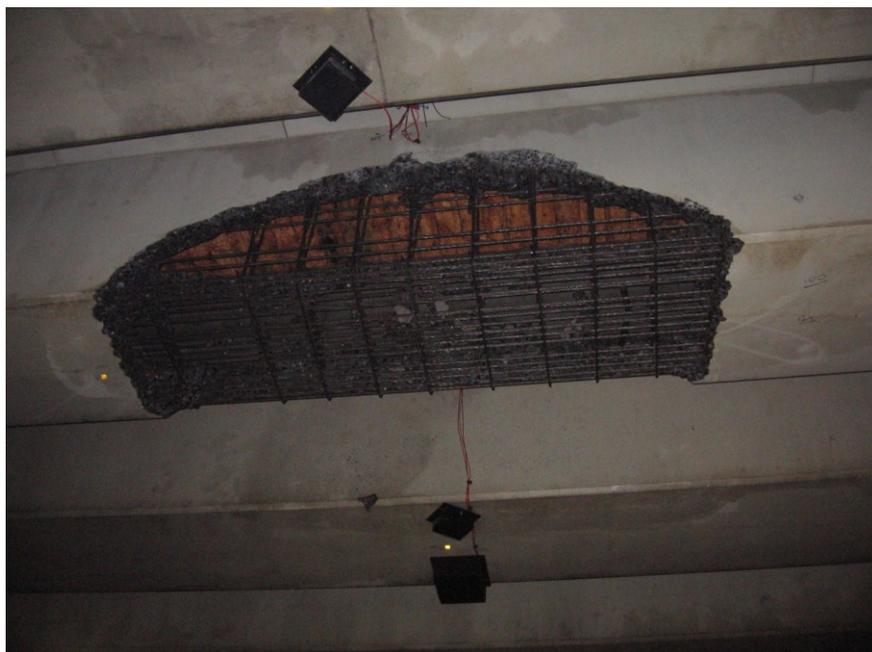
Figure 5 – Removal of Concrete through Hydrodemolition

was carried out. The organisation of hydrodemolition, including the erection of safety fencing and scaffolding was carried out during this time by Structural Concrete Bonding. Figure 5 shows a photograph of the removal of concrete through hydrodemolition. Although this method is a high risk activity and should only be carried out by experts, the process was chosen to be the best for the current project due to its precision and low impact on the existing strands.

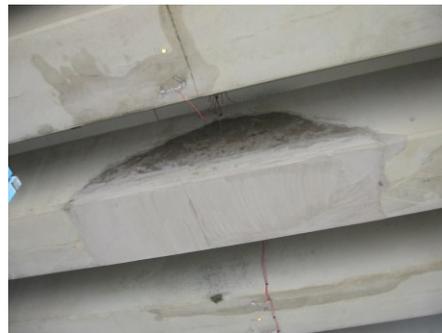
Figure 6 – Repaired Section of Damaged Beam

Hydrodemolition was followed by the installation of embedded strain gauges within the existing tendons and the application of high strength repair material. The material was expected to gain adequate strength within 12 hours and can take significant tension as well.

The preload was removed from the top of the bridge after the repair material gained adequate strength and some amount of prestress was reinstated following the removal of prestrain. The repaired section is shown in Figure 6 while the removal of preload is shown in Figure 7. A sample photograph of the traffic management provided by Complete Highway Maintenance throughout the rehabilitation is provided as Figure 8.

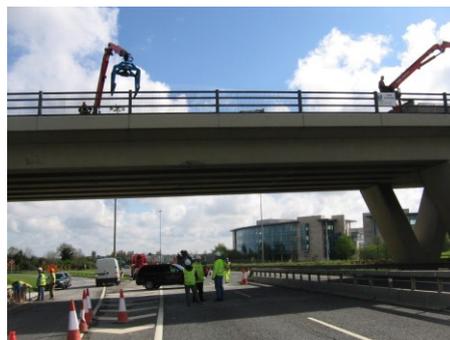
Figure 7 – Removal of Preload
