EMERGENCY REHABILITATION OF BROWNSBARN BRIDGE

V.PAKRASHI¹, J.KELLY¹, J.HARKIN² & S.NANUKUTTAN²

¹Roughan & O'Donovan Consulting Engineers, Dublin, Ireland

This paper outlines the repair methodology of Brownsbarn Bridge situated over the N7 near Dublin. The repair strategy was formulated following impact damage to the soffit from a low-loader carrying an excavator passing underneath the bridge. Significant damage was observed to one of the beams. The repairs were carried out as emergency works over a bank holiday weekend in Ireland successfully. The rehabilitation methodology is based on preloading the bridge before repair followed by a removal of load to ensure the reestablishment of some of the lost prestress. This paper outlines the various stages of rehabilitation and establishes the timelines of significant events along with practical discussions on the execution of the rehabilitation methodology. The bridge was continuously monitored throughout the refurbishment process. This case study is expected to be of topical interest to researchers, practicing engineers, bridge owners and end-users alike.

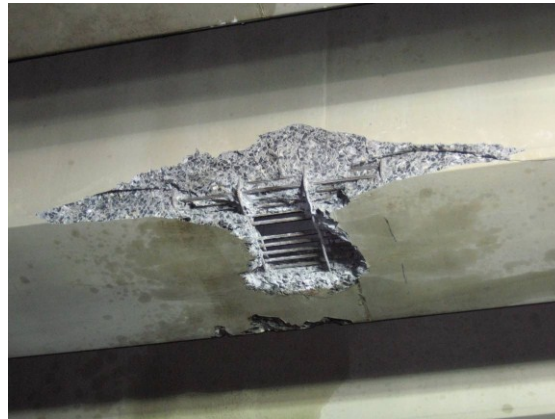
The impact damage affected two of the prestressed U8 beams the bridge consists of. The edge of the outer beam was damaged in a relatively benign fashion than a more extensively damaged inner beam. The main requirements of the rehabilitation involved

The damage extent was assessed and estimated by a number of techniques including an initial visual, photographic and hammer tapping condition survey. The extent was further investigated by incorporating an impact echo test (Tinkey et.al, 2005). In addition, a 3-D visualization was made available through laser scanning. Figure 2 and Figure 3 show the impact damage photograph and the 3-D visualization respectively. Significant damage was established to be extending at least 1.5m on either side of the visually apparent damage.

Figure 2 – Photograph of Impact Damage

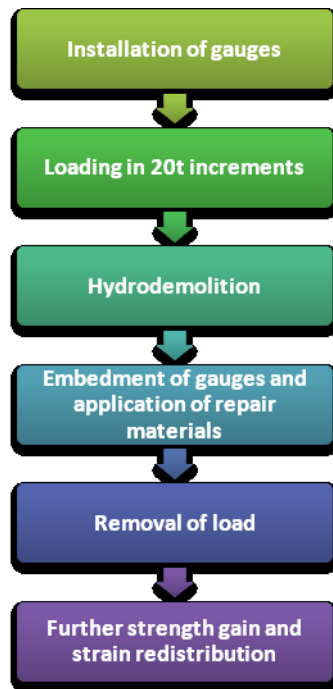
Figure 4 – Brownsbarn Bridge Rehabilitation Flowchart

The emergency rehabilitation process on Brownsbarn Bridge can be divided into seven significant zones of activity distributed chronologically in time. Figure 4 provides a flow chart indicating these stages. The first stage comprises of the installation of gauges. These gauges corresponded to monitoring points of the damaged beam and the two adjacent beams. In total, five monitoring points were selected. Each monitoring point comprised of a number of strain gauges, including sacrificial strain gauges and targets for the measurement of deflection. A vibrating wire strain gauge was used in this regard. The instrumentation and real time remote data logging was provided by Datum Geotechnical and Structural Monitoring.

The two ends of the damage were patch loaded in 20t increments on each side, quasistatically and equally, using bales of concrete blocks. This loading provided the prestrain in the beam. The loading was carried up to 60t on each side. Consequently, the bridge was preloaded to 120t in total before hydrodemolition

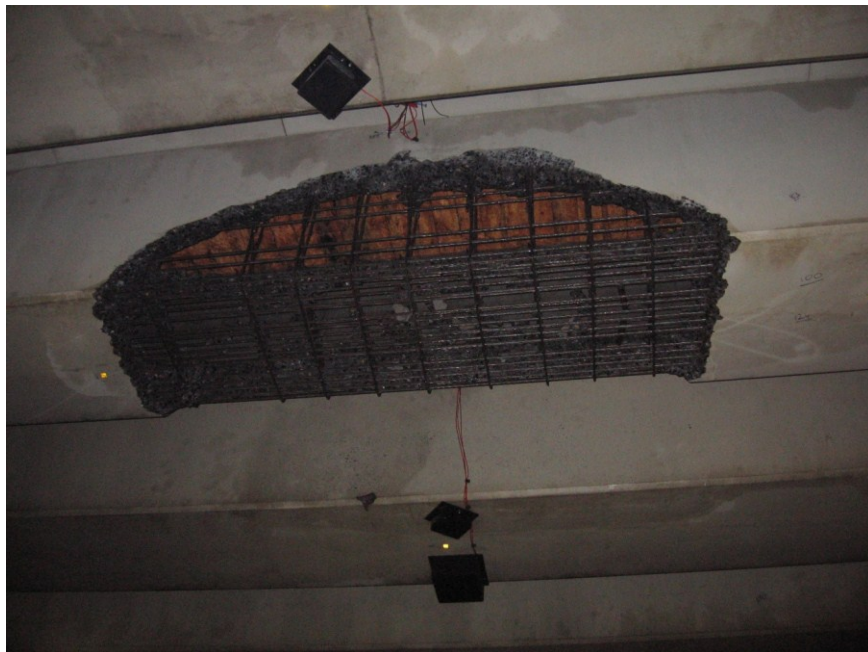
Figure 5 – Removal of Concrete through Hydrodemolition

was carried out. The organisation of hydrodemolition, including the erection of safety fencing and scaffolding was carried out during this time by Structural Concrete Bonding. Figure 5 shows a photograph of the removal of concrete through hydrodemolition. Although this method is a high risk activity and should only be carried out by experts, the process was chosen to be the best for the current project due to its precision and low impact on the existing strands.

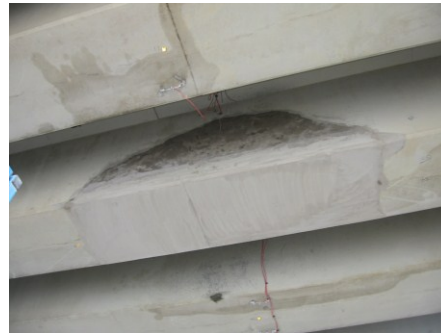
Figure 6 – Repaired Section of Damaged Beam

Hydrodemolition was followed by the installation of embedded strain gauges within the existing tendons and the application of high strength repair material. The material was expected to gain adequate strength within 12 hours and can take significant tension as well.

The preload was removed from the top of the bridge after the repair material gained adequate strength and some amount of prestress was reinstated following the removal of prestrain. The repaired section is shown in Figure 6 while the removal of preload is shown in Figure 7. A sample photograph of the traffic management provided by Complete Highway Maintenance throughout the rehabilitation is provided as Figure 8.

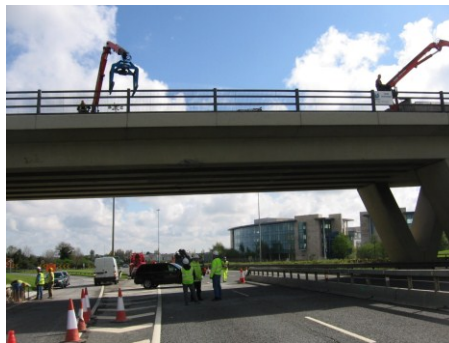
Figure 7 – Removal of Preload

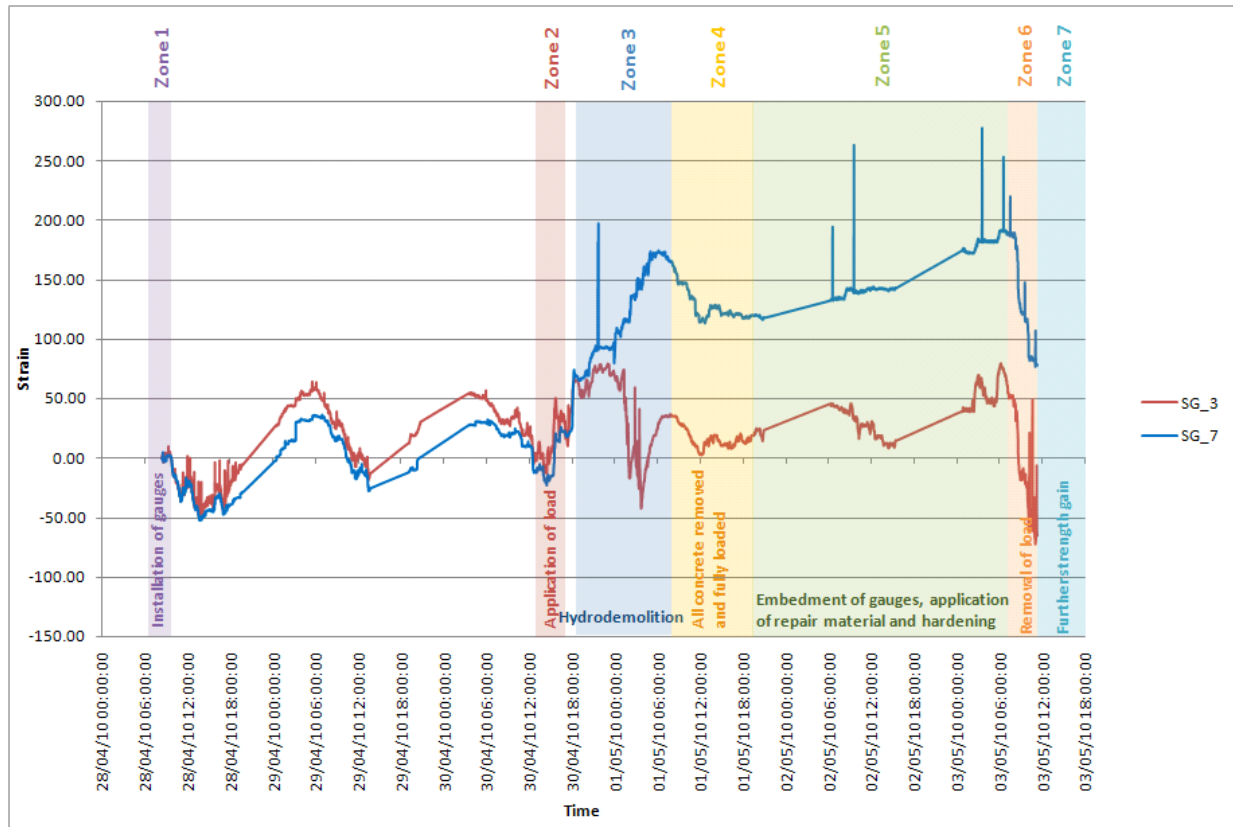
Figure 9 provides the example of two strain gauges from adjacent beams (damaged and undamaged) results during the entire rehabilitation process and zones them into the main activities along the timeline. The strains are in multiples of 10^{-6} . This graph creates the departure point of detailed structural health monitoring analyses including the effects of thermal oscillations, shrinkage characteristics, redistributions of strains, release of entrapped strains, participation and energy flow of adjacent beams and the real mechanics of structures similar to Brownsbarn Bridge. Such analyses are beyond the scope of the current paper.

Figure 9 – Activity Footprints in Strain Gauge Monitoring Data and Event Hotspots
