EMERGENCY REHABILITATION OF BROWNSBARN BRIDGE

V.PAKRASHI¹, J.KELLY¹, J.HARKIN² & S.NANUKUTTAN²

¹Roughan & O'Donovan Consulting Engineers, Dublin, Ireland

This paper outlines the repair methodology of Brownsbarn Bridge situated over the N7 near Dublin. The repair strategy was formulated following impact damage to the soffit from a low-loader carrying an excavator passing underneath the bridge. Significant damage was observed to one of the beams. The repairs were carried out as emergency works over a bank holiday weekend in Ireland successfully. The rehabilitation methodology is based on preloading the bridge before repair followed by a removal of load to ensure the reestablishment of some of the lost prestress. This paper outlines the various stages of rehabilitation and establishes the timelines of significant events along with practical discussions on the execution of the rehabilitation methodology. The bridge was continuously monitored throughout the refurbishment process. This case study is expected to be of topical interest to researchers, practicing engineers, bridge owners and end-users alike.

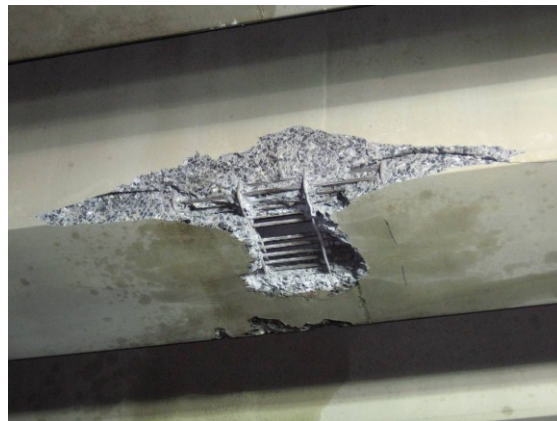
The impact damage affected two of the prestressed U8 beams the bridge consists of. The edge of the outer beam was damaged in a relatively benign fashion than a more extensively damaged inner beam. The main requirements of the rehabilitation involved

detailed repair of both beams including the introduction of some of the lost prestress into the damaged location of the inner beam. Although one of the prestressing strands was severed on the outer beam, it was computed that apart from this isolated severing of a strand, the prestressing tendons are essentially unaffected in both of the damaged beams. Under these circumstances, it was not envisaged that the damaged prestressing strand will be replaced.

The damage extent was assessed and estimated by a number of techniques including an initial visual, photographic and hammer tapping condition survey. The extent was further investigated by incorporating an impact echo test (Tinkey et.al, 2005). In addition, a 3-D visualization was made available through laser scanning. Figure 2 and Figure 3 show the impact damage photograph and the 3-D visualization respectively. Significant damage was established to be extending at least 1.5m on either side of the visually apparent damage.

Figure 2 – Photograph of Impact Damage

The main elements of the works comprised of site clearance, protective fencing, construction of temporary and permanent safety barriers and guardrails, traffic management, hydrodemolition of damaged concrete, preloading of damaged beam to induced prestrain, repair of concrete beam using an appropriate material and the real time monitoring of the rehabilitation process.

These works were inspired from the fact that the preload in the form of vertical loading from the top surface on the two sides of the damage would release high prestressing forces at the bottom and will introduce compressive stresses at the top. This situation was deemed favourable since a significant section was lost from damage and the hydrodemolition would temporarily increase the stresses even further. With uncertainty of the retained stresses within fractured concrete and the redistribution of stresses and the participation of adjacent beams, the prestressing forces alone can be significant. Under such circumstances, the external loads are beneficial.

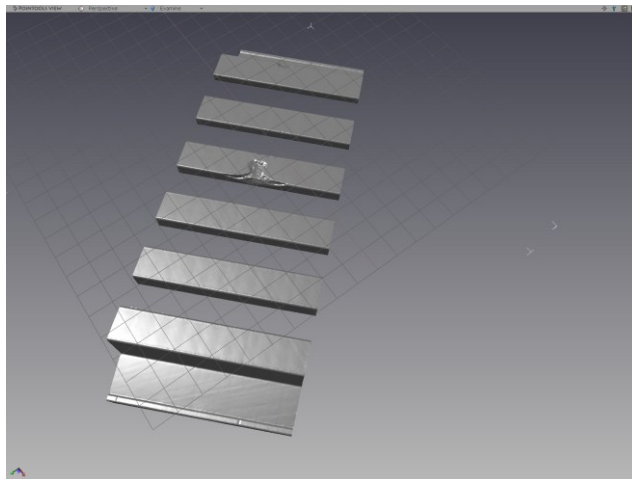
Figure 3 – 3-D Laser Scanning Visualisation made Available by Coastway Ltd.

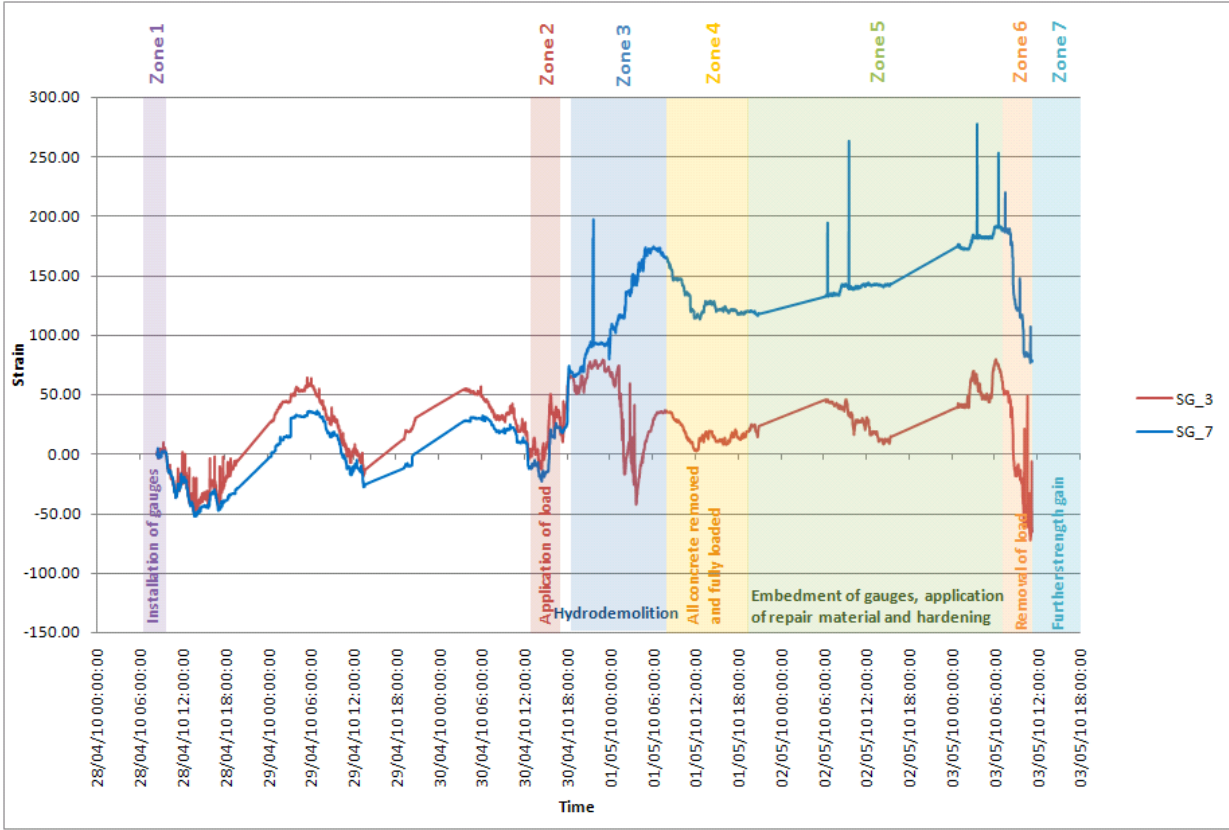
Figure 9 provides the example of two strain gauges from adjacent beams (damaged and undamaged) results during the entire rehabilitation process and zones them into the main activities along the timeline. The strains are in multiples of 10^{-6} . This graph creates the departure point of detailed structural health monitoring analyses including the effects of thermal oscillations, shrinkage characteristics, redistributions of strains, release of entrapped strains, participation and energy flow of adjacent beams and the real mechanics of structures similar to Brownsbarn Bridge. Such analyses are beyond the scope of the current paper.

Figure 9 – Activity Footprints in Strain Gauge Monitoring Data and Event Hotspots
