An Image Analysis Based Damage Classification Methodology

V. Pakrashi & A.O' Connor

ABSTRACT: Measurement of the extent of damage in a real structure is extremely important in terms of any maintenance strategy. However, this measurement often turns out to be difficult, time consuming and error – prone. The necessity of a simple, fast and relatively inexpensive damage monitoring system with reliable measurements is growing for quite sometime. The paper proposes a camera based image analysis technique to quantify and classify damage in structures at various levels of scale. The general method has been applied to corroded plate specimens in the laboratory with the aim to identify the affected areas on a steel pile due to pitting corrosion. The method depends on the contrast of the corroded region with respect to its surroundings, performs intelligent edge detection through image processing techniques and computes each affected and closed region to predict the total area of the affected part along with its spatial distribution on a two dimensional plane. Moreover the performance of the camera allows defining a detection threshold and the so-called probability of detection (PoD) and p

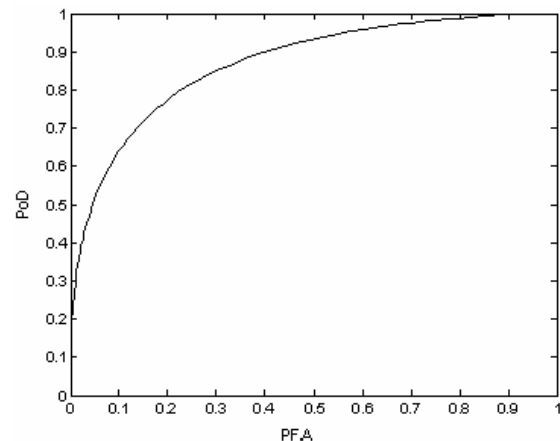
where A is the measured area. A_d is a deterministic parameter or a random variable. This definition implies that PoD is a monotonic increasing function. To complete this concept, the probability of false alarm has been introduced. It is the probability to defect a non-existing defect. For a given range of defects A_i , the curve that joints the points of coordinates (PFA, $PoD(A_i)$) is called Receiver Operating Characteristic (ROC) curves (Arques (1982), Fücsök et al. (2000)). Such a curve is plotted on figure 4.

Figure 4. Receiver Operating Characteristic curve.
