Pakrashi, V., O'Connor, A., Schoefs, F., 2007. An Image Analysis Based Damage Classification Methodology. In: Kanda, J., Takada, T., Furuta, H. (eds) *Applications of Statistics and Probability in Civil Engineering: Proceedings of the 10th International Conference, ICASP10*. Tokyo, Japan, 31 July - 3 August 2007. London: Taylor & Francis. pp.147-148 ISBN: 9780415452113

An Image Analysis Based Damage Classification Methodology

V. Pakrashi & A.O' Connor

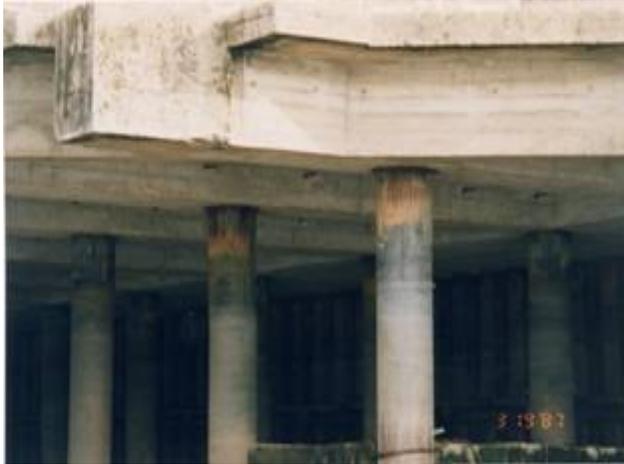
The benchmark structure is a wharf located at St. Nazaire, France and the general arrangement of the wharf is provided in Figure 1. This wharf belongs to the category of on piles wharfs. It is located in the

Figure 1. Steel piles with Corrosion.

Being in the marine environment, the steel piles are susceptible to corrosion and hence the assessment of the structural health of such a structure is considered to be of great practical importance. In fact steel piles play two major roles - the first being a mechanical function and the second being a protection of reinforced concrete inside against corrosion, which is generally uniform. Submarine inspections and investigations of localized corrosion have been observed by divers in this regard. These damage conditions have been recorded on video tapes and reported as pictures on inspection report. The damages look like pitting in white metals, which is usually why the corrosion is referred to as 'pitting corrosion'. This type of corrosion is often a consequence of the defects in the metals that the structure is comprised of. In fact, these piles come sometimes from the rebus of the pipe-lines (non-conforming pieces).

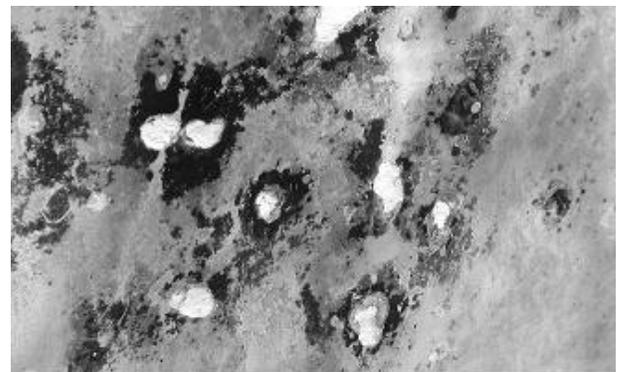
Figure 2. A Treated Specimen with Corrosion.

An example of a successful image processing based damage region detection as proposed in the paper is given in Figure 3, where Figure 2 has been successfully analyzed to isolate eight major closed damaged areas of irregular geometry with precision. Some spurious features are also identified due to the environmental noise but are insignificant with respect to the damaged regions. Sometimes, a visual idea about the spurious features can be helpful to preprocess the picture to make the computational effort of the pattern recognition scheme easier and the scanning region comparatively smaller.

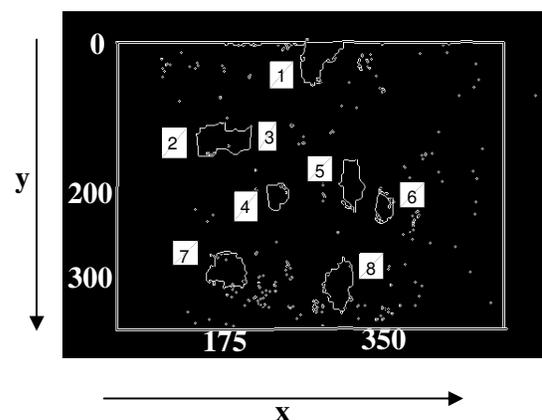
Figure 3. Detected Damage Regions in a Specimen.

It is also important to note that the objects labeled 2 and 3 in Figure 3 are considered to be a single object while processing and hence the combined geometric property of the system has been rendered instead of their individual statistics. This is due to the fact that in the real specimen the damages are in fact physically connected. However, by a proper control on preprocessing, lighting and camera resolution these two geometric regions can be separate incorporating some additional effort.

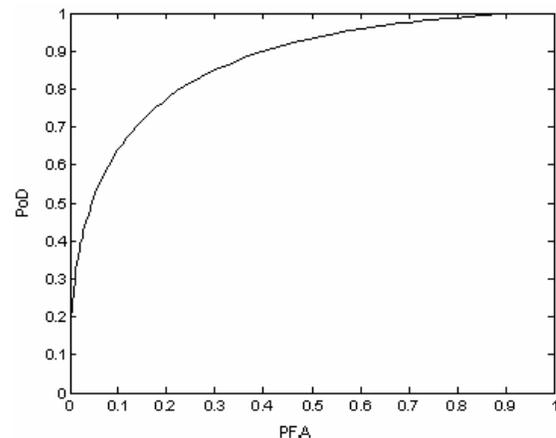
where A is the measured area. A_d is a deterministic parameter or a random variable. This definition implies that PoD is a monotonic increasing function. To complete this concept, the probability of false alarm has been introduced. It is the probability to defect a non-existing defect. For a given range of defects A_i , the curve that joints the points of coordinates (PFA, $PoD(A_i)$) is called Receiver Operating Characteristic (ROC) curves (Arques (1982), Fücsök et al. (2000)). Such a curve is plotted on figure 4.

Figure 4. Receiver Operating Characteristic curve.

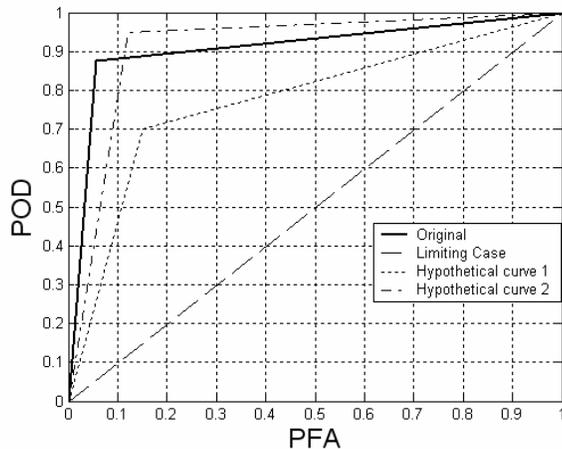
An application of such a case is provided in the current problem and the results are provided in Figure 5. The ROC of the current detection condition is constructed. With the increase of resolution, the PoD detection increases, but so does the PFA. On the other hand with poor resolution characteristics within the image, both PoD and PFA are considerably low. It is only at some intermediate level of resolution is the optimized value obtained where a high PoD corresponds to a minimum of PFA. The effects of high and low resolutions are earmarked within the figure. Two alternative hypothetical curves in dotted lines are employed to emphasize the effects of the presence of other factors within the same methodology like lighting, nature of damage, etc.

Figure 5 ROC Curves for the Current Problem.

The hypothetical ROC curves illustrate the uncertainties associated with the measuring conditions (which are variable) like luminosity, contrast, noise etc. and emphasize the shift of the efficiency achieved using the proposed NDT tool due to such uncertainties. It can be observed from Figure 5 that there may be possible cases where the ROC can be unsatisfactory due to the quality of the measured data itself and such situations can be identified by considering an envelope of ROC due to various conditions through existing data or simulations close to the chief governing conditions due to the change of the major affecting parameters. The efficiency and the robustness of the methodology are thus illustrated within the structural health monitoring framework in this regard.
