# Experimental testing on the influence of shaft rotary lip seal misalignment for a marine hydro-kinetic turbine

Article in *Sustainable Energy Technologies and Assessments* · December 2021

Brian P. Hand<sup>a,\*</sup>, Nuh Erdogan<sup>b</sup>, Dónal Murray<sup>a</sup>, Patrick Cronin<sup>c</sup>, John Doran<sup>d</sup>, Jimmy Murphy<sup>a</sup>

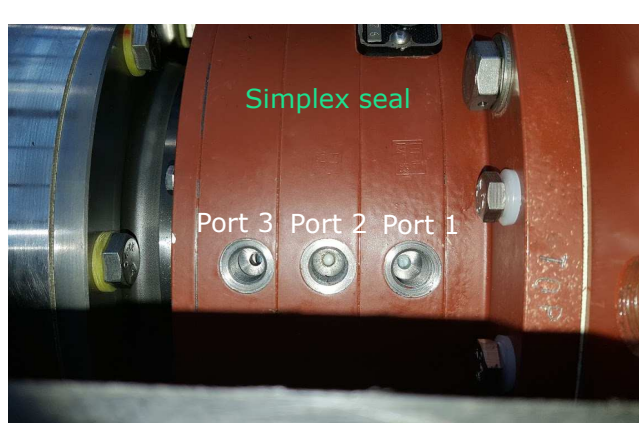
Figure 5: (a) Simplex seal chamber access ports (b) seal sectional view.

Each Simplex seal consists of three chambers and can be accessed by a port as shown in Figure 5a. Within each chamber is two lip seals as shown in Figure 5b, which are in contact with a cylindrical liner surrounding the drive shaft. The lip seal closest to the water pressure which in this case is lip seal 4 is pressed strongly against the seal liner.

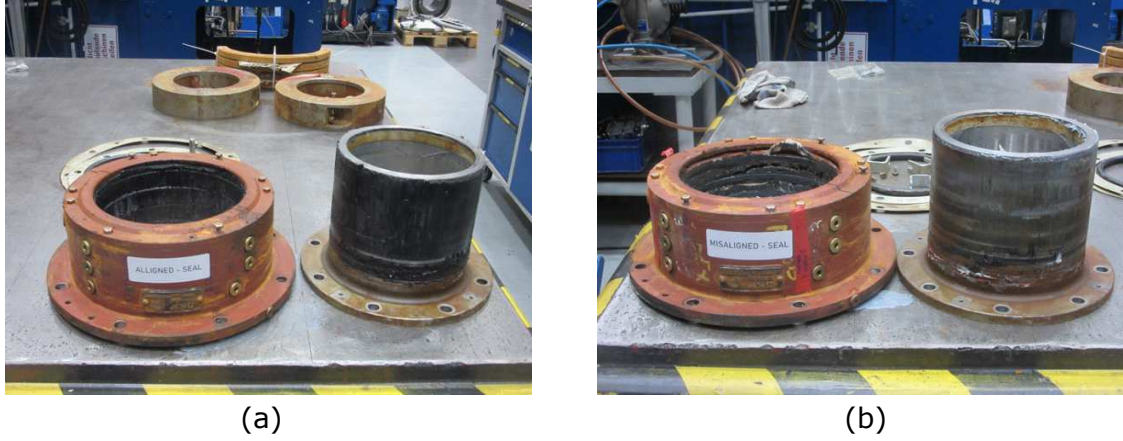
Figure 16: Simplex seals and associated liners prior to wear inspection (a) aligned (b) misaligned.

After the pressure and temperature data was collected from the experimental test rig, it was disassembled to permit wear inspection of both the lip seals and the seal liners as shown in Figure 16.

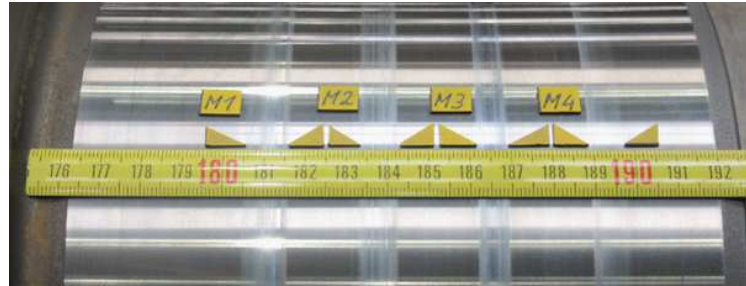
Figure 18: Track on the surface of the liner (a) aligned position (b) misaligned position.

It can be seen in Figure 18 that the lip seals left visible marks on the liners. It was expected that the track widths on the liner would be larger than the ones on the sealing rings. This is due to the ubiquitous run-out of the drive shaft or pressure fluctuations. In turn this produces wiping effects of the sealing rings on the liner. In Figure 18a, the wear tracks on the liner are clearly defined. On the other hand, the seal in the misaligned position as shown in Figure 18b, the tracks on the liner surface are less defined. It can also be observed in Figure 18 that there is significantly wider track widths on the misaligned liner when compared to its aligned state. Table 2 outlines the measurements of liner track widths and depths. The track depths

It was determined that in the misaligned state the wiping effects are more stronger than in the aligned state. From Table 2, it can be seen that the track width differences are large with the maximum difference being found to be between 52.94% and 97.60%. Another striking point is the track depth. This is significantly lower in the misaligned state than in the aligned state. This is because the sealing rings around the circumference do not have a constant surface pressure (as with the ideally aligned seal) on the liner and the contact pressure is distributed over a wider running surface. As expected the greatest differences is noted for LS1 and LS4 with approximately 100% difference between the aligned and misaligned seal liner wear track depths encountered. It is worth highlighting here the shaft deflection was  $1^\circ$ , which is the maximum the turbine would experience during operation.
