# Automatic inspection and assessment of a cross-passage twin tunnel using UAV

The inspection of large-scale tunnel networks is essential to identify any long-term deterioration mechanisms. Traditional manual inspection is not automatic and adaptive in geometrically complex tunnel configurations. This paper presents an automatic unmanned aerial vehicle (UAV)-based tunnel assessment application in a critical cross-passage twin tunnel section of Dublin Port Tunnel. It adopts a reactive method for UAV navigation and photogrammetry, and a point cloud for data processing. This study specifically verifies the patterns of cross-section deformation and defect distribution in twin tunnels and discovers that the deterioration pattern agrees with previous monitoring results. It shows that observed tunnel deformation could be attributed to the effect of twin tunnel interaction and vehicle cross passage, whilst the distribution of lining cracks could be associated with the differential structural stiffness and the differential longitudinal bending along the tunnel section.

The UAV tunnel inspection method is applied to a cross-passage twin tunnel section of DPT to evaluate its structural heal

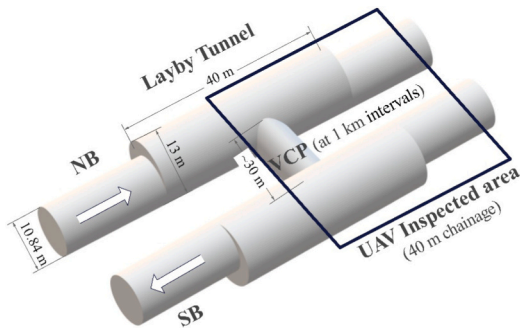
(b) Illustration of the cross-passage twin tunnel section

**Fig. 1.** DPT cross-passage twin tunnel section for UAV inspection.

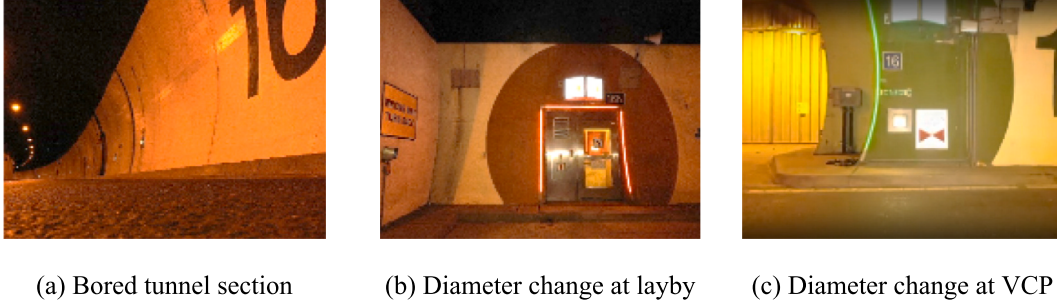
The complexity of tunnel geometrical variations poses a challenge to UAV image acquisition, as shown in Fig. 2. Along bored tunnel, the circular tunnel is c.a. 10 m in internal diameter. Near the start and end of the layby tunnel, there's an interior periphery change from 10 m to 13 m. Near the VCP where the twin tunnels are connected, the tunnel interior periphery achieves its maximum of 20–40 m. In this condition, the use of UAV enables image collection of 3D components with less cameras and more views in DPT than ground vehicles.

Fig. 2. Illustration of complex engineering geometry of the DPT section.

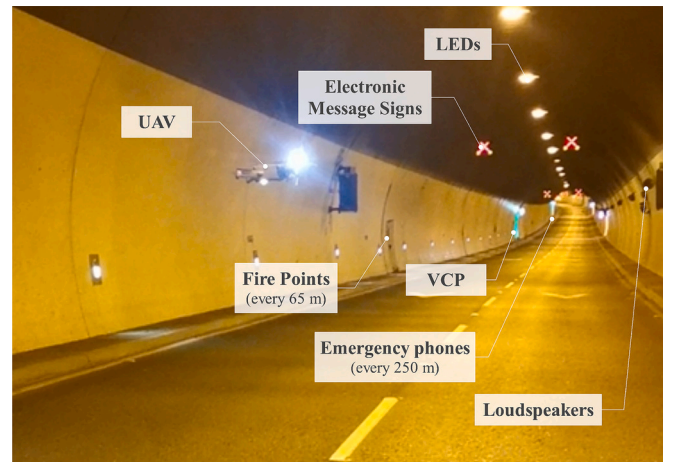
Fig. 6. Automatic UAV inspection of DPT.

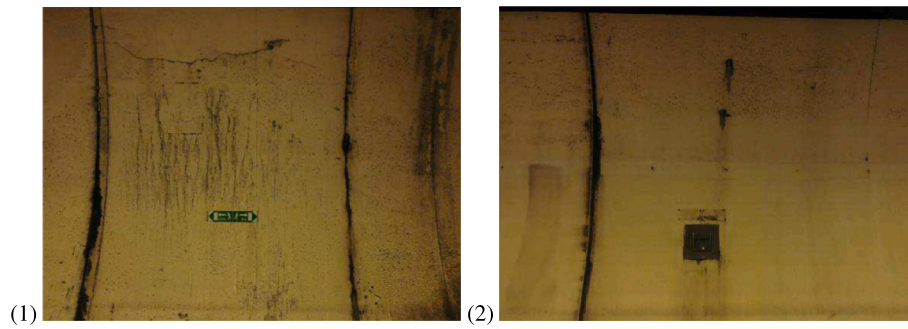
Fig. 7. Example images from raw DPT image dataset.

Two example raw images are shown in Fig. 7.

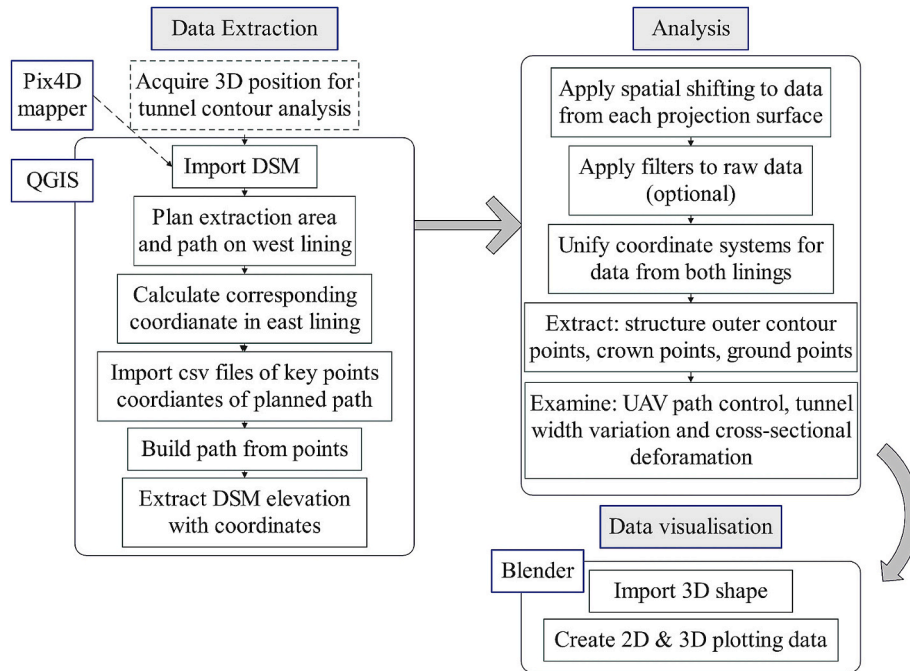
Fig. 10. Step-by-step workflow of data extraction and analysis from 3D tunnel models and software.

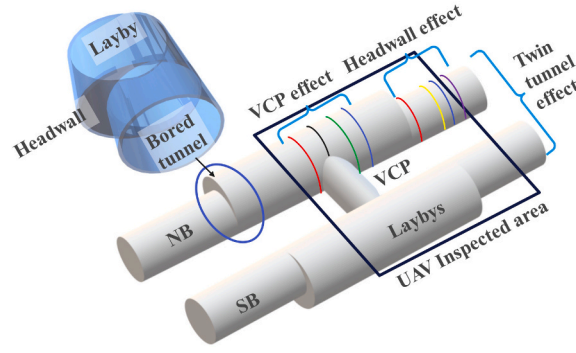
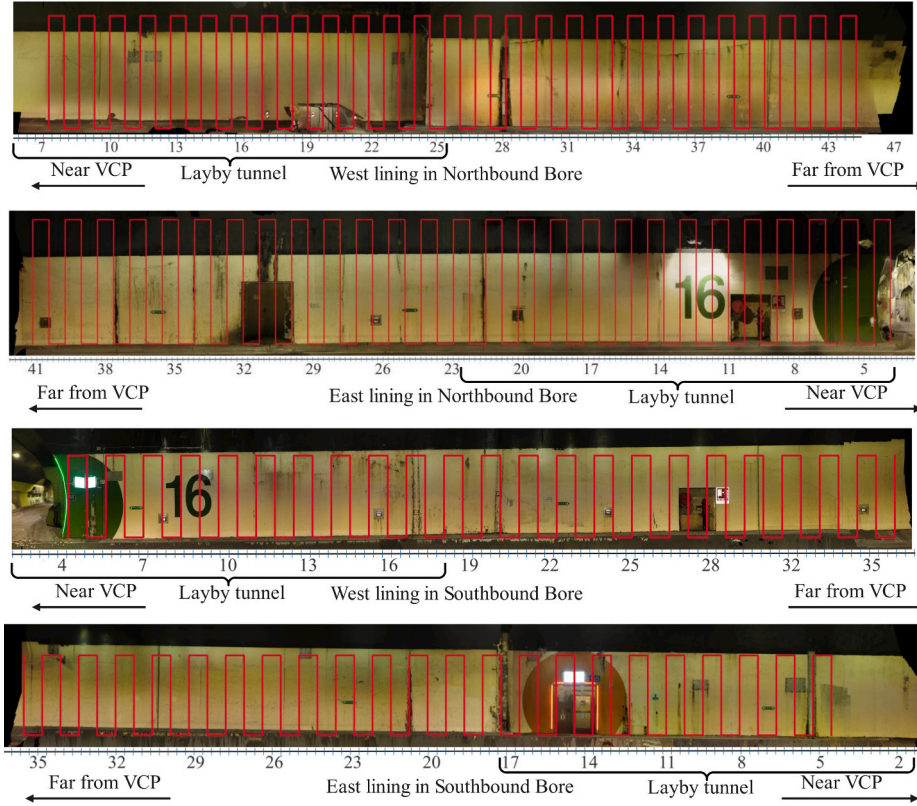
(a) Overview of data extraction at the cross-passage twin tunnel section

(b) Data extraction in four linings (tunnel mileage starts from VCP and is in the unit m)

**Fig. 12.** Cross-section shape extraction in DPT with extraction path in red lines. (For interpretation of the references to colour in this figure legend, the reader is referred to the web version of this article.)

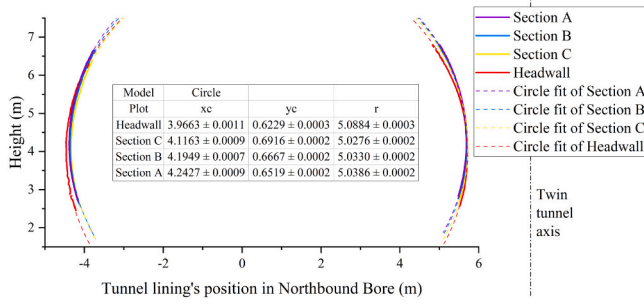
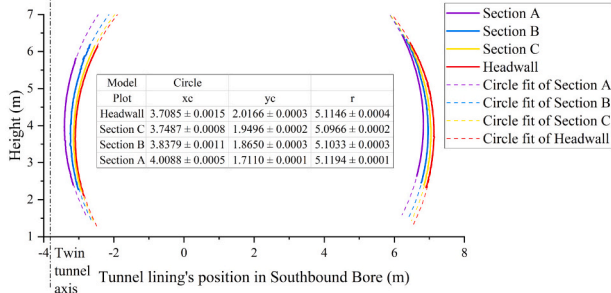
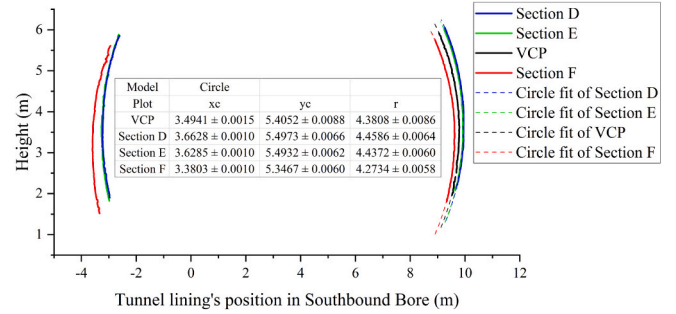
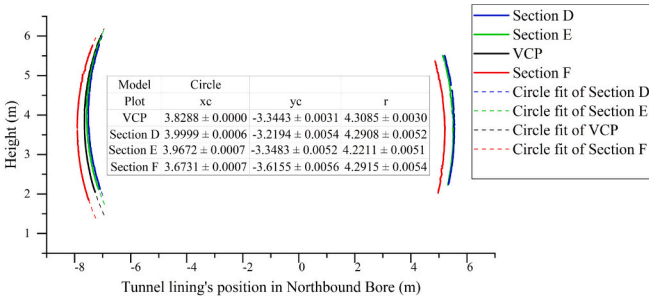
(a) Circular tunnels cross section comparison in NB

(b) Circular tunnels cross section comparison in SB

(d) Layby tunnels cross section comparison in SB

(c) Layby tunnels cross section comparison in NB

Fig. 15. Cross-sectional spatial information extraction and comparison

Figure 15 presents the spatial information extractions of the cross-

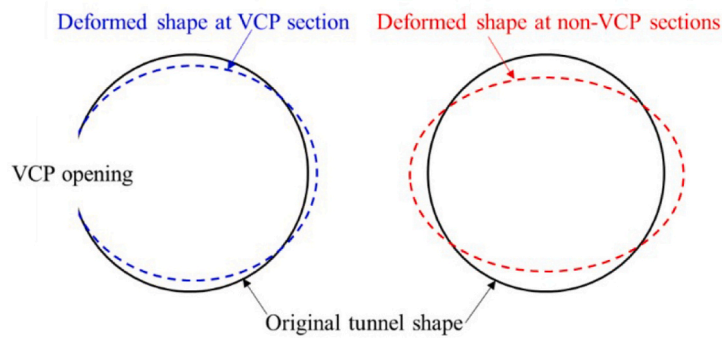
(a) Tunnel deformation under twin tunnel effect ([20])

(b) Tunnel deformation under VCP effect (modified from [24])

Fig. 17. Twin tunnel effect and VCP effect

Figure 19(b) and (c) demonstrates that the area surrounding the VCP in the layby tunnel exhibits minimal cracking, in contrast to the other side of the same bore, as shown in Fig. 19(a) and (d), respectively. This phenomenon may be attributed to the pushback from the VCP at the layby-VCP conjunction area, which results in strengthening and stiffening in the lateral compression responses at the layby-VCP connection, as illustrated in Fig. 17(b).
