# Automatic inspection and assessment of a cross-passage twin tunnel using UAV

The inspection of large-scale tunnel networks is essential to identify any long-term deterioration mechanisms. Traditional manual inspection is not automatic and adaptive in geometrically complex tunnel configurations. This paper presents an automatic unmanned aerial vehicle (UAV)-based tunnel assessment application in a critical cross-passage twin tunnel section of Dublin Port Tunnel. It adopts a reactive method for UAV navigation and photogrammetry, and a point cloud for data processing. This study specifically verifies the patterns of cross-section deformation and defect distribution in twin tunnels and discovers that the deterioration pattern agrees with previous monitoring results. It shows that observed tunnel deformation could be attributed to the effect of twin tunnel interaction and vehicle cross passage, whilst the distribution of lining cracks could be associated with the differential structural stiffness and the differential longitudinal bending along the tunnel section.

The inspected section of DPT is a cross-passage twin tunnel section called VCP 16. Its lining cracking, water leakage and

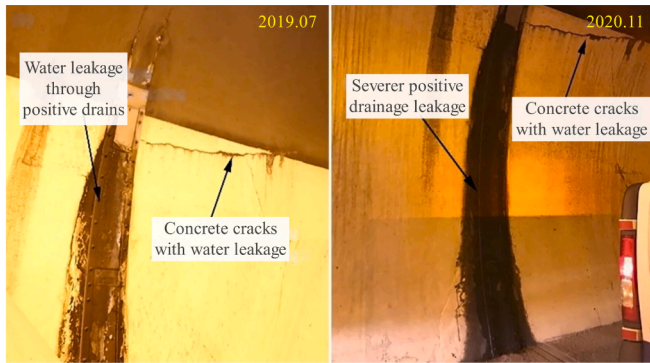
(a) Tunnel surface defects at VCP 16 [20]

**Fig. 1.** DPT cross-passage twin tunnel section for UAV inspection.

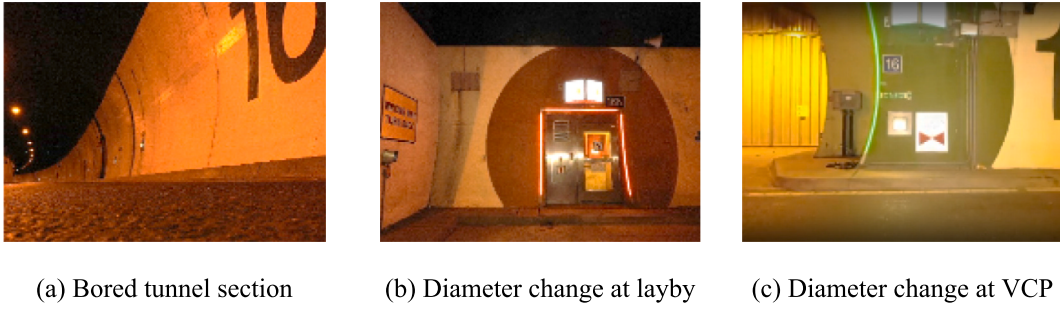
The complexity of tunnel geometrical variations poses a challenge to UAV image acquisition, as shown in Fig. 2. Along bored tunnel, the circular tunnel is c.a. 10 m in internal diameter. Near the start and end of the layby tunnel, there's an interior periphery change from 10 m to 13 m. Near the VCP where the twin tunnels are connected, the tunnel interior periphery achieves its maximum of 20–40 m. In this condition, the use of UAV enables image collection of 3D components with less cameras and more views in DPT than ground vehicles.

Fig. 2. Illustration of complex engineering geometry of the DPT section.

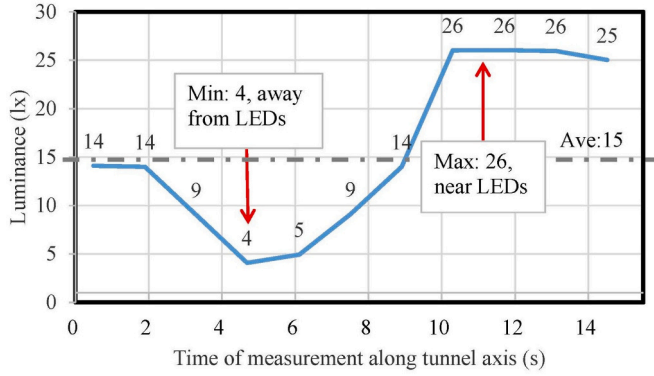
Fig. 3. Intensity variation of reflective light on tunnel side wall along DPT alignment.

In addition to its complex geometry, the DPT has low light conditions (see Fig. 3) that are unfavourable for UAV navigation. This is due to the uneven and low luminance of the LEDs in the DPT. As outlined in DJI's technical documentation, a minimum illumination level of 15 lx is necessary to ensure dependable navigation of UAVs. Therefore, the DJI spotlight module specifically designed for the M2ED model (refer to Fig. 4) has been integrated to facilitate visual navigation within the confines of tunnels. The light module is installed with a lampshade to produce even and scattering light [11]. It has a brightness of 2400 lm and can provide an adjustable light source of 300 lx in the field tests. Due to structural symmetry of DPT, the area boxed in Fig. 1(b) is chosen as the area of interest for UAV inspection where more cracks are observed compared to the opposite symmetrical section.

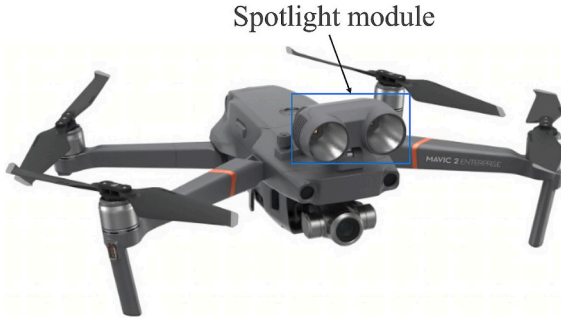
Fig. 4. UAV M2ED installed with DJI spotlight module.

The PMPP-SDI real-time reactive control algorithm is built on a light weight (909 g) M2ED platform [15,16]. The M2ED is equipped with lens of DJI FC6510, which has 85° FOV, 5472 × 3078 resolution and 12 M effective pixels. Each battery allows for 22 min flight with spotlight on. An innovative method PMPP-SDI is adopted for UAV image acquisition [31]. This method is tailored for the inspection of tunnels, caverns, and shafts. Its data acquisition principle (see Fig. 5) is to use dual visual sensors' feedback to navigate a UAV along the tunnel linings and rotate gimbals for image data collection. It enables UAVs to adapt their flight path to the environmental complexity, along the surface of diameter-variant tunnel geometries. In addition, the autopilot system of a UAV maintains a constant horizontal distance between its lens and the tunnel

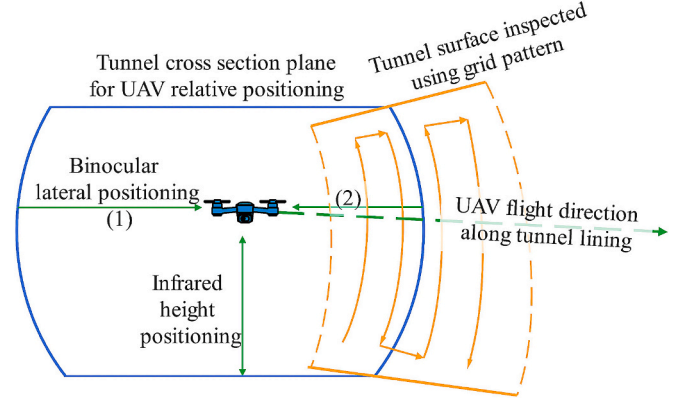
Fig. 5. Schematic of PMPP-SDI in tunnel surface information acquisition.

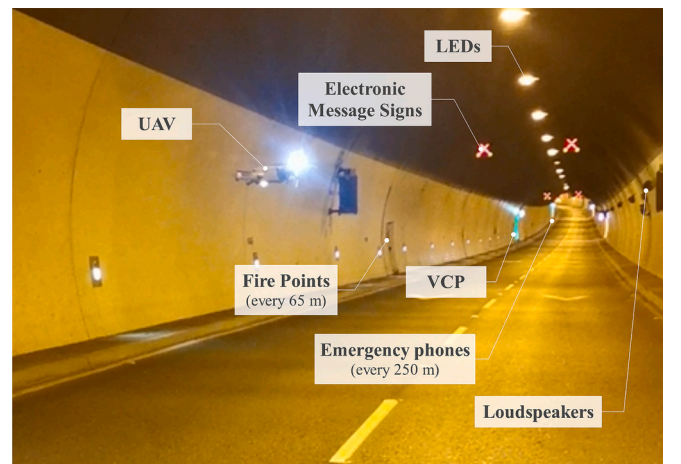
Fig. 6. Automatic UAV inspection of DPT.

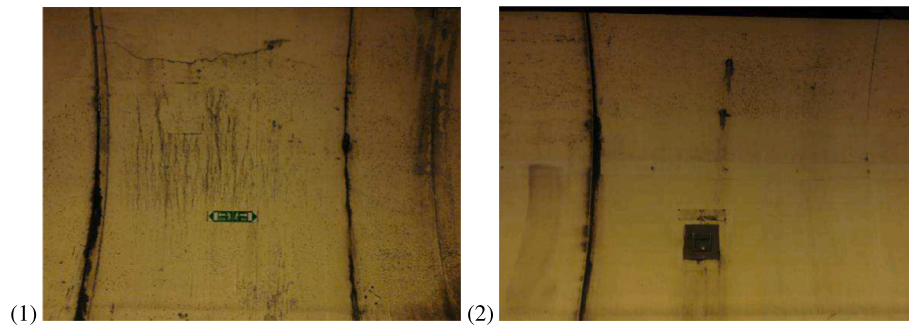
Fig. 7. Example images from raw DPT image dataset.

Two example raw images are shown in Fig. 7.

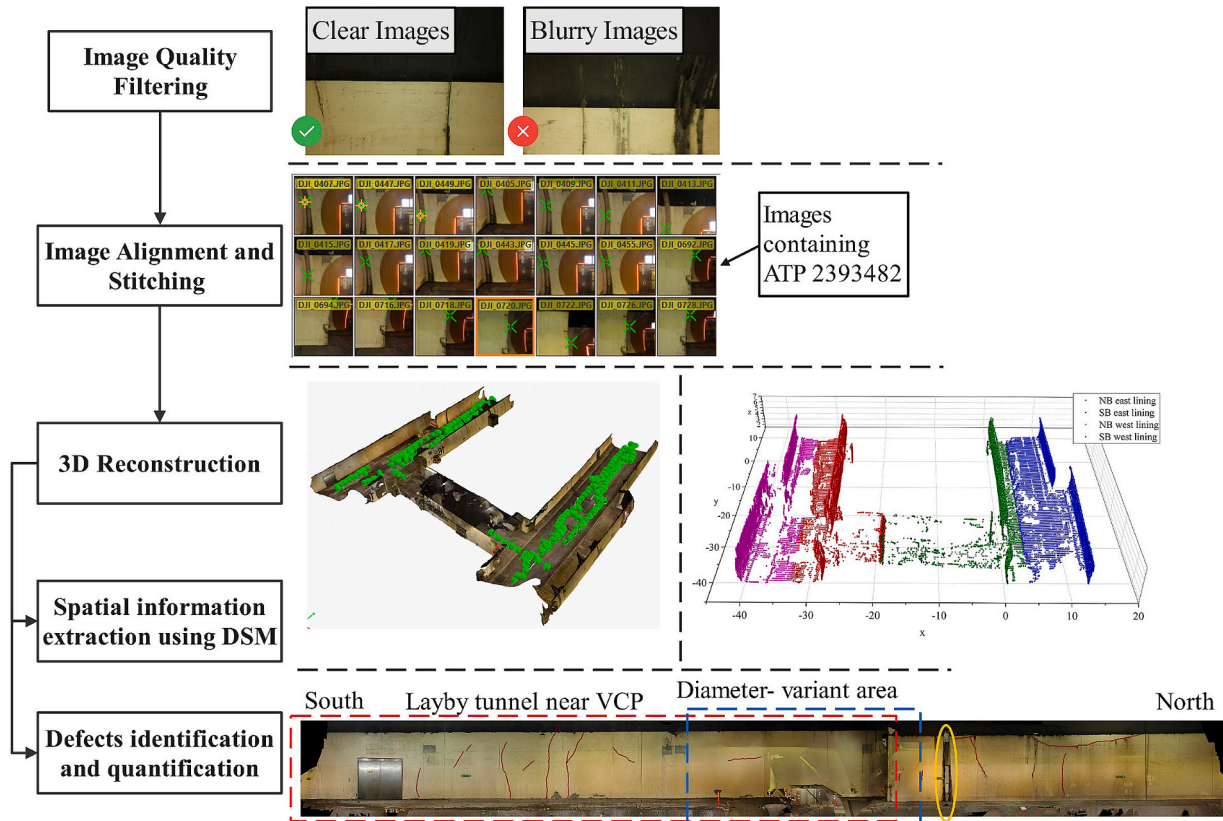
Fig. 8. Image processing workflow for DPT field test.

Fig. 8 illustrates the data processing workflow for 3D model reconstruction and defect analysis from a set of images using photogrammetry techniques. The method includes several key steps:

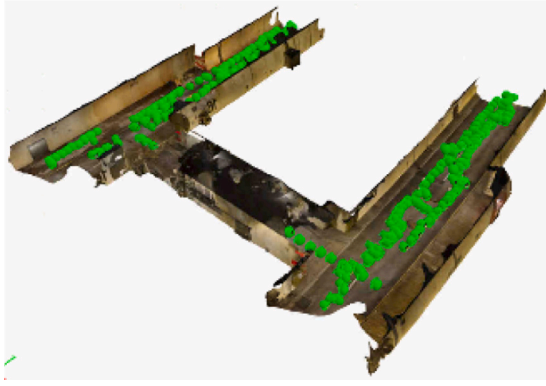
Fig. 9. Actual and target automated UAV flight trajectory in twin tunnels.

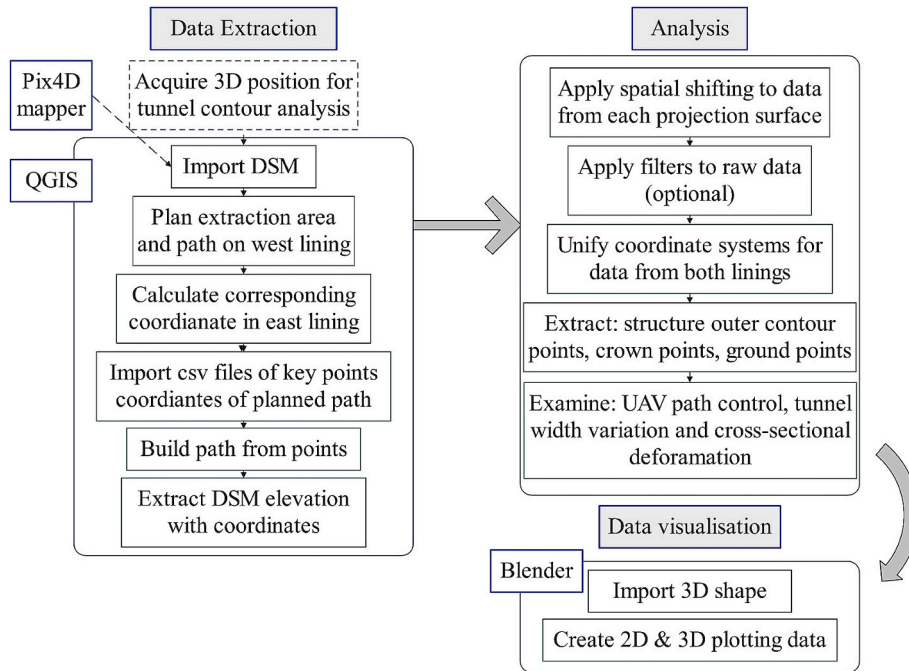
Fig. 10. Step-by-step workflow of data extraction and analysis from 3D tunnel models and software.

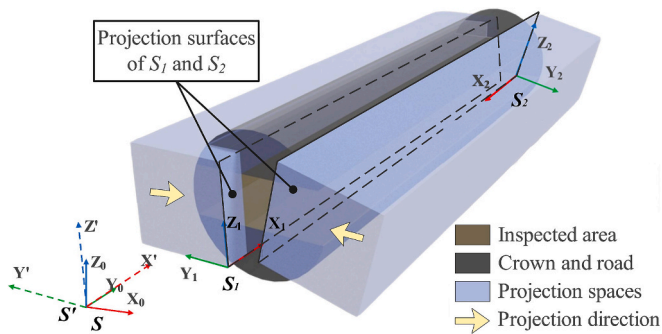
Fig. 11. Schematic of coordinate system unification ( $S'$ ) from DSM data ( $S_1, S_2$ ) and software local ( $S$ ) coordinate systems (by using the direction of  $S_1$  and origin of  $S$ ).

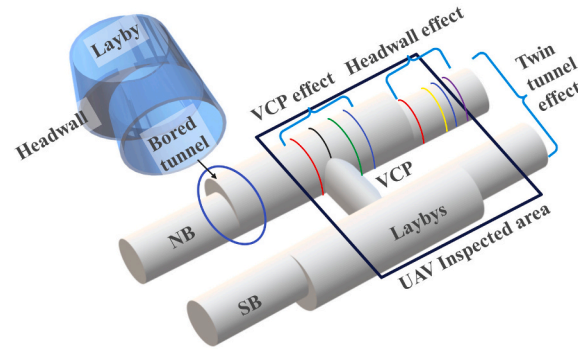
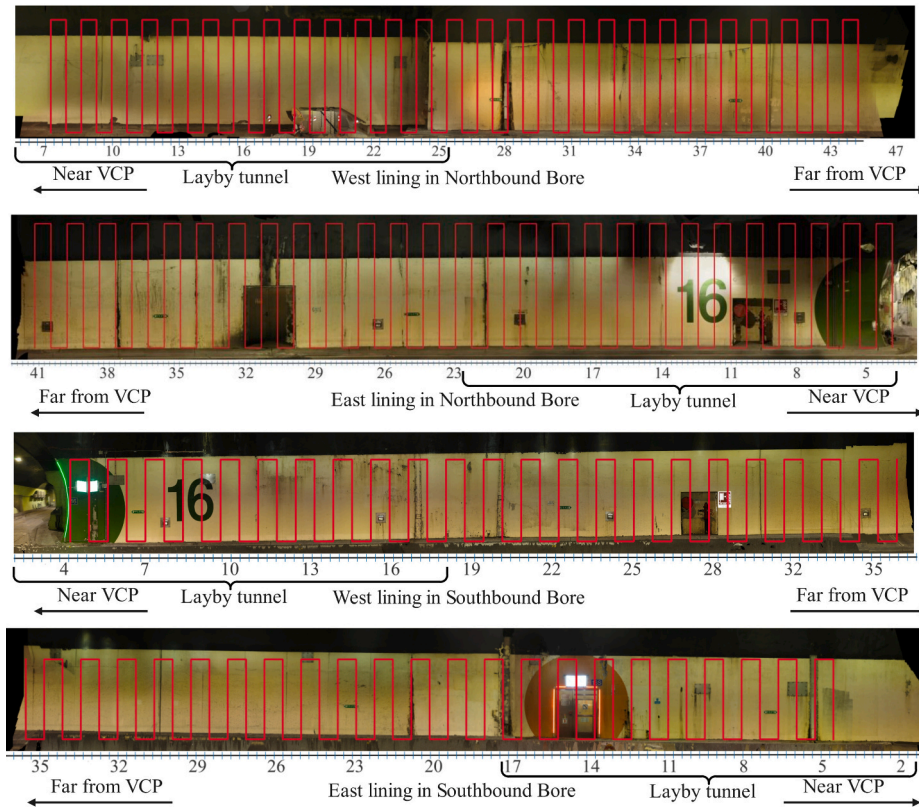
(a) Overview of data extraction at the cross-passage twin tunnel section

(b) Data extraction in four linings (tunnel mileage starts from VCP and is in the unit m)

**Fig. 12.** Cross-section shape extraction in DPT with extraction path in red lines. (For interpretation of the references to colour in this figure legend, the reader is referred to the web version of this article.)

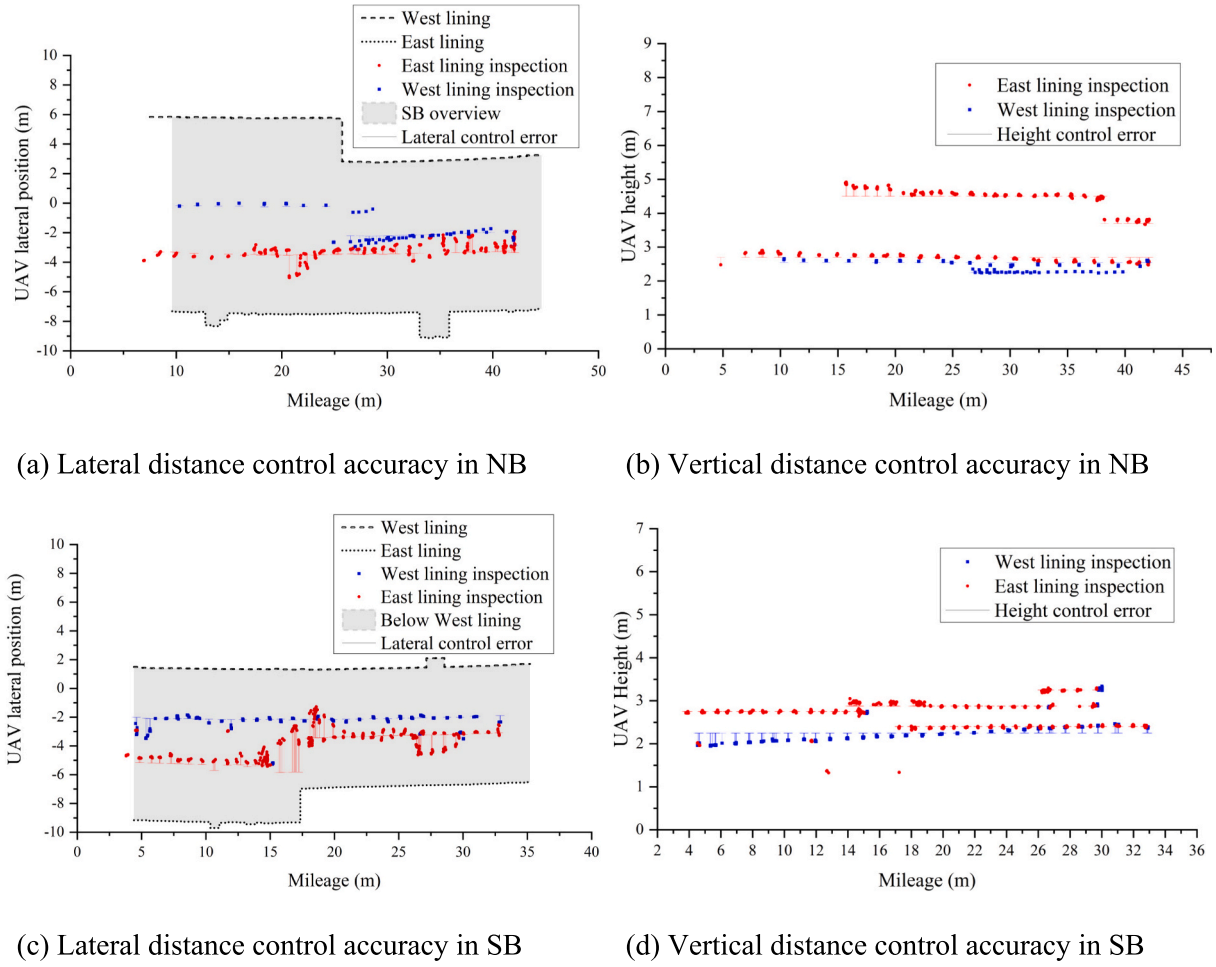
Fig. 13. UAV flying routes and control errors in the twin tunnels under coordinate system  $S'$ .

The UAV has a tolerable standard deviation of 0.6 m in lateral control and 0.1 m in height (as shown in Table 2). These minor errors highlight the effectiveness of UAV inspection in GPS-denied environments with varying tunnel geometries along the alignment. Occasional irreversible

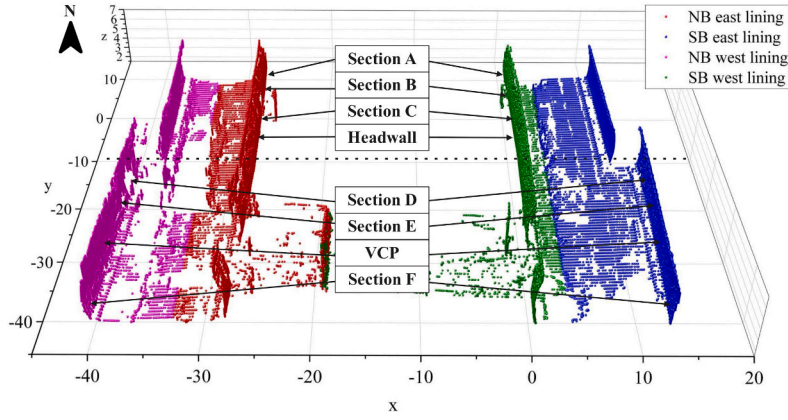
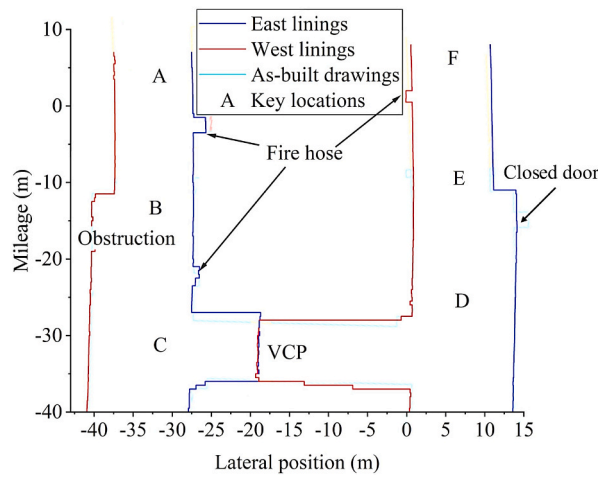
(a) 3D overview of extracted coordinates (m) with key cross section extraction locations

(b) Comparison of tunnel top view from DSM and as-built drawing

Fig. 14. Spatial information extraction results of DPT inspection

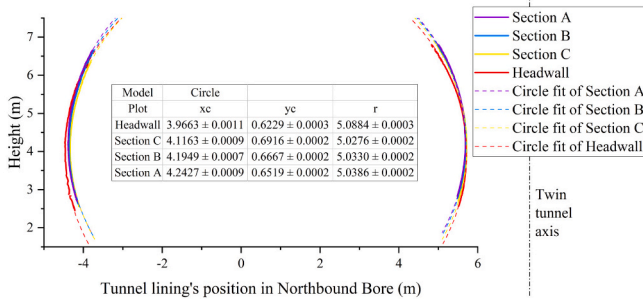
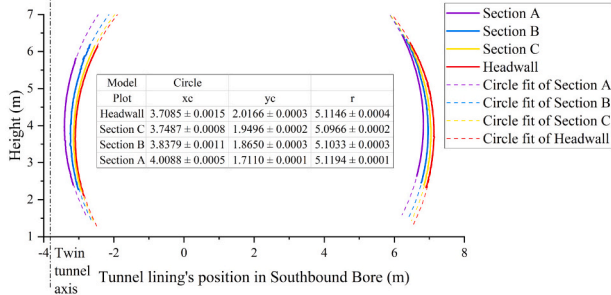
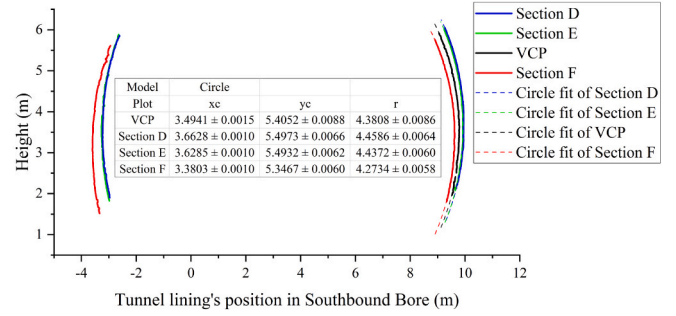
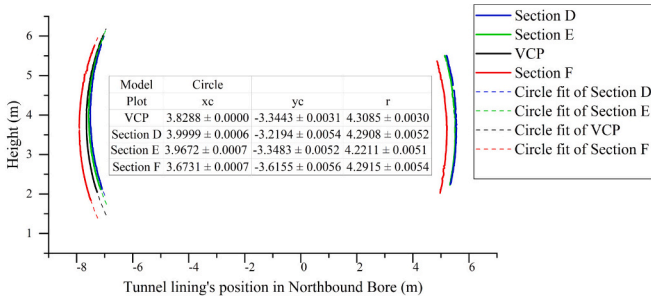
(a) Circular tunnels cross section comparison in NB

(b) Circular tunnels cross section comparison in SB

(d) Layby tunnels cross section comparison in SB

(c) Layby tunnels cross section comparison in NB

Fig. 15. Cross-sectional spatial information extraction and comparison

Figure 15 presents the spatial information extractions of the cross-

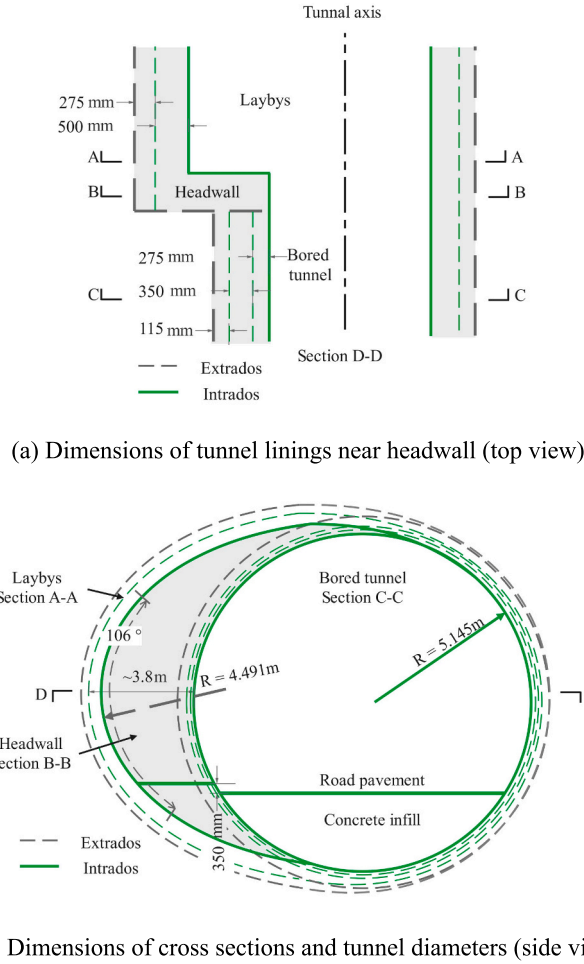
Fig. 16. Schematic of layby and bored tunnel geometry

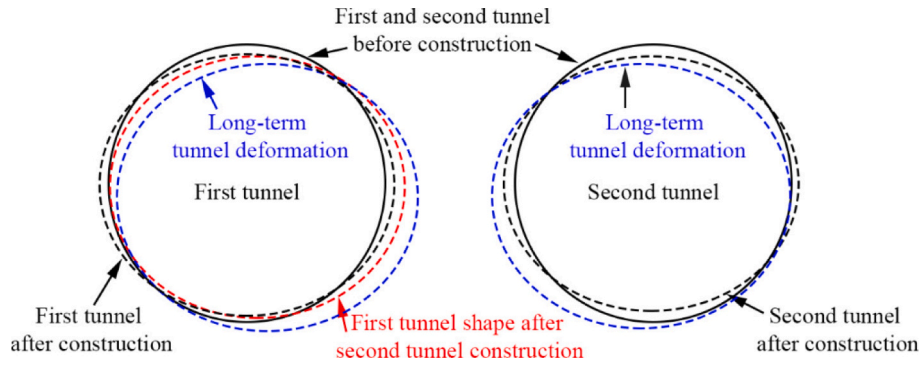
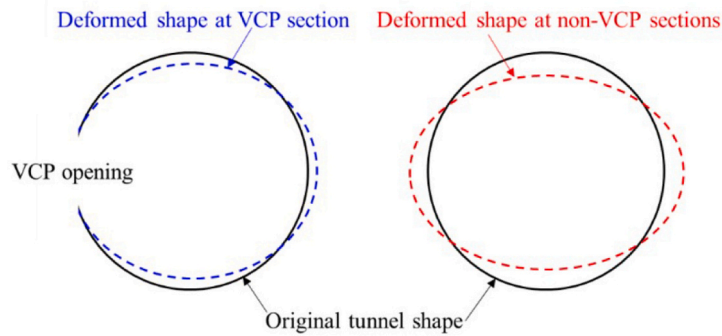
(a) Tunnel deformation under twin tunnel effect ([20])

(b) Tunnel deformation under VCP effect (modified from [24])

Fig. 17. Twin tunnel effect and VCP effect

Figure 19(b) and (c) demonstrates that the area surrounding the VCP in the layby tunnel exhibits minimal cracking, in contrast to the other side of the same bore, as shown in Fig. 19(a) and (d), respectively. This phenomenon may be attributed to the pushback from the VCP at the layby-VCP conjunction area, which results in strengthening and stiffening in the lateral compression responses at the layby-VCP connection, as illustrated in Fig. 17(b).

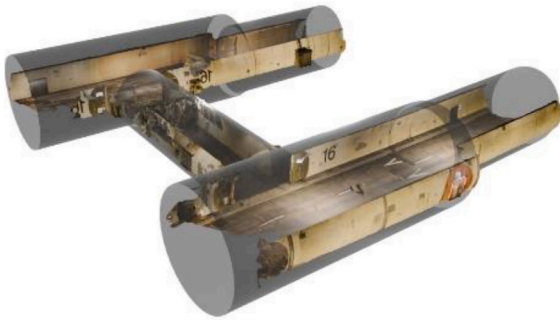
Fig. 18. 3D model of inspected DPT section (with VCP and layby tunnels)

The 3D visualization of the obtained tunnel model is shown in Fig. 18. Previous studies have analysed the accuracy of 3D UAV model reconstruction. In some studies, a resolution of 0.2 mm/pixel for static images was adopted for tunnel lining inspections [28]; and another has a resolution of 20–30 mm/pixel for UAV stitched images for road pavement crack identification [17]. Another UAV reconstruction quality assessment metric is defect reflection level index, such as the metric ‘pavement condition index’ (PCI) for highway surface assessment [29,30]. This index gives defect identification results along with

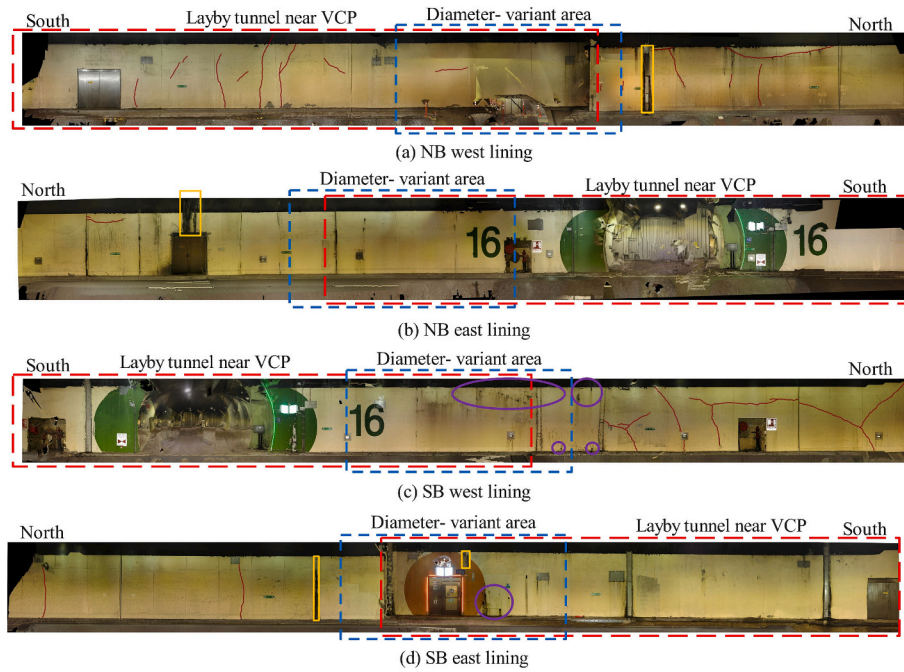
Fig. 19. Defect identification in the DSM from UAV images

shows almost no cracks. Leakage was observed on NB west linings at positive drains in the bored tunnels. Fig. 19(b) shows that NB east lining exhibited minimal cracks, while the layby area exhibited slight leakage, which is distant from the VCP. In Fig. 19(c), cracks were observed at the section away from the VCP. Similarly, Fig. 19(d) shows water leakage at positive drains and some vertical cracks at the north side of the SB east lining. As spalling may merely be a secondary effect of cracks and water seepage, and analysing it requires more complex methods than visual inspection, its role in lining degradation was not considered in the preliminary analysis presented below.

Figure 19 presents observations that verify the previous finding on the local deterioration patterns of tunnels. The number of cracks observed in diameter-variant areas is notably lower than in other areas, indicating that these areas exhibit greater resistance to deformation.

Figure 19(a) shows that most cracks are concentrated in the central area of the west layby enlargement, with a higher density in contrast to the diameter-variant area in non-VCP sections. This suggests that the strength and stiffness of the lining (due to the tunnel configuration) increased less around the central area of the layby tunnel, resulting in a greater subsequent increase in tunnel internal forces and deformation.

The data regarding the number and size of water leakage are presented in Fig. 19 with yellow box and Table 6 with the dimensions. In the tunnel sidewall inspection scenario, the water leakage is either from horizontal cracks or the blocked drainage. They can be identified by the width of the leakage (length in the horizontal direction of the tunnel). The crack-oriented leakage has a greater width, while the drainage-oriented width is almost the same as the drainage’s. The length of the leakage reflects its severity since the last cleaning of the tunnel lining. A greater length along the tunnel surface indicates a greater volume of leakage.

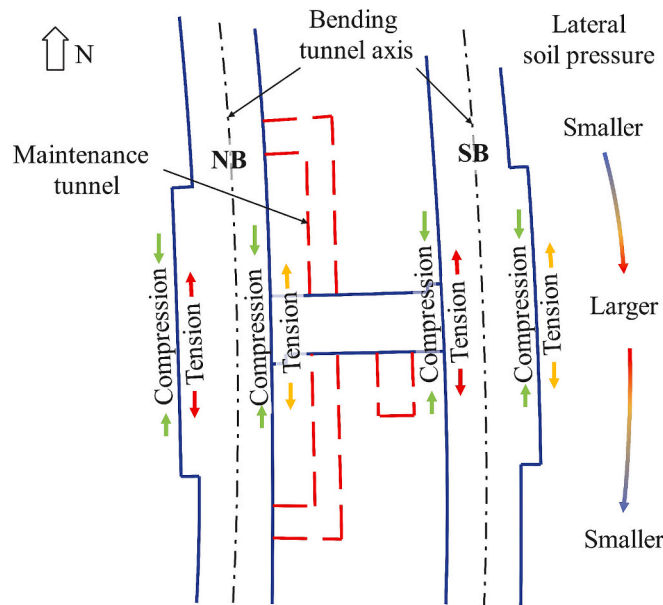
Fig. 20. Schematic of the tunnel construction plan

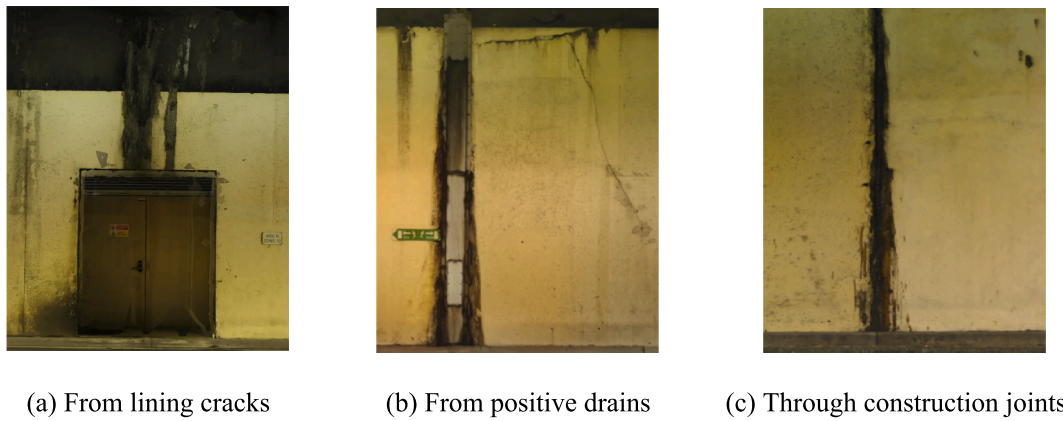
Fig. 21. Water leakage example in orthomosaics

Regarding water leakage in DPT, maintenance records indicate greater hydraulic deterioration in the northern part of the tunnel, as exemplified by the orthomosaics in Fig. 21. Water leakage penetrates the tunnel lining through various channels in the form of seepage, such as positive drains, construction joints, and lining cracks. The leakage of groundwater into the tunnel comes with intruding dark ground particles, indicating ground erosion and/or weathering behind tunnel lining [20]. The presence of progressive water leakage, together with the indicative ground erosion/weathering, leads to an increased humidity inside tunnel, an acceleration of deterioration of tunnel lining materials and soil behind, and an increase in ground pressure acting on tunnel lining. This means that an increasing tunnel internal forces and deformation is imminent. In the long term, the propagation of concrete cracks aggravates water leakage (i.e., a growing amount of water leakage into the tunnels), and in turn, the development of water infiltration also exacerbates lining cracking, contributing to an increasing tunnel deformation [20].

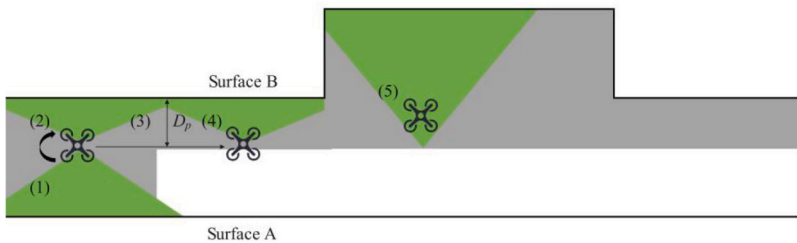
(2c) Scenario C: UAV moves along the original route.

Figure A describes the UAV inspection strategies in three scenarios of DPT for surface defect identification:

Fig. A. Three flying strategies in the PMPP-SDI method for UAV inspection varying structural and luminance (see [11] for details).
