| Title | An image analysis based damage classification methodology |

Pakrashi, V., O'Connor, A., Schoefs, F., 2007. An Image Analysis Based Damage Classification Methodology. In: Kanda, J., Takada, T., Furuta, H. (eds) *Applications of Statistics and Probability in Civil Engineering: Proceedings of the 10th International Conference, ICASP10*. Tokyo, Japan, 31 July - 3 August 2007. London: Taylor & Francis. pp.147-148 ISBN: 9780415452113

# An Image Analysis Based Damage Classification Methodology

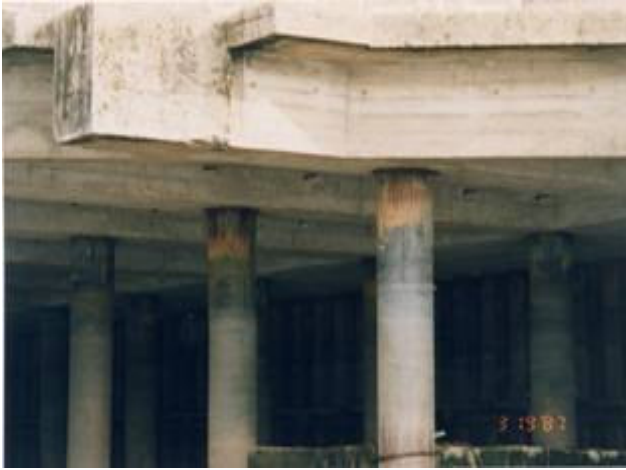
The benchmark structure is a wharf located at St. Nazaire, France and the general arrangement of the wharf is provided in Figure 1. This wharf belongs to the category of on piles wharfs. It is located in the

Figure 1. Steel piles with Corrosion.

Being in the marine environment, the steel piles are susceptible to corrosion and hence the assessment of the structural health of such a structure is considered to be of great practical importance. In fact steel piles play two major roles - the first being a mechanical function and the second being a protection of reinforced concrete inside against corrosion, which is generally uniform. Submarine inspections and investigations of localized corrosion have been observed by divers in this regard. These damage conditions have been recorded on video tapes and reported as pictures on inspection report. The damages look like pitting in white metals, which is usually why the corrosion is referred to as 'pitting corrosion'. This type of corrosion is often a consequence of the defects in the metals that the structure is comprised of. In fact, these piles come sometimes from the rebus of the pipe-lines (non-conforming pieces).

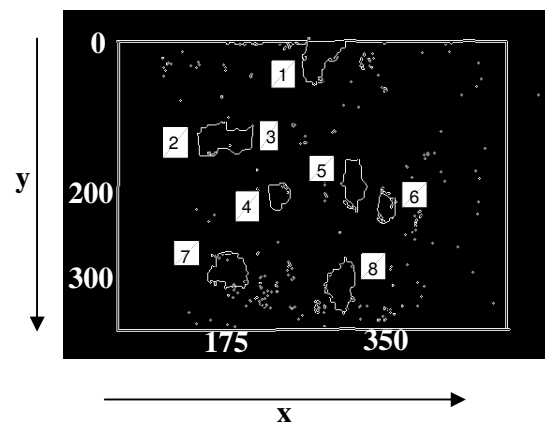
Figure 3. Detected Damage Regions in a Specimen.

An example of a successful image processing based damage region detection as proposed in the paper is given in Figure 3, where Figure 2 has been successfully analyzed to isolate eight major closed damaged areas of irregular geometry with precision. Some spurious features are also identified due to the environmental noise but are insignificant with respect to the damaged regions. Sometimes, a visual idea about the spurious features can be helpful to preprocess the picture to make the computational effort of the pattern recognition scheme easier and the scanning region comparatively smaller.

It is also important to note that the objects labeled 2 and 3 in Figure 3 are considered to be a single object while processing and hence the combined geometric property of the system has been rendered instead of their individual statistics. This is due to the fact that in the real specimen the damages are in fact physically connected. However, by a proper control on preprocessing, lighting and camera resolution these two geometric regions can be separate incorporating some additional effort.

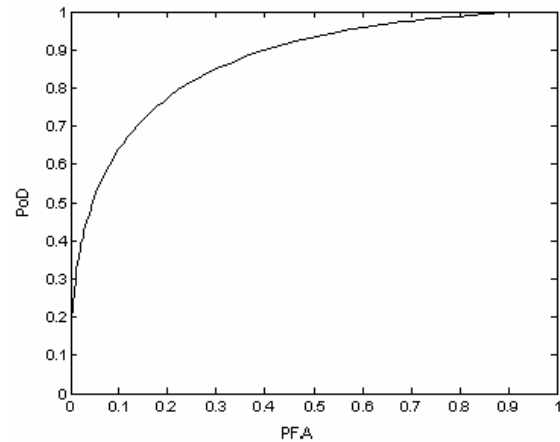
where  $A$  is the measured area.  $A_d$  is a deterministic parameter or a random variable. This definition implies that PoD is a monotonic increasing function. To complete this concept, the probability of false alarm has been introduced. It is the probability to detect a non-existing defect. For a given range of defects  $A_i$ , the curve that joints the points of coordinates (PFA,  $\text{PoD}(A_i)$ ) is called Receiver Operating Characteristic (ROC) curves (Arques (1982), Fücsök et al. (2000)). Such a curve is plotted on figure 4.

Figure 4. Receiver Operating Characteristic curve.

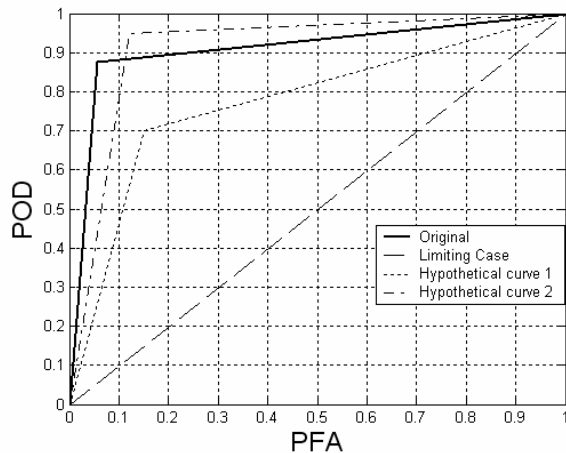
An application of such a case is provided in the current problem and the results are provided in Figure 5. The ROC of the current detection condition is constructed. With the increase of resolution, the PoD detection increases, but so does the PFA. On the other hand with poor resolution characteristics within the image, both PoD and PFA are considerably low. It is only at some intermediate level of resolution is the optimized value obtained where a high PoD corresponds to a minimum of PFA. The effects of high and low resolutions are earmarked within the figure. Two alternative hypothetical curves in dotted lines are employed to emphasize the effects of the presence of other factors within the same methodology like lighting, nature of damage, etc.

Figure 5 ROC Curves for the Current Problem.

The hypothetical ROC curves illustrate the uncertainties associated with the measuring conditions (which are variable) like luminosity, contrast, noise etc. and emphasize the shift of the efficiency achieved using the proposed NDT tool due to such uncertainties. It can be observed from Figure 5 that there may be possible cases where the ROC can be unsatisfactory due to the quality of the measured data itself and such situations can be identified by considering an envelope of ROC due to various conditions through existing data or simulations close to the chief governing conditions due to the change of the major affecting parameters. The efficiency and the robustness of the methodology are thus illustrated within the structural health monitoring framework in this regard.
