Title	Automatic UAV surface inspection method for underground infrastructure - a case study of Dublin Port Tunnel
Authors	Zhang, Ran;Li, Zili
Publication date	2023
Original Citation	Zhang, R. and Li, Z. (2023) 'Automatic UAV surface inspection method for underground infrastructure - a case study of Dublin Port Tunnel', Proceedings of the 11th International Conference on Sustainable Development in Building and Environment (SuDBE2023), Aalto, Finland, 14-18 August, Extended Abstract 288 (9pp).
Type of publication	Conference item
Rights	© 2023, the Authors.
Download date	2024-05-21 00:41:42
Item downloaded from	https://hdl.handle.net/10468/15788

Conference topic:**Automatic UAV surface inspection method for underground infrastructure – a case study of Dublin Port Tunnel**

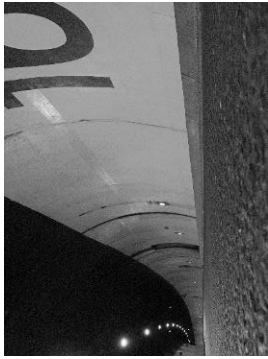
(1a) Scene A: Example of a slightly curved surface

Figure 4 Three flying strategies in the MPP method for UAV inspection varying structural and luminance.

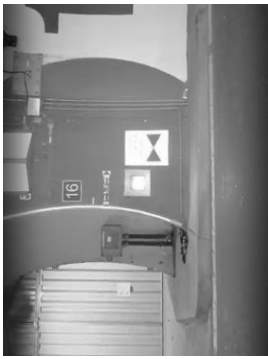
(3a) Scenario C: Example of large tunnel diameter change
