Pakrashi, V., Kelly, J., Harkin, J., Farrell, A., Nanukuttan, S., 2010. Emergency Rehabilitation of Brownsbarn Bridge. In: BCRI2010 Joint Symposium: Bridge and Infrastructure Research in Ireland BRI'10 and Concrete Research in Ireland CRI'10. Cork, Ireland 2 - 3 Sep 2010.

# EMERGENCY REHABILITATION OF BROWNSBARN BRIDGE

This paper outlines the repair methodology of Brownsbarn Bridge situated over the N7 near Dublin. The repair strategy was formulated following impact damage to the soffit from a low-loader carrying an excavator passing underneath the bridge. Significant damage was observed to one of the beams. The repairs were carried out as emergency works over a bank holiday weekend in Ireland successfully. The rehabilitation methodology is based on preloading the bridge before repair followed by a removal of load to ensure the reestablishment of some of the lost prestress. This paper outlines the various stages of rehabilitation and establishes the timelines of significant events along with practical discussions on the execution of the rehabilitation methodology. The bridge was continuously monitored throughout the refurbishment process. This case study is expected to be of topi

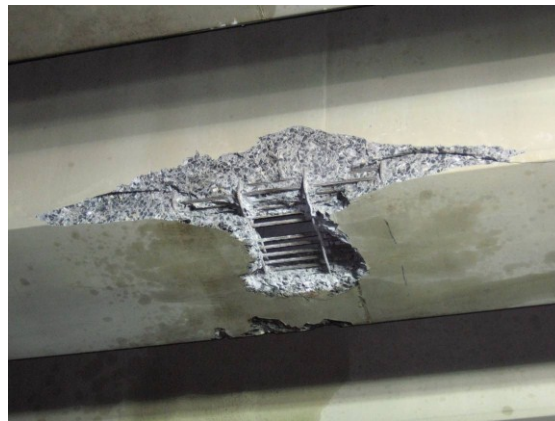
The damage extent was assessed and estimated by a number of techniques including an initial visual, photographic and hammer tapping condition survey. The extent was further investigated by incorporating an impact echo test (Tinkey et.al, 2005). In addition, a 3-D visualization was made available through laser scanning. Figure 2 and Figure 3 show the impact damage photograph and the 3-D visualization respectively. Significant damage was established to be extending at least 1.5m on either side of the visually apparent damage.

**Figure 2 – Photograph of Impact Damage**

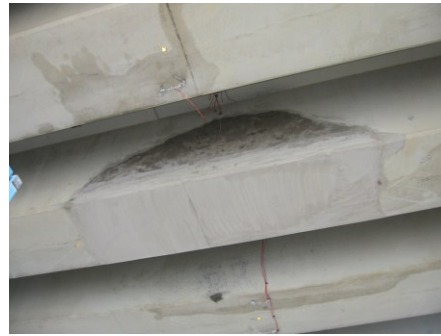
The preload was removed from the top of the bridge after the repair material gained adequate strength and some amount of prestress was reinstated following the removal of prestrain. The repaired section is shown in Figure 6 while the removal of preload is shown in Figure 7. A sample photograph of the traffic management provided by Complete Highway Maintenance throughout the rehabilitation is provided as Figure 8.

**Figure 6 – Repaired Section of Damaged Beam**

Hydrodemolition was followed by the installation of embedded strain gauges within the existing tendons and the application of high strength repair material. The material was expected to gain adequate strength within 12 hours and can take significant tension as well.

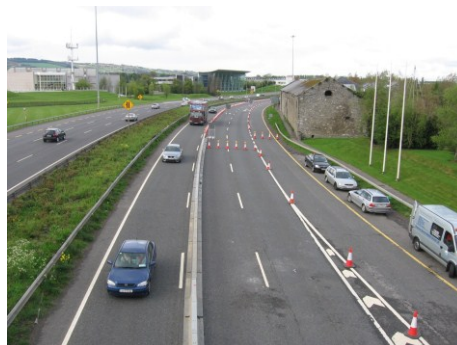
**Figure 8 – Traffic Management Provided during Rehabilitation**
