Pakrashi, V., Kelly, J., Harkin, J., Farrell, A., Nanukuttan, S., 2010. Emergency Rehabilitation of Brownsbarn Bridge. In: BCRI2010 Joint Symposium: Bridge and Infrastructure Research in Ireland BRI'10 and Concrete Research in Ireland CRI'10. Cork, Ireland 2 - 3 Sep 2010.

EMERGENCY REHABILITATION OF BROWNSBARN BRIDGE

This paper outlines the repair methodology of Brownsbarn Bridge situated over the N7 near Dublin. The repair strategy was formulated following impact damage to the soffit from a low-loader carrying an excavator passing underneath the bridge. Significant damage was observed to one of the beams. The repairs were carried out as emergency works over a bank holiday weekend in Ireland successfully. The rehabilitation methodology is based on preloading the bridge before repair followed by a removal of load to ensure the reestablishment of some of the lost prestress. This paper outlines the various stages of rehabilitation and establishes the timelines of significant events along with practical discussions on the execution of the rehabilitation methodology. The bridge was continuously monitored throughout the refurbishment process. This case study is expected to be of topica

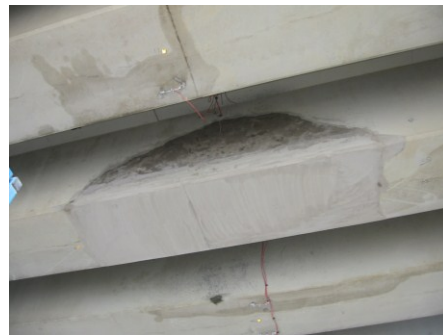
Figure 6 – Repaired Section of Damaged Beam

Hydrodemolition was followed by the installation of embedded strain gauges within the existing tendons and the application of high strength repair material. The material was expected to gain adequate strength within 12 hours and can take significant tension as well.

The preload was removed from the top of the bridge after the repair material gained adequate strength and some amount of prestress was reinstated following the removal of prestrain. The repaired section is shown in Figure 6 while the removal of preload is shown in Figure 7. A sample photograph of the traffic management provided by Complete Highway Maintenance throughout the rehabilitation is provided as Figure 8.

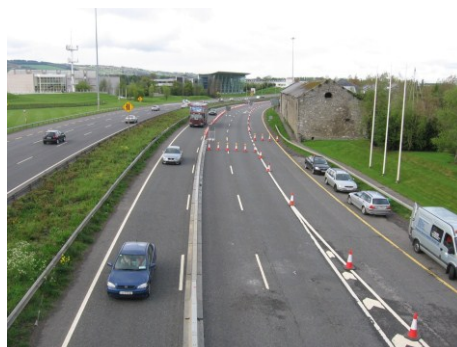
Figure 8 – Traffic Management Provided during Rehabilitation
