Souterrain in Grallagh Lower Td., Co. Waterford

By J. P. McCARTHY

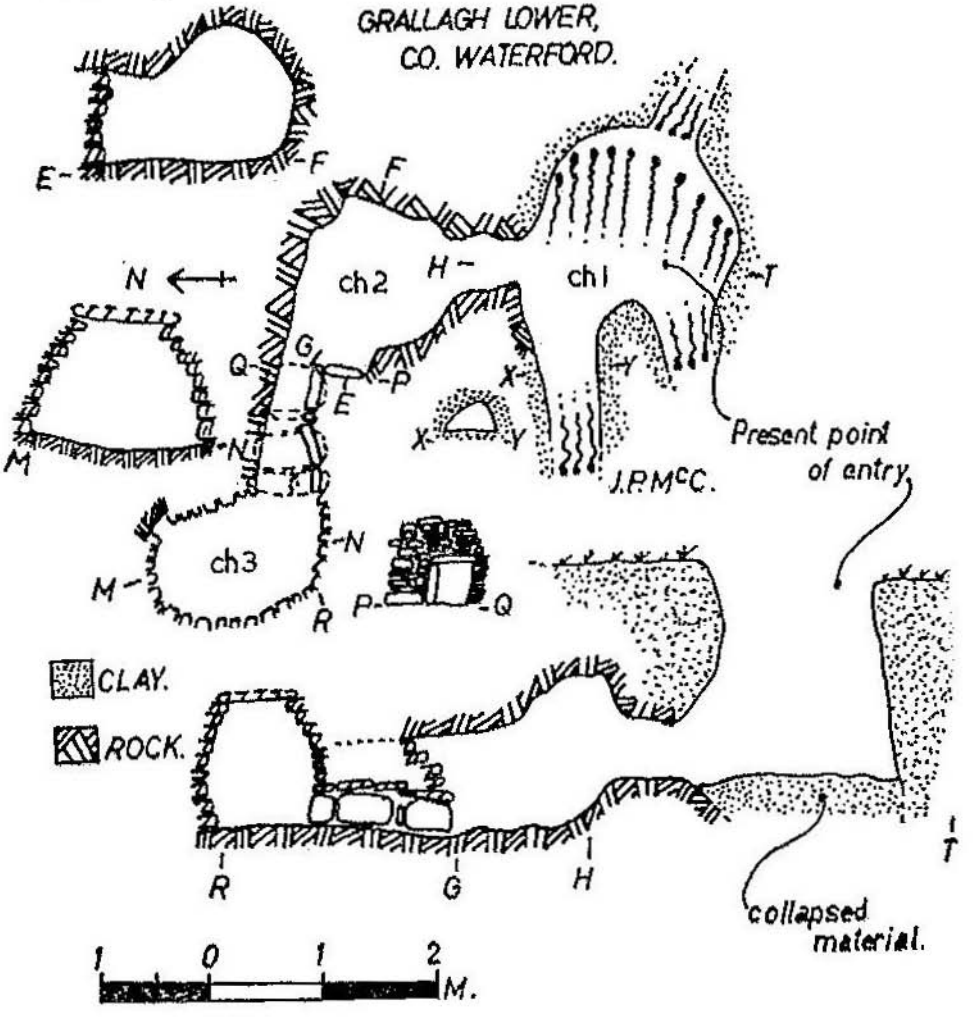
The souterrain consists of three chambers. Chamber 1 is clay-cut and has an irregularly circular plan. As a result of the collapse of the roof, there is a large deposit of soil on the E side. Running from the NW, SW and SE corners of the chamber are three low tunnels, the maximum average height of which is 30cm. Due to a soil fall the SW and SE tunnels could not be explored. However, that portion of the NW one which could be entered showed that the height of the tunnel decreased outward. It gave no indication of leading to another chamber. In the N wall of the chamber is a short, narrow, rock-cut creepway leading to Chamber 2. This chamber is oblong in plan, orientated NW/SE and totally rock-cut. The cleavage lines of the bedrock are also orientated in this direction. At the W end of the chamber is a dry-stone built wall. In this is the entrance to a creepway running W. The creepway is roofed with five lintels. Its S wall is slab-lined while the N wall is rock-cut. It slopes gently upwards from the floor of Chamber 2. It enters the SE corner of Chamber 3 which is a dry-stone built beehive chamber. The capping slab of this chamber is cracked and in danger of collapsing. Its floor is rock-cut.

There was no indication of the position of the original entrance to the site. Perhaps this was located at the end of one of the tunnels from Chamber I. A particular feature of interest at this site is its construction in three different types of material i.e., rock, stone and clay.
