EMERGENCY REHABILITATION OF BROWNSBARN BRIDGE

Abstract
This paper outlines the repair methodology of Brownsbarn Bridge situated over the N7 near Dublin. The repair strategy was formulated following impact damage to the soffit from a low- loader carrying an excavator passing underneath the bridge. Significant damage was observed to one of the beams. The repairs were carried out as emergency works over a bank holiday weekend in Ireland successfully. The rehabilitation methodology is based on preloading the bridge before repair followed by a removal of load to ensure the reestablishment of some of the lost prestress. This paper outlines the various stages of rehabilitation and establishes the timelines of significant events along with practical discussions on the execution of the rehabilitation methodology. The bridge was continuously monitored throughout the refurbishment process. This case study is expected to be of topical interest to researchers, practicing engineers, bridge owners and end-users alike.

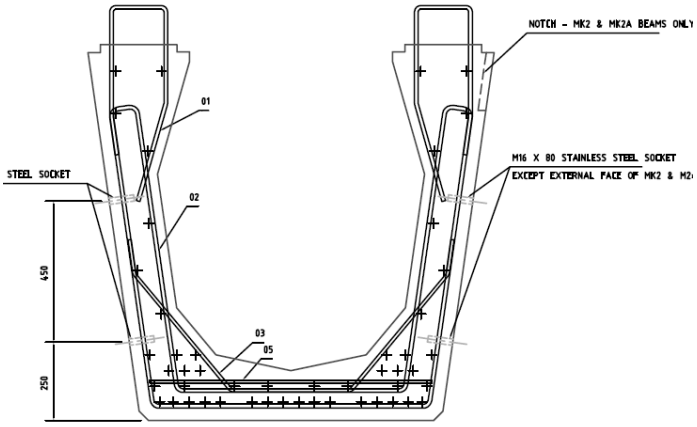
Figure 1 – As Manufactured Tendon Arrangement

detailed repair of both beams including the introduction of some of the lost prestress into the damaged location of the inner beam. Although one of the prestressing strands wass severed on the outer beam, it was computed that apart from this isolated severing of a strand, the prestressing tendons are essentially unaffected in both of the damaged beams. Under these circumstances, it was not envisaged that the damaged prestressing strand will be replaced.

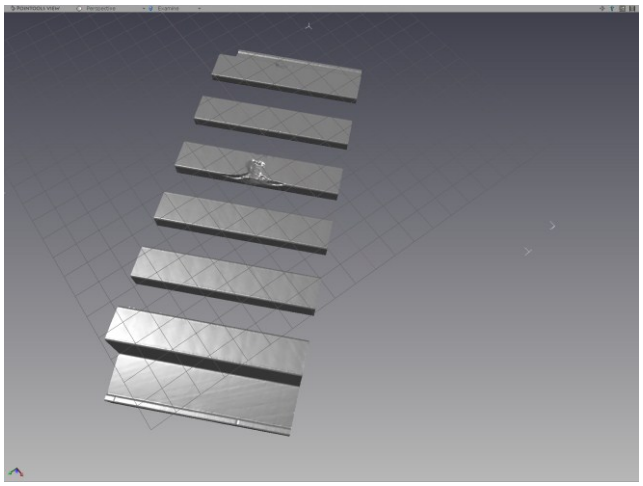
Figure 3 – 3-D Laser Scanning Visualisation made Available by Coastway Ltd.

The damage extent was assessed and estimated by a number of techniques including an initial visual, photographic and hammer tapping condition survey. The extent was further investigated by incorporating an impact echo test (Tinkey et.al, 2005). In addition, a 3-D visualization was made available through laser scanning. Figure 2 and Figure 3 show the impact damage photograph and the 3-D visualization respectively. Significant damage was established to be extending at least 1.5m on either side of the visually apparent damage.

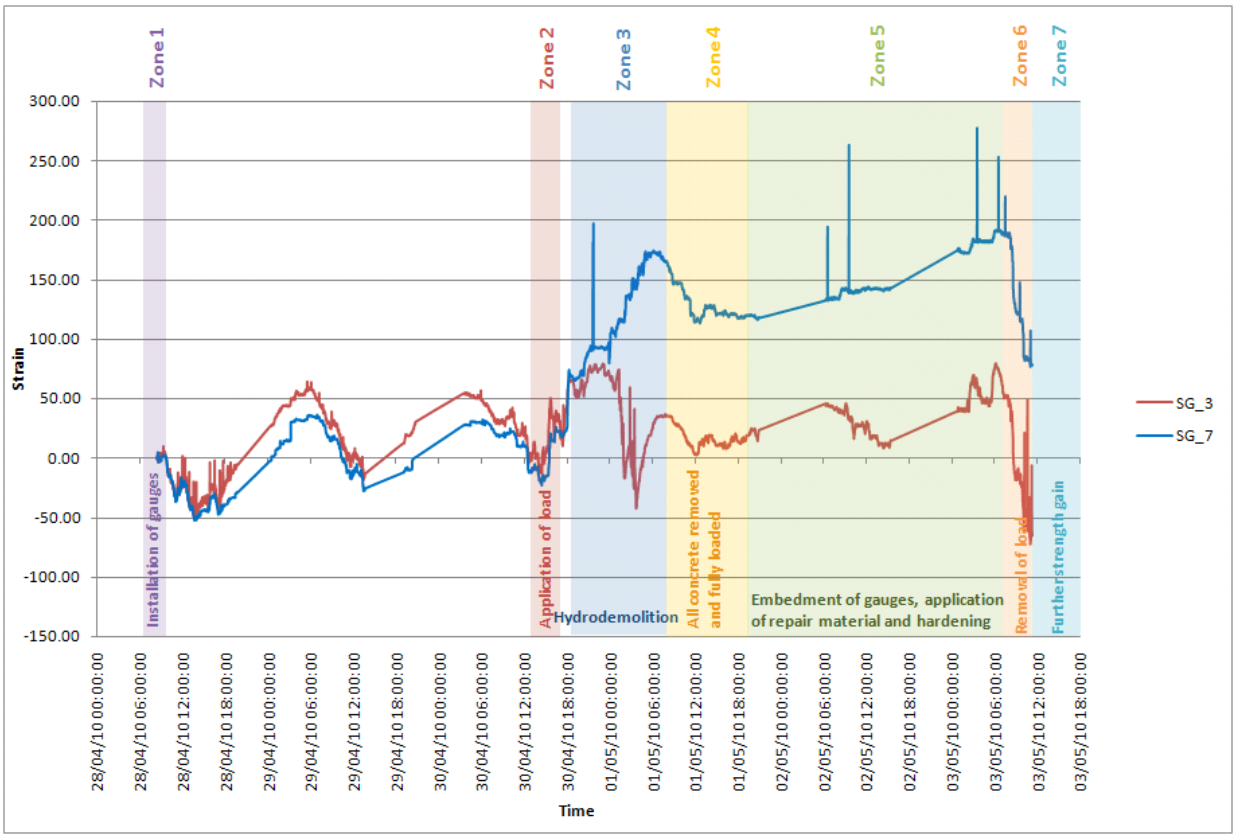
Figure 9 – Activity Footprints in Strain Gauge Monitoring Data and Event Hotspots

Figure 9 provides the example of two strain gauges from adjacent beams (damaged and undamaged) results during the entire rehabilitation process and zones them into the main activities along the timeline. The strains are in multiples of 10^{-6}. This graph creates the departure point of detailed structural health monitoring analyses including the effects of thermal oscillations, shrinkage characteristics, redistributions of strains, release of entrapped strains, participation and energy flow of adjacent beams and the real mechanics of structures similar to Brownsbarn Bridge. Such analyses are beyond the scope of the current paper.
