| Title | Real-time condition assessment of a painted megalithic cave using Wireless Sensor Network |

# Real-time condition assessment of a painted megalithic cave using Wireless Sensor Network

Chao Wang[a], Alice Tavares[b], Jorge Fonseca[b], Filipe Soares[c], Zili Li[a,*]

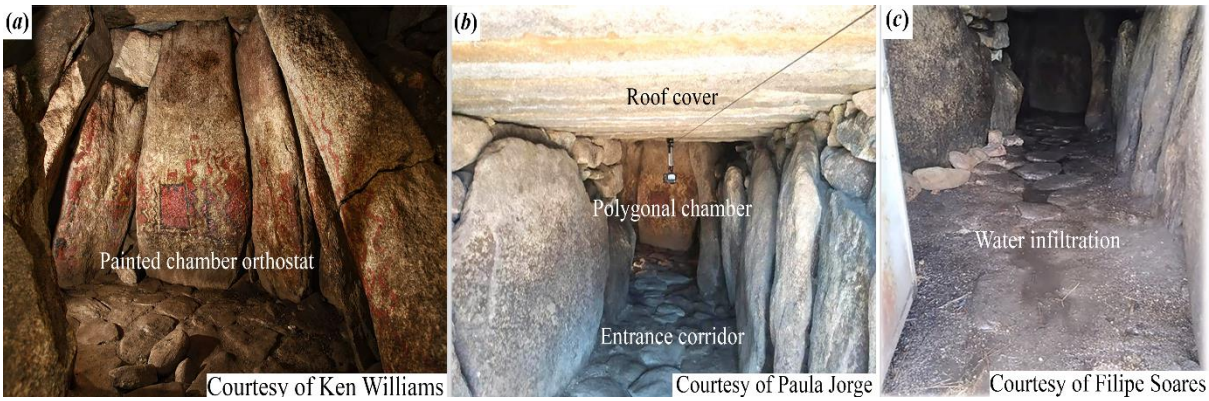
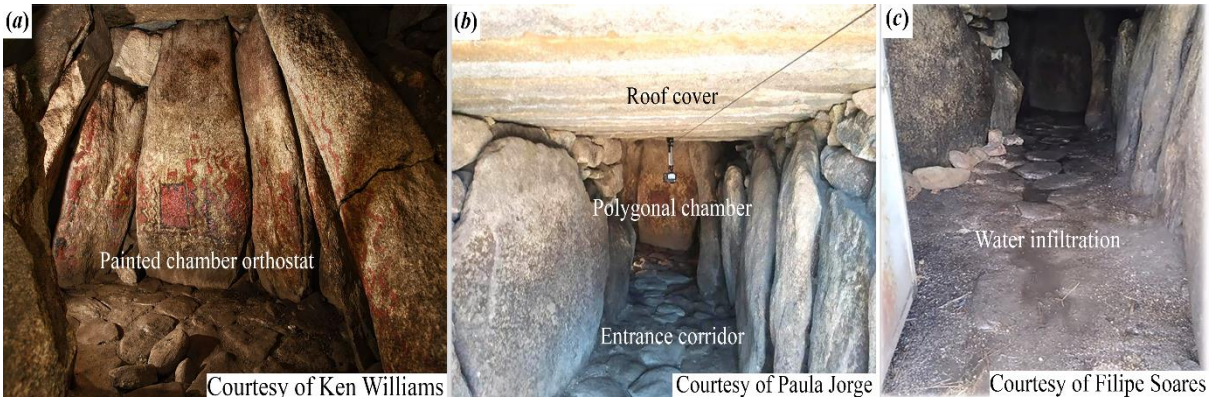
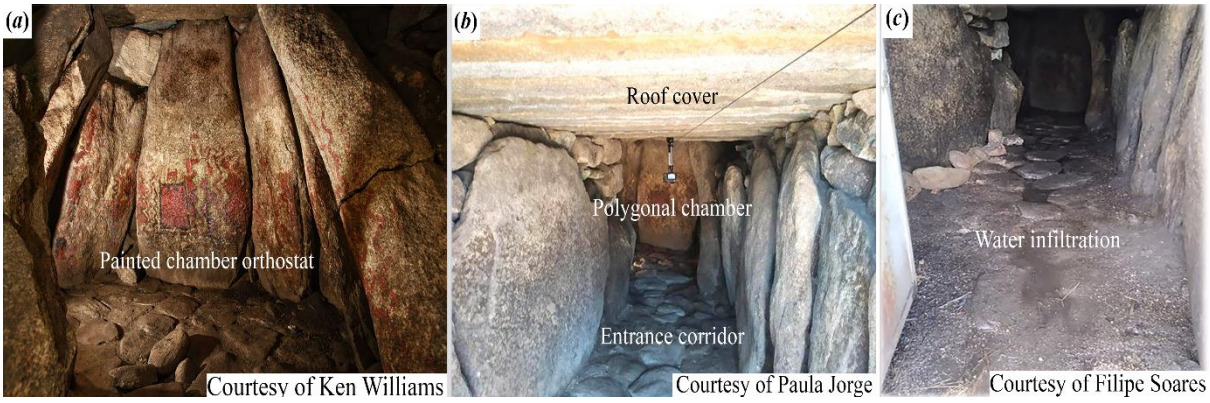
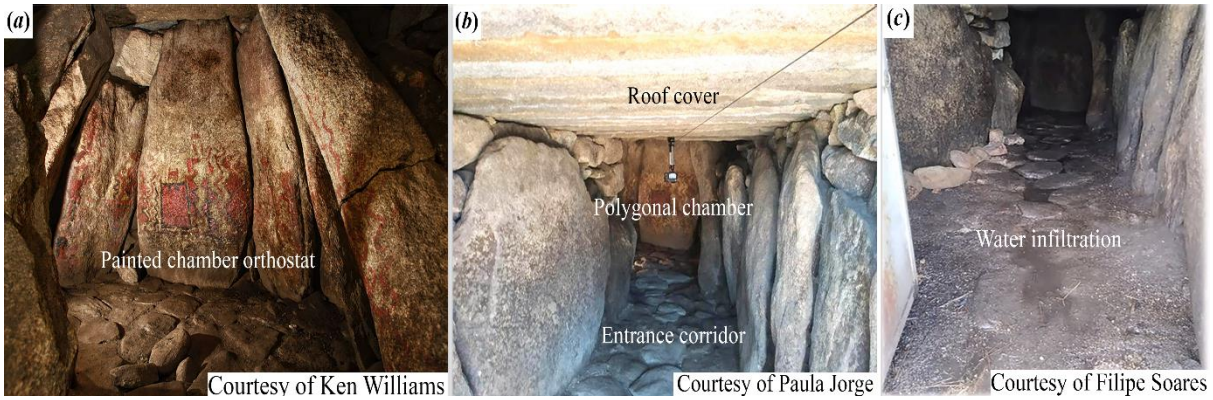
**Figure** 2. Painted chamber of Dólmen de Antelas

**Figure** 2(*b*)). With time, deteriorations of the Dolmen were observed. The infiltration of water (

**Figure** 2(*c*)), the lack of circulation in a confined space (Figure 4(*a*)), and the decades-long canvas perforation by vegetation roots (Figure 4(*a*)) are all likely contributors threatening painting deterioration and structure stability. If left unmanaged, the Dolmen will deteriorate even faster, further jeopardising its archaeological, cultural, historic values.

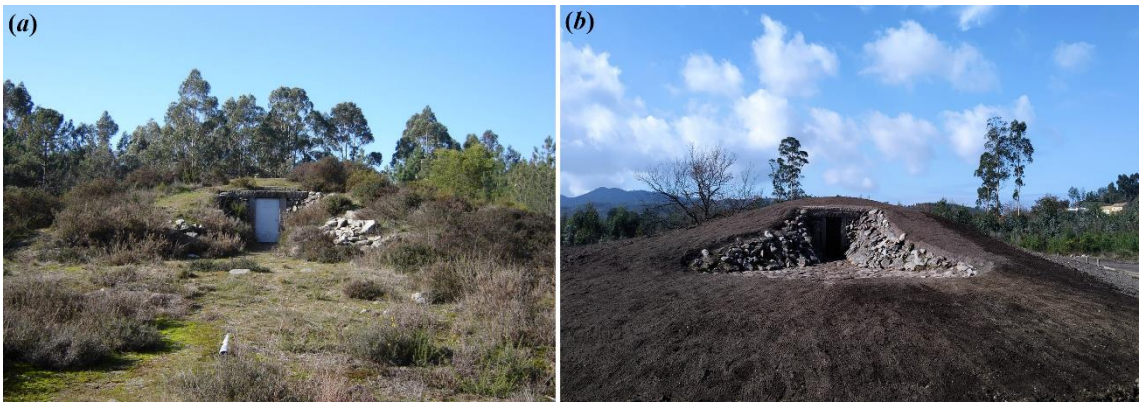
**Figure** 4. Dolmen view. (a) Before intervention (b) After intervention

Twenty-plus years on, the previous restoration efforts turned out not as effective as expected in the long run. Having been aware of this, the Municipality has developed a series of rescue actions aiming at preserving the paintings and protecting the dolmen. In 2019, a comprehensive characterisation and diagnosis of the monument, including the identification of rock, biological colonisation, and painting pigments (see Section 2.3), was firstly conducted, contributing to the definition of future clear-cut conservation measures for this megalithic art piece (Antonio et al., 2019; Costa, 2020). Following the diagnosis, another recent conservation project aiming at creating better environmental conditions for preserving the prehistoric remains was implemented in 2020. The main tasks included the replacement of the perforated waterproofing screen and the placement of a drain around the perimeter of the artificial mound to stabilise the interior environment of the monument as well as to restore acceptable levels of humidity and temperature inside the chamber and eliminate condensation problem. Figure 3 and Figure 4 present the detailed tasks carried out in this recent intervention project and the dolmen view before and after the intervention, respectively. In the last quarter of 2020, a joint research under the COST U4V framework was carried out to investigate the long-term structural and environmental performance of this monument, aiming to understand the data-based structural stability and environmental conditions before planning the next-stage conservation and officially opening it to the public.

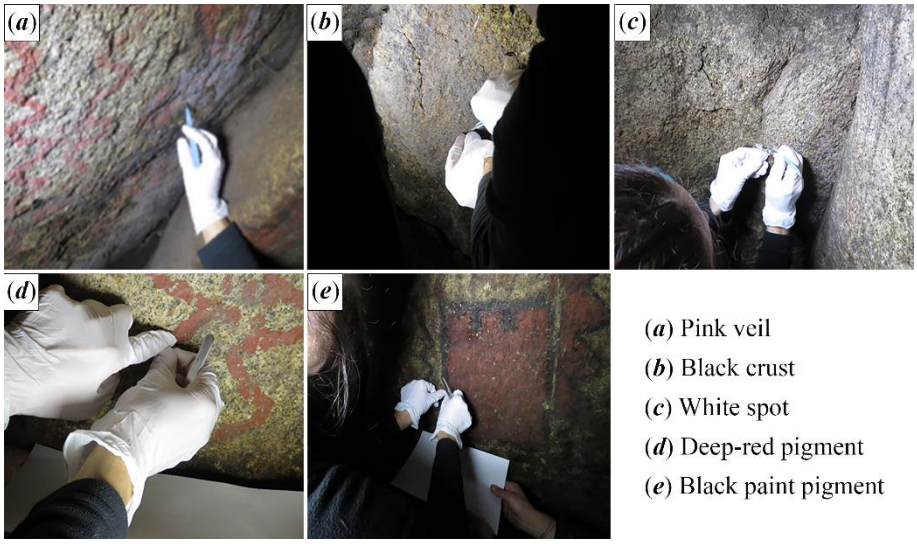
**Figure** 5. Dolmen painting characterisation (Antonio et al., 2019)

To better understand this painted heritage cave, a group of specialists conducted a series of detailed analyses on the characterisation of dolmen pillars, paintings, and biological colonisation. The rock pillars were identified as weathered granite rich in three minerals: quartz, potassium feldspar and muscovite, upon analysing the petrographic and X-ray diffraction results (Antonio et al., 2019). Based on microscopic analyses, it was concluded that there is a wide pink existence of a fungi in its growth and colonisation phases on all granite pillars (Figure 5(*a*)) and all other coloured samples collected were found to have no obvious live microorganisms (Figure 5(*b-c*)) (Antonio et al., 2019). Moreover, the composition of painting materials was determined by X-ray diffraction and SEM: (1) the deep-red painting layer (Figure 5(*d*)) is dominantly-rich in hematite ($Fe_2O_3$), with a cracked base layer suggesting

some deterioration possibly associated with wet-dry cycles; (2) the black pictorial layer (Figure 5(*e*)) is identified to be plant-nature, *C*-rich and *Al*-rich charcoal sitting on a base layer of kaolinite.

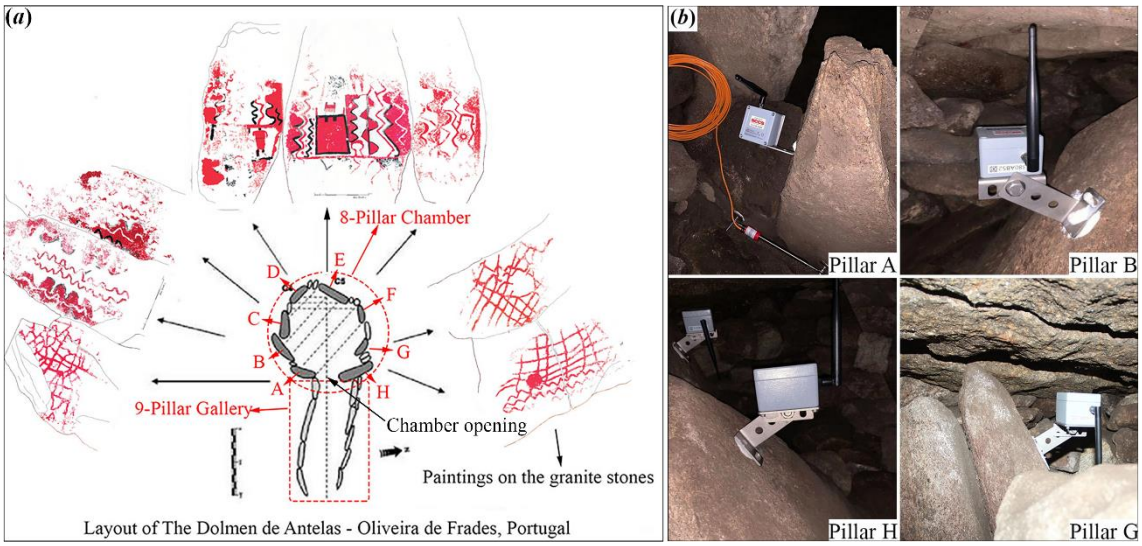
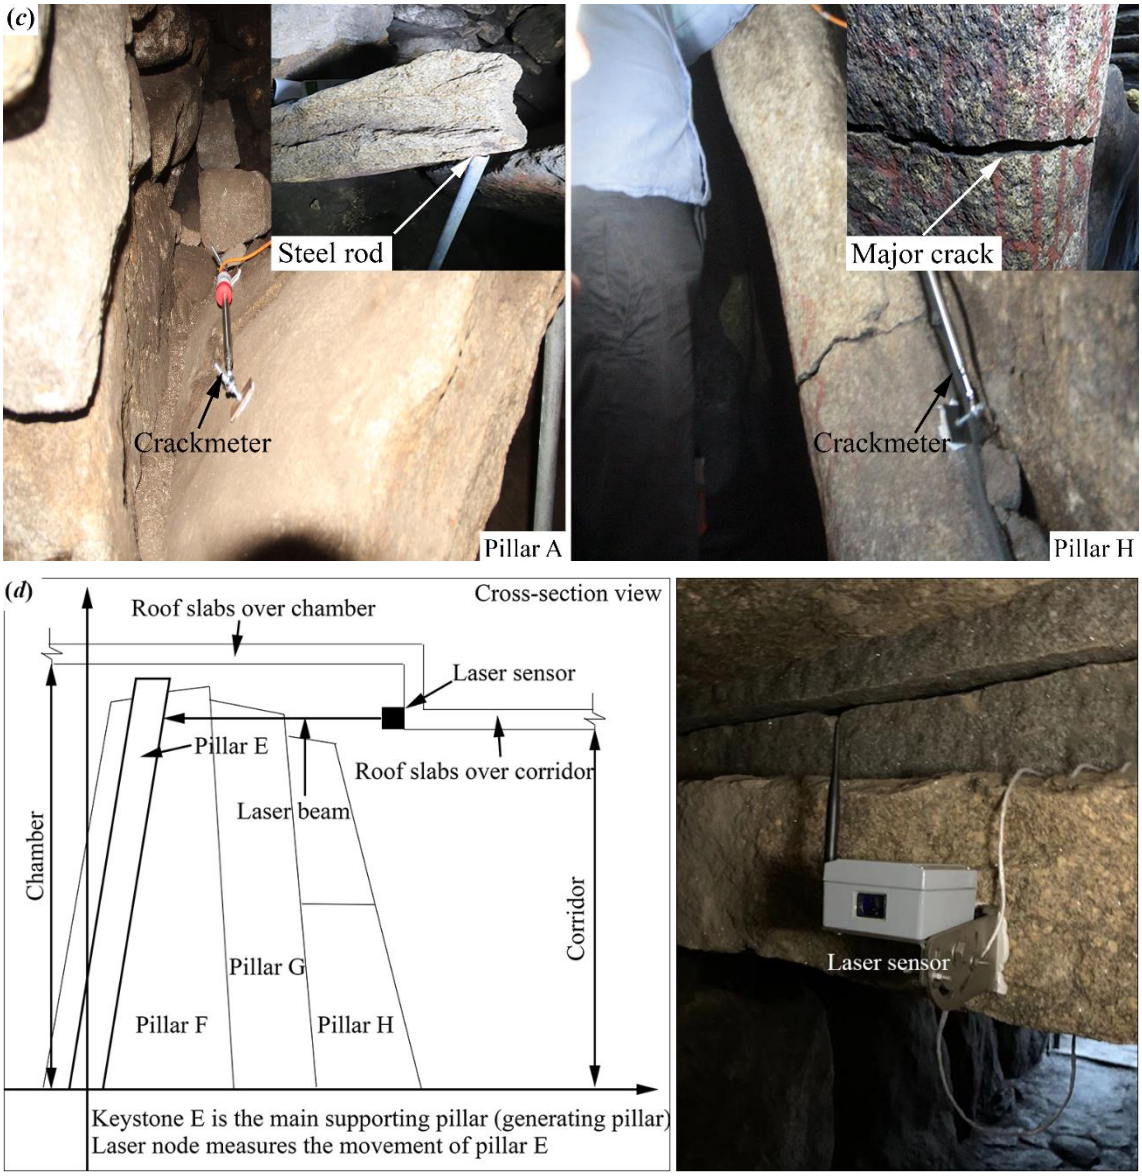
**Figure** 7. Onsite deployment of WSN

Based on the configuration and onsite conditions of the Dolmen, a package of WSN sensors was deployed on some critical chamber pillars to investigate the long-term structural behaviour of this self-supporting structure. Figure 7(*a*) presents the layout of this painted dolmen (Sanches, 2009).

Theoretically, the two pillars A and H are more structurally unstable than the remaining pillars as no support exists for their flanks close to the chamber opening. To mitigate the risk of potential instability, pillar A is now supported (partially penetrated) by a steel rod on its upper part (Figure 7(*c*)). Moreover, only limited space is accessible at the back of pillars A, B, G and H as these pillars are mostly surrounded by earth and stone fragments, whereas the other four pillars are nearly inaccessible. Therefore, in the light of structural stability, four two-axial wireless tilt-meters with an accuracy of 0.01° were mounted to the back of these four accessible pillars using non-intrusive industrial adhesive to monitor their radial and tangential inclination with time, respectively (Figure 7(*b*)). The inclinometer on pillar A was installed at a height of around 0.8m above the ground surface, with the one on pillar H around 1.6m and the other two on pillars B and G around 1.8m respectively. In addition, two crack-meters (with an accuracy of ±0.025mm) were installed on pillar A and pillar H to detect the relative movement between pillars A and B and to monitor the movement of pillar H's two broken halves, respectively (Figure 7(*c*)). To determine the movement of the main chamber generating pillar E (keystone), one laser convergence sensor with an accuracy of 0.5mm was deployed at the entrance headstone (Figure 7(*d*)).

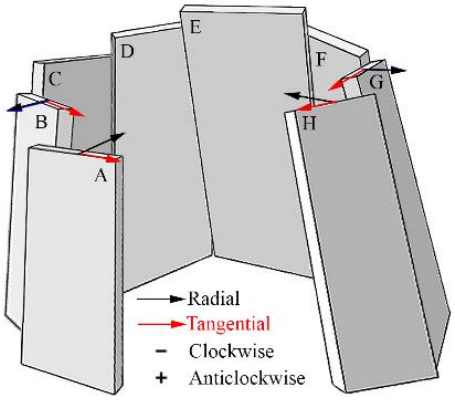
(*a*) Inclinometer axis direction

Figure 8 gives the inclination development of four critical pillars of the dolmen structure with time. The four two-axial inclinometers monitor both the radial (moving inwards/outwards the chamber) and tangential (moving away from/close to adjacent pillars) inclination development of pillars A, B, G and H, as illustrated in Figure 8(*a*). Readings are negative when the two directions move clockwise and vice versa. According to Figure 8(*b*), all four pillars were observed with slight inward movement, in general. For the two near-opening pillars, a maximum inward inclination of around 0.7° during the first 1.5 months was recorded for pillar A, while a negligible inclination variation of less than 0.1° for pillar H. This indicates a much faster rate of inclination development for A than that for H, but their development stabilised after around 1.5 months for both pillars. In particular, an accidental increase in inclination was observed on 27/12/2020 for the most structurally unstable pillar A of the whole dolmen structure. To the authors' best knowledge, there were no known onsite manmade interventions during the accidental inclination change on that day, which may be attributed to a sudden natural instability caused by possible contact interface sliding of pillar A away from pillar B. For their supporting pillars B and G, a first fast increase in inward inclination for both was obtained during a period of approximate 20 days into the monitoring, followed by a stabilisation for the rest of the monitoring period. The maximum inclinations developed during the monitoring period for pillar B and G are 0.15° and 0.26° respectively.

The inclination movement of these four pillars in the tangential direction is presented in Figure 8(*c*). All four pillars are slightly moving away from their supporting pillar gradually. For example, pillar H was moving away from pillar G towards the opening during the first 1.5 months into the period and stabilised at around 0.1° thereafter. However, pillar G's inclination development towards pillar H nearly

levelled off at a maximum of 0.2° after around one month. For the other two pillars, near-zero development for pillar A was observed before the same accidental instability in tangential inclination occurred, followed by a stabilisation at around 0.2° for the rest of the monitoring period. Upon comparison, the slightest tangential inclination development of around 0.03° during the same period was recorded for pillar B.

Therefore, it can be summarised that during the short five-month period, the four pillars were moving inwards the chamber while moving towards the opening at a very slow rate within the first six weeks and the obtained maximum inclination was even less than an ignorable 1.0° on the most unstable pillar A, indicating a generally structurally-stable state for the dolmen structure. However, it is worthwhile to note that the rate of inclination development for pillar A and the accidental instability caused by possible contact interface sliding between pillar A and B should be given prioritised attention as such factors may destabilise the dolmen in the long run if left disregarded.

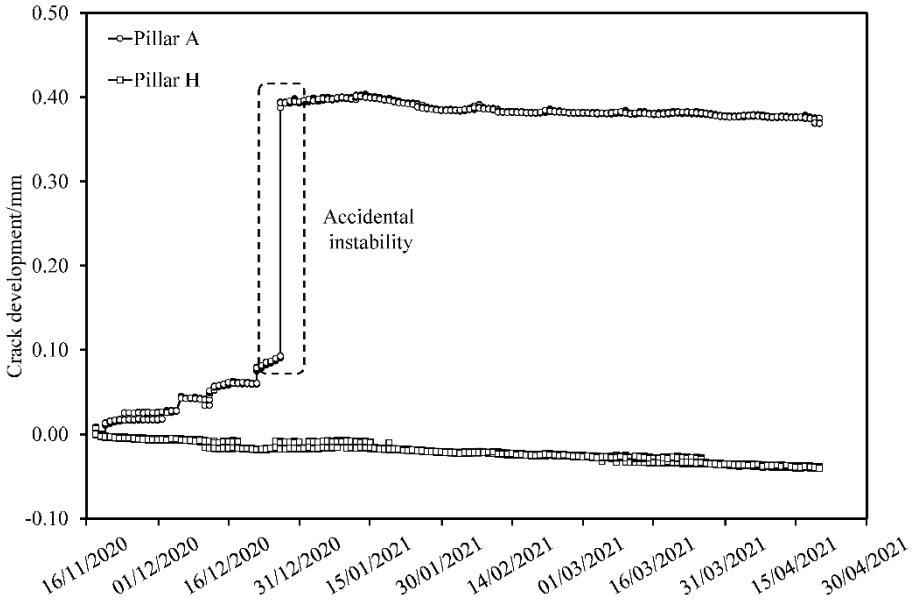
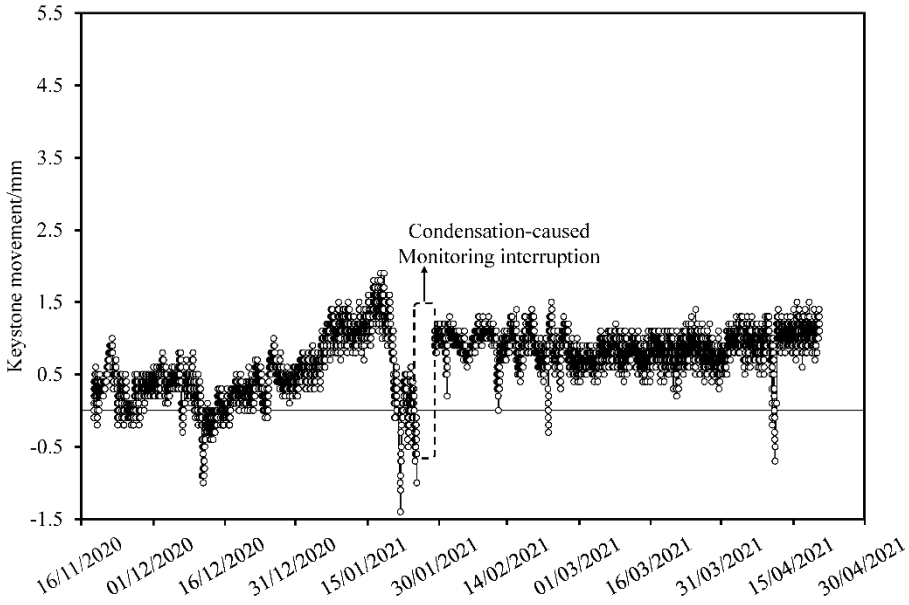
**Figure** 9. Crack development and keystone movement

Figure 9 shows the development of crack on pillars A and H and movement of the keystone E with time. The crack-meter mounted on pillar A monitors its relative movement away/close to its supporting pillar B while the crack-meter on pillar H records the crack propagation between its two broken halves, as shown in Figure 7(*c*). Figure 9(*a*) shows that during the five-month period, a receding movement of a negligible maximum 0.4mm between pillar A and B was recorded whereas a minute contraction of less than 0.05mm between the two broken halves of pillar H was detected, indicating an acceptable structural stability for the two near-opening pillars. However, the increasing rate of relative movement between pillar A and B during the first 1.5 months and the subsequent accidental propagation possibly

caused by the same contact interface sliding effect may threaten the long-term global stability of the dolmen if these two factors are ignored.

Figure 9(*b*) presents the movement of the keystone E recorded by the laser sensor node. Frequent fluctuations were observed during the monitoring period but a generally slight rising tendency was manifest during the first two months, with a maximum of around 2.0mm which is still insignificant from the structural stability point of view. The absence of data from 25/01/2021 to 29/01/2021 was caused by the condensation accumulation on the laser protection glass interrupting the transmission of laser beam (relative humidity during this period remained near saturation 99.3%). This monitoring interruption indicates the challenges of laser sensing for long-term distance monitoring in a constantly highly-humid indoor environment but in turn demonstrates the ability of WSN system to visualise the encountered problems in real time. Subsequently, a generally stabilising development of keystone movement within 0.5~1.5mm was observed for the rest of the monitoring period.

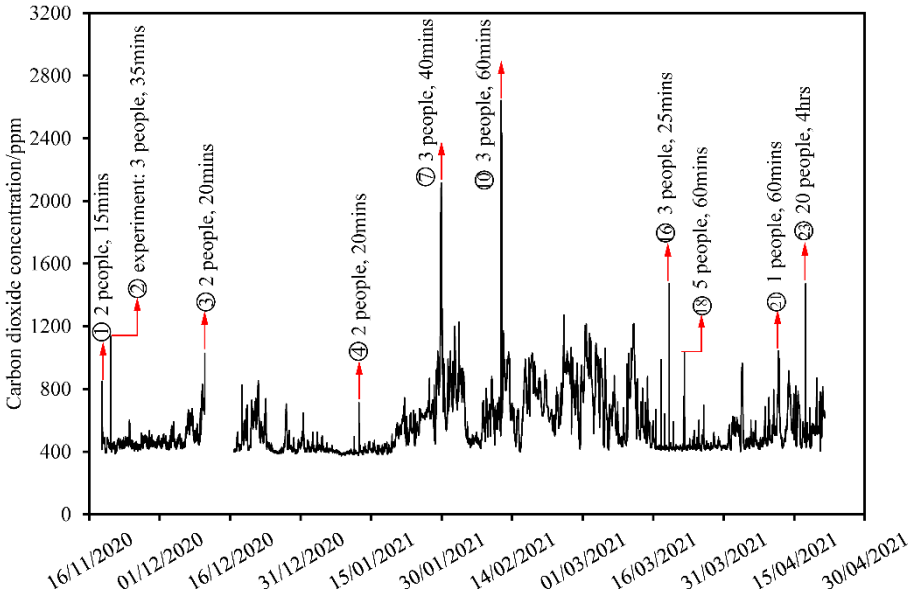
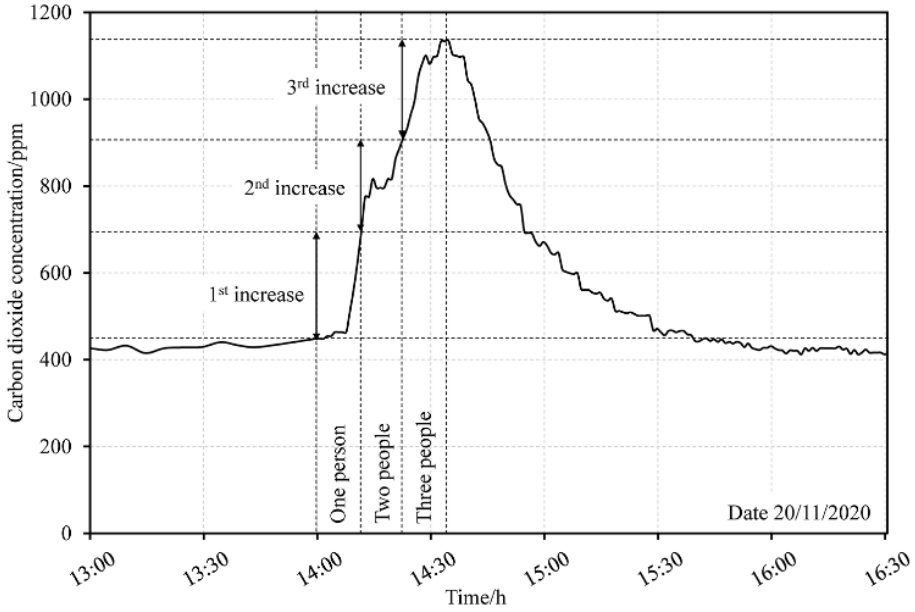
**Figure** 10. $CO_2$ concentration changes inside the dolmen (Note: the duration shown for visits after the 10th visitation is the total time spent on site instead of the time spent in the chamber.)

Figure 10 gives the fluctuations of $CO_2$ concentration (CDC) inside the dolmen chamber during the five months. Several significant spikes associated with visitations were observed (see Table 2 and Figure 10(*a*)). The second CDC surge arises from the onsite experiment aiming to mimic the visitation effect. During the no-visitation period, the interior CDC level fluctuated mostly between 400ppm and 800ppm depending on the local climate, in consistency with but slightly higher than open-air $CO_2$ concentration of around 400ppm (Batog and Badura, 2013), whereas, during human interventions, the concentration level was observed with obvious increases, followed by gradual restoration to normal levels, in line with previous findings (Bourges et al., 2014; Dragovich and Grose, 1990; Saiz-Jimenez et al., 2011).

To take the second spike as an example, three phases of CDC increases were recorded during the three-stage experiment. The first visitor raised the interior CDC level from 440ppm to around 640ppm in the first 10 minutes, followed by another increase of 240ppm to 880ppm after the second visitor joined for another 10 minutes, and finally, a third person's presence for further 15 minutes prompted the CDC to a maximum of around 1,140ppm, as shown in Figure 10(*b*). Likewise, a spiralling surge of CDC level from around 500ppm to a maximum of around 2,600ppm was observed during the 10$^{th}$ visit for a duration of 60mins with the same number of people. For a maximum of three visitors, an increase of CDC to 1,140ppm during 35mins is less than the threshold considered damaging for heritage caves (2,400ppm) or visitor comfort (5,000ppm) (Dragovich and Grose, 1990) but a maximum of 2,600ppm within 60mins has exceeded the heritage conservation threshold (2,400ppm). This means that for one thing, a 160% increase of CDC level during the 2$^{nd}$ experiment indicates more visitors lead to higher level of $CO_2$ concentration; for another, a 420% increase in 60mins might deteriorate the wall paintings. The 700ppm increase of CDC level caused by the 2$^{nd}$ visit with three people in a short period of time poses a stark contrast to a similar increase of CDC for the gigantic "El Soplao" cave in Spain but caused by 1,654 visits in August 2014 (a daily average of 55 visits) alone (Novas et al., 2017), meaning that the management and conservation measures for big heritage show caves may not be directly applicable to this type of megalithic dolmen as the extremely confined interior space lack of ventilation makes it easier for $CO_2$ concentration. Additionally, according to spikes 2, 7 and 10, it suggests that longer duration of visitation may lead to more significant increase of CDC with the same number of visitors. However, it should be noted that this duration effect may not be accurate as it relies on various factors, such as how visitors behave in the chamber, where the sensor is deployed, etc. Also, the presence of visitors may not be the sole cause of CDC increase but is widely believed to be the major source based upon previous findings (Ming et al., 2008; Novas et al., 2017).

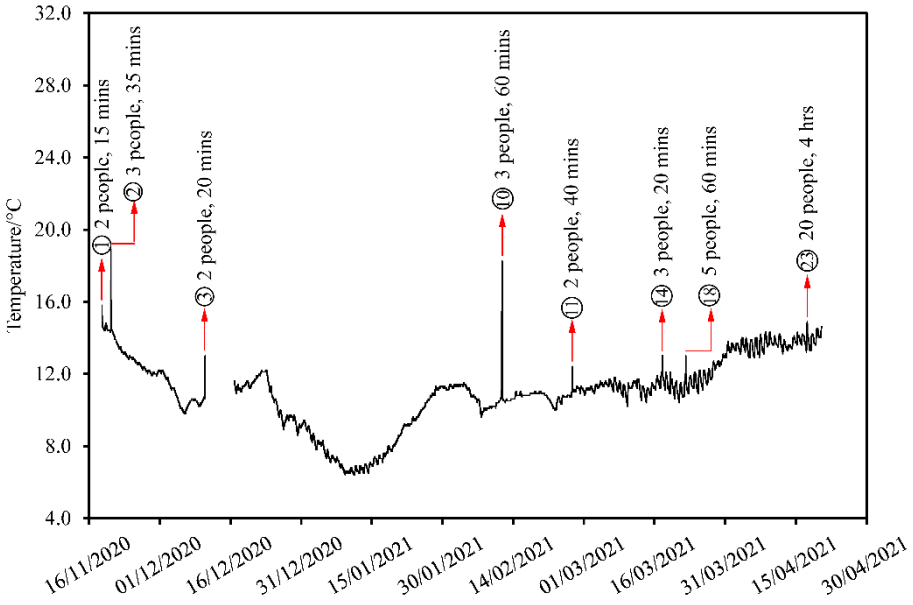
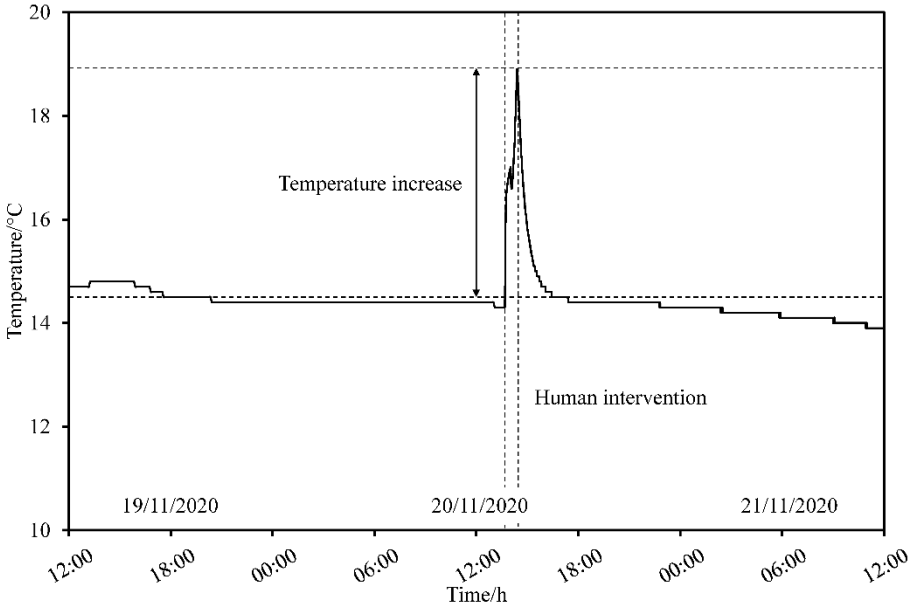
**Figure** 11. Temperature changes inside the dolmen (Note: the duration shown for visits after the 10th visitation is the total time spent on site instead of the time spent in the chamber.)

Figure 11 presents the temperature changes during the monitoring period where several visitation-related major increases were also recorded. The temperature increases observed in **Figure** 11(*a*) exhibit an obvious effect of visitation on dolmen chamber temperature. The second temperature rise associated with visitation experiment reached a maximum of 18.9°C after the third person joined, increasing by 4.4°C up from a natural temperature of 14.5°C with no human presence, as presented in Figure 11(*b*).

The temperature spike caused by the 10th group visitation of three people for data retrieval witnessed an increase from around 11.2°C to 18.5°C by 7.3°C in a continuous period of 60 minutes. The 4.4°C and 7.3°C increase of temperature for the 2nd and 10th spike respectively strikes a remarkable contrast to a maximum variation of ±0.5°C in the 17-mile-long "El Soplao" cave during a six-year monitoring period (Novas et al., 2017). Unlike significant temperature increases caused by the 2nd and 10th visitation, relatively mild temperature increases were captured for other spikes caused by the 14th, 18th and 23rd visitation shown in Figure 11(*a*). This is because the latter three visitations (the 14th, 18th and 23rd visitation) were conducted in the form of individual visitation within a short period of time, such as 5 minutes, and the duration shown is the total time spent onsite instead of the time spent in the chamber.

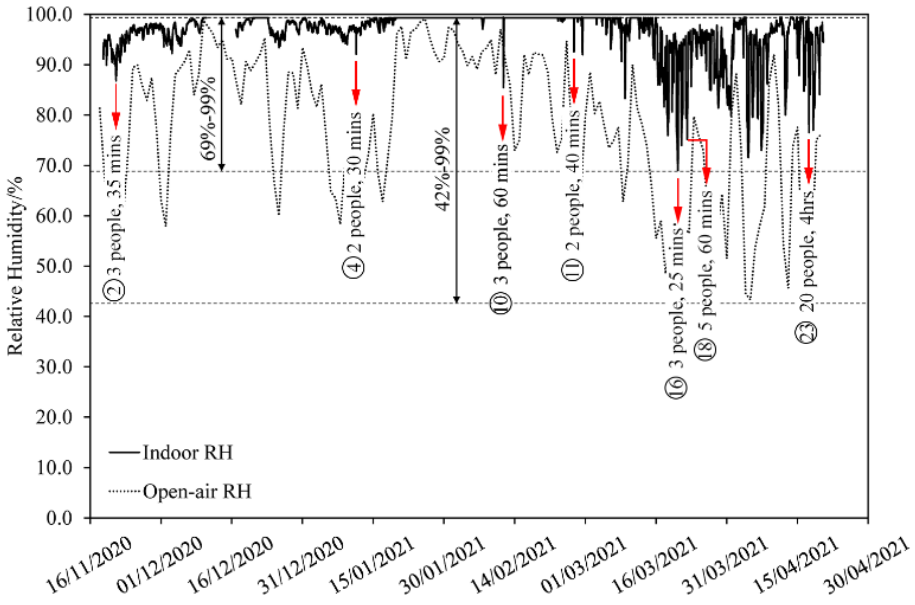
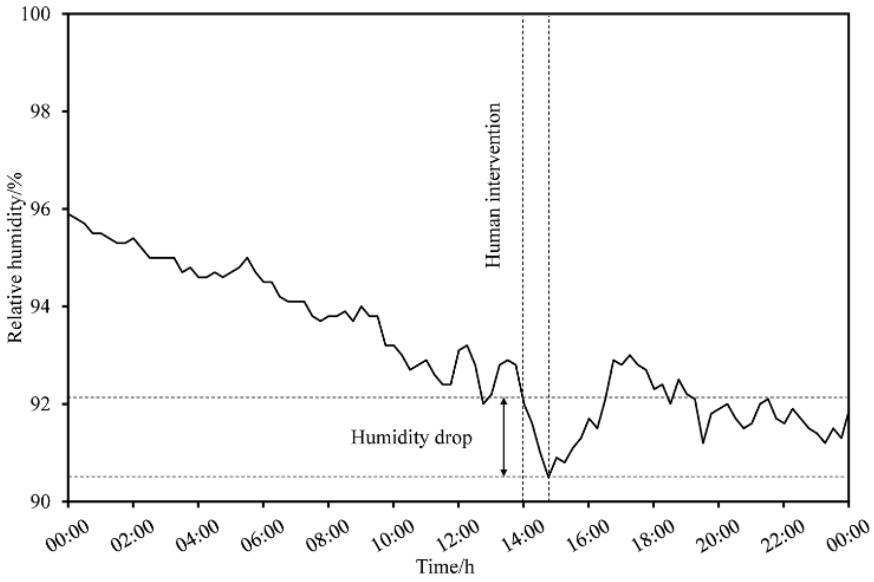
**Figure** 12. Relative humidity changes during the period (Note: the duration shown for visits after the 10th visitation is the total time spent on site instead of the time spent in the chamber.)

Figure 12 shows the RH variations with time. Due to the lack of ventilation in the cave chamber, the interior humidity mostly maintained within 90%~100%, with significant fluctuations in the last 1.5 months of the monitoring period from around 69% to 99%. This is because in the first 3.5 months, the local rainy season in winter contributed to the high relative humidity whereas in the last 1.5 months, an increasingly warmer and dryer weather led to significant reduction of RH during the day. Upon comparison, the open-air RH lies within 42%~99% based on the data from the nearest meteorological station, indicating a comparatively lower level of RH outside the dolmen, as shown in Figure 12(*a*).

To explore the visitation effect on relative humidity, the RH variation during the second experimental visit and the 10th visit for data retrieval was specifically analysed. Unlike an increase in T and CDC, a slight 2% reduction and a significant 14% reduction in RH, were recorded during the 2nd

and 10th intervention, respectively, as shown in Figure 12(*b*). The RH drop possibly arises from the dominating natural ventilation effect, which features the airflow exchange between the highly-humid interior and the moderately-humid outside due to the state of an open dolmen gate during visitation (Rosbach et al., 2013; Teleszewski and Gładyszewska-Fiedoruk, 2020). The difference in magnitude of drop is likely to be caused by the duration of the ventilation effect, which means longer duration of ventilation may lead to longer duration of airflow exchange, thus bigger reduction in RH, in such type of confined underground caves. Similarly, the reduction of RH during the 16th, 18th and 23rd visitations could possibly be attributed to this cause as well.

The extremely humid interior, together with the cyclic RH variation in warmer seasons (low RH during the day but high RH during the night), may accelerate/contribute to painting deterioration due to the possible RH-caused microstructural changes of painting materials, the growth of microorganisms on painting colorants (Issa et al., 2020) and the potential coupled geochemical/biochemical effect (Iriarte et al., 2009; Unković et al., 2017).

Therefore, such a mechanical ventilation system may also be adopted for the preservation of the rock paintings in this confined dolmen. The deployment of this system will provoke fast dispersion of $CO_2$ concentration caused by visitors, bring down the high humidity and maintain a steady temperature inside the cave chamber, even during frequent visitations. Figure 13(*b*) shows a possible solution to maintain acceptable level of microclimatic conditions (the mechanical system can only be deployed at the back of accessible pillars A and H), which aims to enhance the environmental/microclimatic resilience for the sustainable valorisation and development of this underground heritage.
