EMERGENCY REHABILITATION OF BROWNSBARN BRIDGE

V.PAKRASHI¹, J.KELLY¹, J.HARKIN² & S.NANUKUTTAN²

¹Roughan & O'Donovan Consulting Engineers, Dublin, Ireland

This paper outlines the repair methodology of Brownsbarn Bridge situated over the N7 near Dublin. The repair strategy was formulated following impact damage to the soffit from a low-loader carrying an excavator passing underneath the bridge. Significant damage was observed to one of the beams. The repairs were carried out as emergency works over a bank holiday weekend in Ireland successfully. The rehabilitation methodology is based on preloading the bridge before repair followed by a removal of load to ensure the reestablishment of some of the lost prestress. This paper outlines the various stages of rehabilitation and establishes the timelines of significant events along with practical discussions on the execution of the rehabilitation methodology. The bridge was continuously monitored throughout the refurbishment process. This case study is expected to be of topical interest to researchers, practicing engineers, bridge owners and end-users alike.

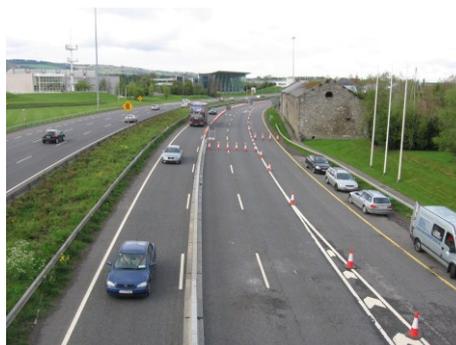
Figure 8 – Traffic Management Provided during Rehabilitation

The preload was removed from the top of the bridge after the repair material gained adequate strength and some amount of prestress was reinstated following the removal of prestrain. The repaired section is shown in Figure 6 while the removal of preload is shown in Figure 7. A sample photograph of the traffic management provided by Complete Highway Maintenance throughout the rehabilitation is provided as Figure 8.

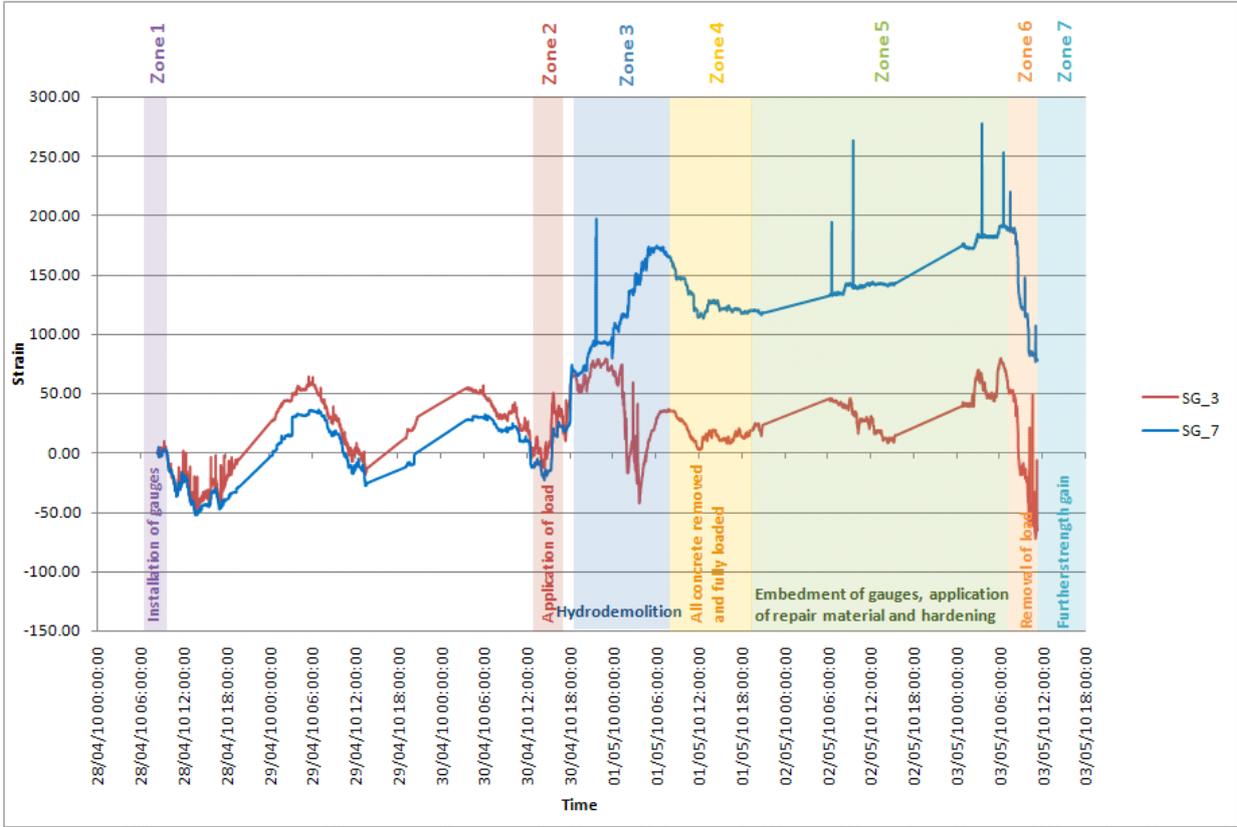
Figure 9 – Activity Footprints in Strain Gauge Monitoring Data and Event Hotspots

Figure 9 provides the example of two strain gauges from adjacent beams (damaged and undamaged) results during the entire rehabilitation process and zones them into the main activities along the timeline. The strains are in multiples of 10^{-6} . This graph creates the departure point of detailed structural health monitoring analyses including the effects of thermal oscillations, shrinkage characteristics, redistributions of strains, release of entrapped strains, participation and energy flow of adjacent beams and the real mechanics of structures similar to Brownsbarn Bridge. Such analyses are beyond the scope of the current paper.
