EMERGENCY REHABILITATION OF BROWNSBARN BRIDGE

V.PAKRASHI¹, J.KELLY¹, J.HARKIN² & S.NANUKUTTAN²

¹Roughan & O'Donovan Consulting Engineers, Dublin, Ireland

This paper outlines the repair methodology of Brownsbarn Bridge situated over the N7 near Dublin. The repair strategy was formulated following impact damage to the soffit from a low-loader carrying an excavator passing underneath the bridge. Significant damage was observed to one of the beams. The repairs were carried out as emergency works over a bank holiday weekend in Ireland successfully. The rehabilitation methodology is based on preloading the bridge before repair followed by a removal of load to ensure the reestablishment of some of the lost prestress. This paper outlines the various stages of rehabilitation and establishes the timelines of significant events along with practical discussions on the execution of the rehabilitation methodology. The bridge was continuously monitored throughout the refurbishment process. This case study is expected to be of topical interest to researchers, practicing engineers, bridge owners and end-users alike.

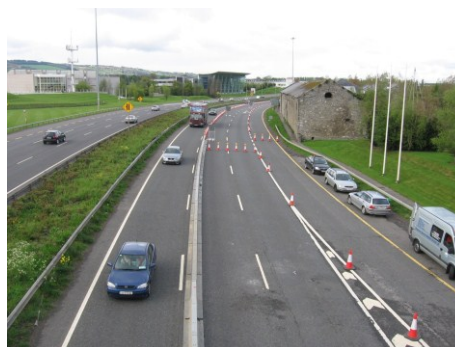
Figure 8 – Traffic Management Provided during Rehabilitation

The preload was removed from the top of the bridge after the repair material gained adequate strength and some amount of prestress was reinstated following the removal of prestrain. The repaired section is shown in Figure 6 while the removal of preload is shown in Figure 7. A sample photograph of the traffic management provided by Complete Highway Maintenance throughout the rehabilitation is provided as Figure 8.
