Effects of Damage Models in Probabilistic Assessment of Structures: An Illustrative Example

Vikram Pakrashi¹, Alan O'Connor² and Denys Breysse³

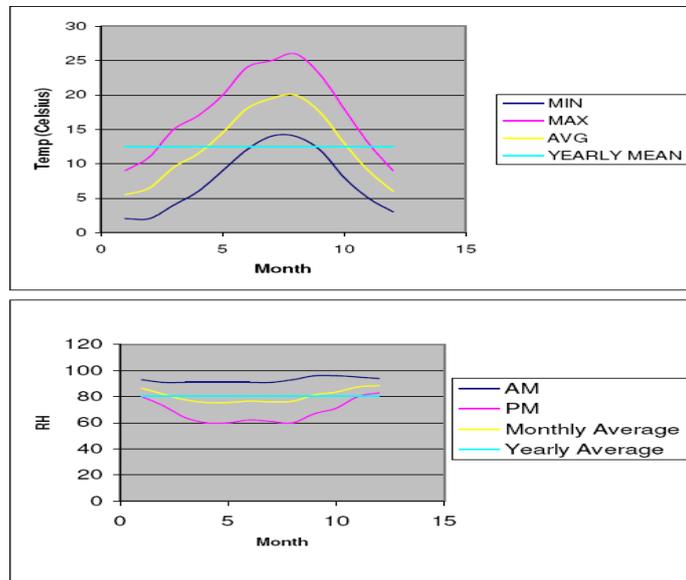
The monthly variation of temperature and relative humidity for Bordeaux (*bbc.co.uk*, accessed 2007) is shown in Figure 1. The activity rate of a fungus for such environment can be found from the activity contour plots provided by Krus *et al.* (2001). The activity rate of a fungus is defined to be the rate at which the fungus grows under a given temperature and humidity condition. This rate can be expressed as the equivalent distance per unit time and directly used for engineering calculations. Due to the seasonal nature of the temperature and humidity at any location, the activity rate approximately repeats itself every year. As a result, an activity profile for a certain location can be constructed by considering the average monthly activity profiles over an entire year. Since the environmental conditions vary randomly about the average cycle every year, a random noise has been added to the yearly activity profiles to obtain a more realistic fluctuating

Figure 1. Temperature and Relative Humidity in Bordeaux.

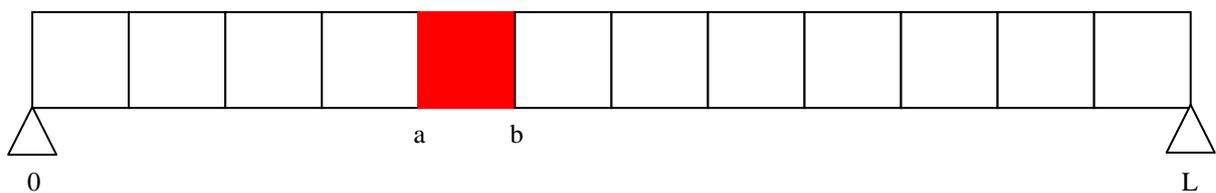
The damaged beam is considered to be divided into a preselected finite number of divisions with one of such division being assumed to be damaged. The sectional loss, leading to subsequent loss of moment of inertia increases the stress in the damaged section and a failure condition is met when the stresses (shear or moment) surpass the allowable values. Figure 2 shows such a smeared damage model for the beam. To estimate the static deflection at the damage location, one has to consider the beam as an assembly of three subbeams with the damaged subbeam having a different sectional property than the undamaged ones. Considering continuity in displacement and slope at the interface points a and b, the static deflection can be solved in closed form (Pakrashi *et al.* 2007) .

Figure 2. Smeared Damage Model.

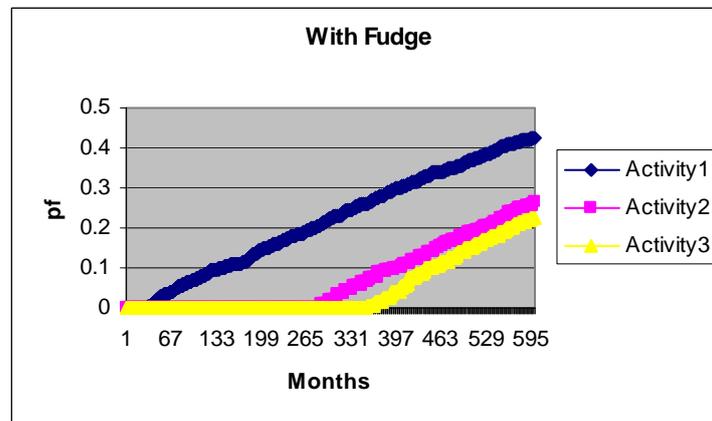
The probability of failure for the owner's definition of failure for different activities with fudge (associated random noise) is given in Figure 3. The values are comparable in terms of average activity over a year. The nearly parallel loci of points of the points indicate the basic deterministic nature of the failure process and the deviations account for the interaction between the germination time and activity rate. Figure 4 shows the numbers of failures for different activity rates for each of the months in a year for owner's definition of failure. The high activity months account for more number of failures. The presence of noise smooths out any sudden change in the modal month that might numerically arise due to the specification of a definite cut-off value for the affected length of failure.

Figure 3. Probability of Failure for Owner's Criteria.

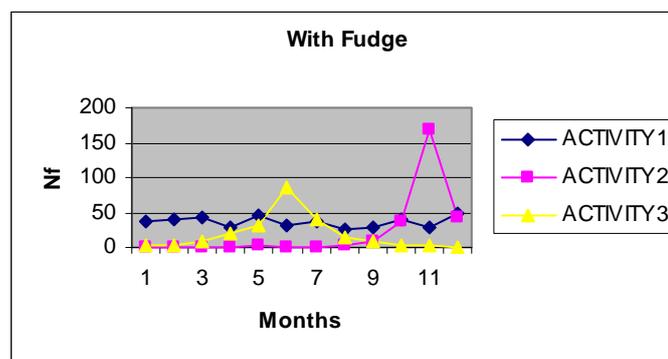
Figure 4. Number of Failures over Different Months for Owner's Criteria.

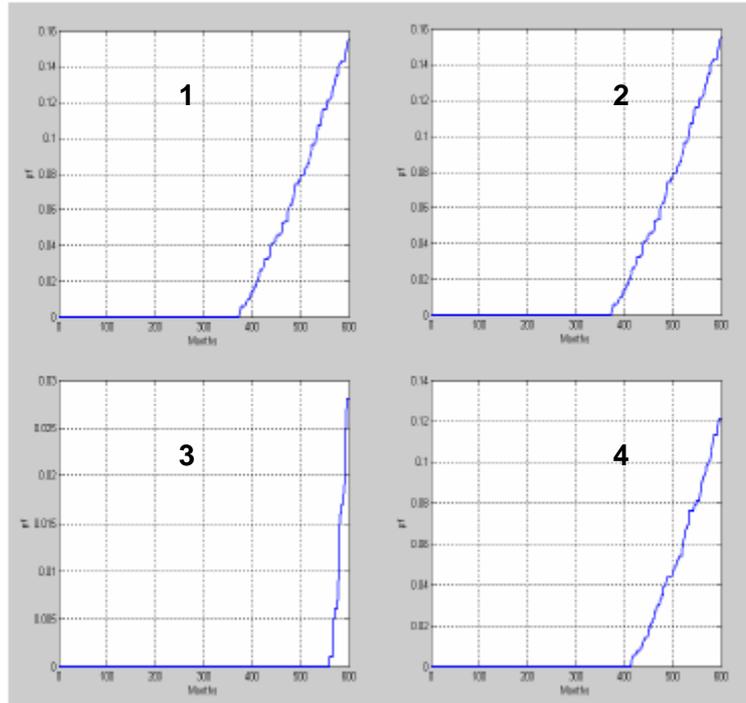
Figures 5 and 6 represent the cumulative probabilities of failure from the engineer's viewpoint and the numbers of failures for a given month respectively. The shape of the activity profile resembles a triangular pattern. The pf and the number of failures are according to combined (1), moment (2), shear (3) and deflection (4) criteria respectively in Figure 5. Figure 6 illustrates the presence of modal months using the engineer's criteria for moment (1) shear (2) and deflection (3) respectively. The moment failure criterion governs the total failure probability. The months of higher activity in terms of failure are seen to match the activity pattern of fungal activity.

Figure 5. Probabilities of Failure for Engineer's Criteria for Combined (1), Moment (2), Shear (3) and Deflection (4).

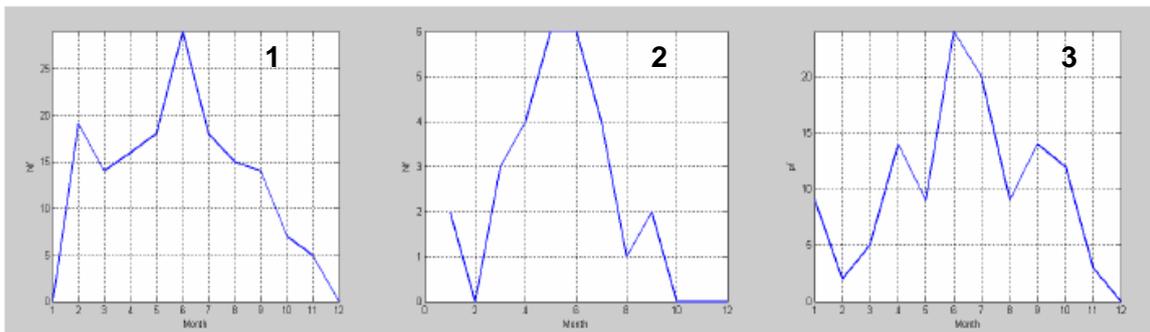
Figure 6. Number of Failures over Different Months for Moment (1), Shear (2) and Deflection (3) following the Engineer's Criteria.

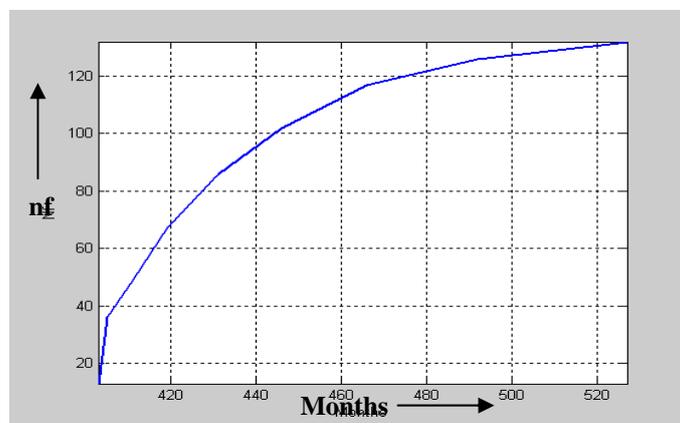
Figure 7. Number of Failures versus Time to Fail once Germinated.

Figure 7 describes the cumulative number of cases of failures recorded as per engineer's criteria with respect to the time to fail. It is assumed that the time to fail is considered from the time of germination. It is seen that there exists an intermediate month after which the number of failure in a single month keeps becoming smaller, as is indicated by the point of inflection in the graph.

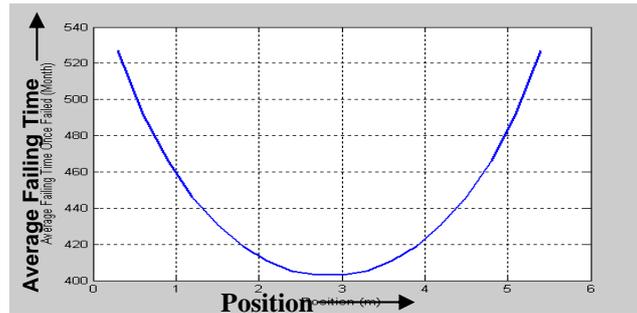
The average failing time, once the beam has failed, against the position of damage is provided in Figure 8. The midpoint of a simply supported beam is identified correctly as a critical location in this regard. The variation in time to failure is indicative of changing risk for different sections under a given set of damage, failure mode and failure definition.

Figure 8. Time to Fail versus Position of Damage.
