6th Transport Research Arena April 18-21, 2016

Novel efficient technologies in Europe for axle bearing condition monitoring – the MAXBE project

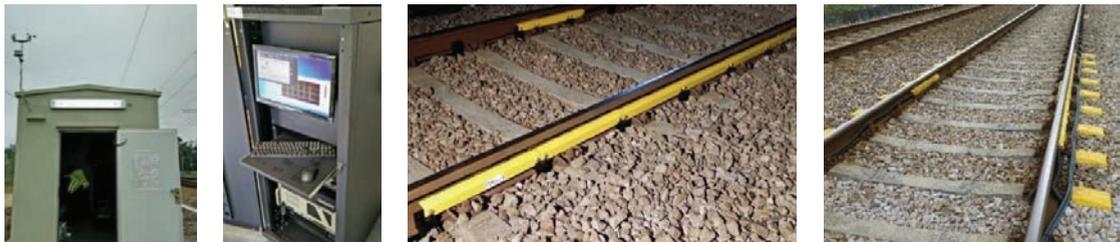
Fig. 4. Wayside system in Portugal: data processor unit and system installation in the track.

In Fig. 4, the acquisition system, the data processor unit and the communication system installed in a cabinet in the side of the track is shown, as well as the installation of the sensors in the track.

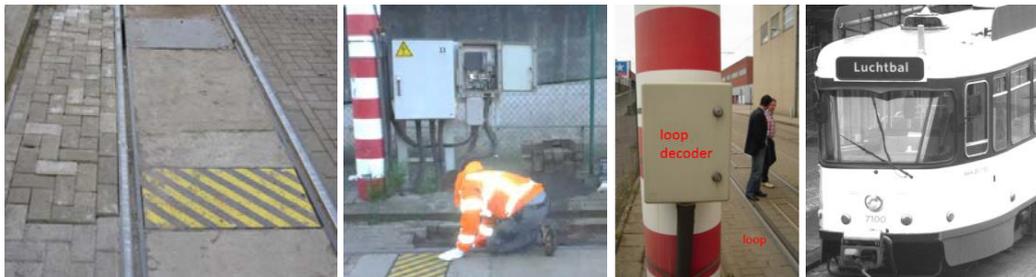
Fig. 6. Wayside axle bearing monitoring system for Light Rail Vehicle.

A high-frequency vibration-based axle bearing fault detection system jointly developed by De Lijn, D2S, and I-moss is installed in the Antwerp depot of De Lijn, the Flemish public transportation company. The system is installed on the exit track of the facility, monitoring all vehicles exiting from the depot onto the Antwerp tram network. Fig. 6 shows some pictures of the wayside installation in Antwerp (MAXBE, 2015b).

The complete system is composed of 8 high frequency accelerometers, mounted on the rail feet, field side. The accelerometers are connected to a processing unit, located in the vicinity of the accelerometer in a weatherproof casing. The accelerometers are specified for high frequency vibration measurement and have a sensitivity of 10 mV/g. A mechanical protection system is installed over the accelerometers for protection against moisture, dirt and EMC and isolating them from external vibration sources. Spacing between the accelerometers is 52 cm, approximately one fourth of the wheel circumference.

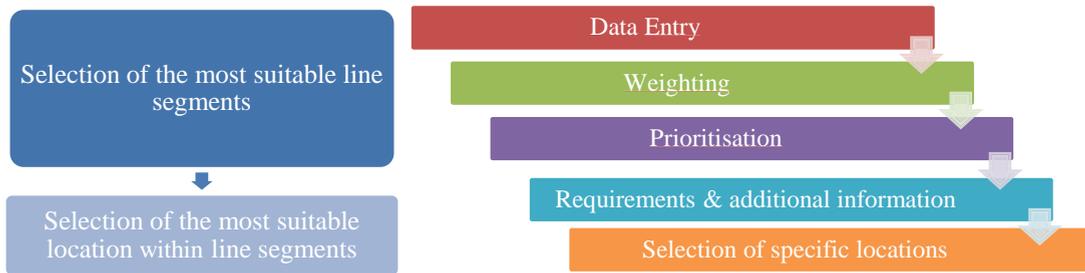
Fig. 9. Methodology of the software tool.

The tool is available in excel format programmed with Visual Basic and therefore is user-friendly, easy to implement and very flexible in order to be adapted to the end-users needs. At the end, the tool is able to suggest the most adequate places to install a wayside monitoring system, by weighting the several risk assessment indicators defined in the software tool (MAXBE, 2015d).
