## Impact of non-optimal grounding of the CC2420 RFIC on a 802.15.4 Tyndall sensor wireless mote

**Abstract:** *The performance of an RF output matching network is dependent on integrity of the ground connection. If this connection is compromised in anyway, additional parasitic elements may occur that can degrade performance and yield unreliable results. Traditionally, designers measure Constant Wave (CW) power to determine that the RF chain is performing optimally, the device is properly matched and by implication grounded. It is shown that there are situations where modulation quality can be compromised due to poor grounding that is not apparent using CW power measurements alone. The consequence of this is reduced throughput, range and reliability. Measurements are presented on a Tyndall Mote using a CC2420 RFIC to demonstrate how poor solder contact between the ground contacts and the ground layer of the PCB can lead to the degradation of modulated performance. Detailed evaluation that required the development of a new measurement definition for 802.15.4 and analysis is presented to show how waveform quality is affected while the modulated output power remains within acceptable

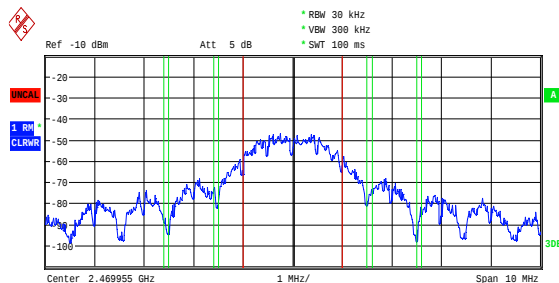
Figures 1 and 2 below, show examples of good and bad 802.15.4 spectra that were measured on a spectrum analyser. Figure 1 shows an 802.15.4 signal with good linearity typified by the well defined troughs in the spectral shape..

**Fig. 1.** Typical 802.15.4 spectrum

A typical 802.15.4 spectra such as in Figure 1, exhibits well defined troughs that are defined by the channel filter characteristic. From experimentation, it was shown that the spectral degradation of these troughs is very sensitive to non-linearity as shown in Figure 2. Two ACPR points at the first and second trough were established leading to the settings summarised in Table 1 below.

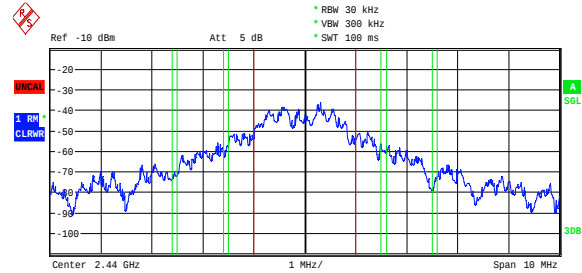
Figure 2 shows a plot of an 802.15.4 signal that has been subjected to non-linear distortion. It is clear that the spectrum has spread out and the troughs have

been filled due to spectral re-growth. Measuring the spectrum in these troughs yields a highly sensitive measurement with respect to linearity.

**Fig. 2.** Typical 802.15.4 distorted spectrum

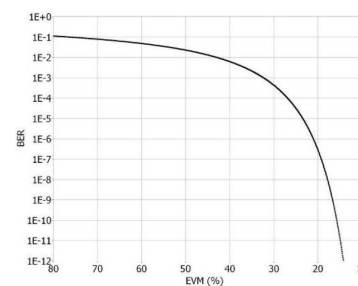
The EVM measurement was conducted as defined in the 802.15.4 standard using a half sine measurement filter. EVM can be used as a measure of SNR, BER and packet loss as it is a measurement of the deviation of the baseband vector from the ideal constellation location. The instantaneous error vector is a function of all noise sources (deterministic and random) and if averaged over time, the noise power and thus SNR can be calculated therefore establishing a correlation with EVM. By applying some analysis, it is also possible to distinguish between random and deterministic noise sources [6]. National Instruments published a graph which is reproduced in Figure 3 below for 802.15.4 and demonstrates the effect of EVM on BER. [3].

**Fig. 3.** EVM verse's BER for 802.15.4

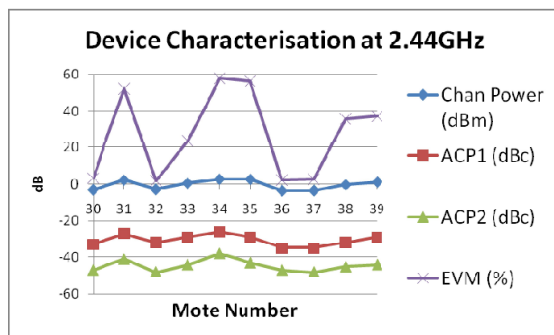
To investigate the reported throughput issues a representative sample of Tyndall Motes [5] were tested. Figures 4 and 5 below, summarises a subsection of these results at 2.44GHz and 2.47GHz respectively.

Six out of ten devices measured an EVM of greater than 20%. Simple link budget tests on these motes confirmed that for a given RSSI value the number of received good packet interrupts at the CC2420 was considerably less for the high EVM motes compared to the low EVM motes. It was also observed that the difference in performance between the high and low EVM motes was considerably less at 2.47GHz compared to 2.44GHz. This is in agreement with the EVM measured values in the figures below.

Fig. 4. Device characterization at 2.44GHz

Closer inspection of the measurements above shows that there is a correlation between EVM, output power and ACPR. As the ACPR is degrading with EVM, this is an indication that the degradation in EVM was due to a linearity issue rather than a random noise source. Further experiments were conducted to test this theory. Figure 6 below plots the output power back off against EVM. One can see that the EVM improves considerably once the power is backed off relative to the maximum output power. This was presented as further indication that the root cause of the problem was linearity rather than noise. If the ACP was dominated by noise (e.g thermal or phase) there would not be such an improvement at back off.

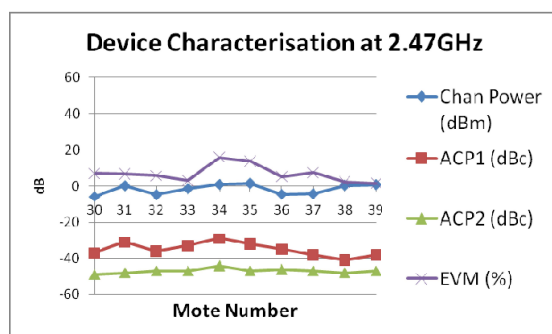
Fig. 5. Device characterization at 2.47GHz

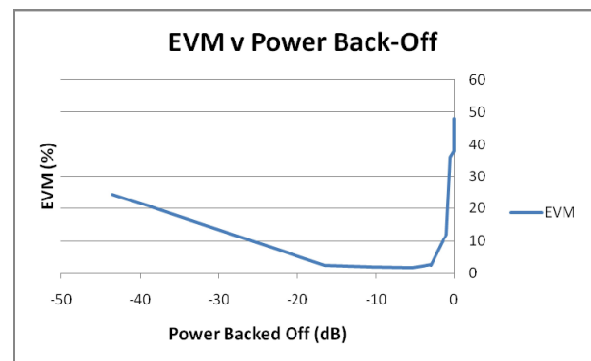
Fig. 6. EVM v Power Back-Off

Note that at the lowest power levels, below approximately -20dBm, the EVM gracefully degrades. This is due to the noise floor of the device beginning to dominate the EVM.

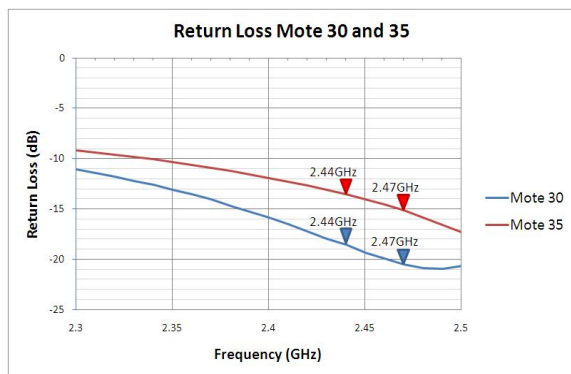
To determine whether the device is seeing the correct load impedances, a simple S11 measurement was taken using a vector network analyser and a 1 port calibration. Figure 7 below shows a typical plot of a high EVM mote (Mote 35) against a low EVM mote (Mote 30). To simplify the measurement, the RFIC is switched to receive mode. As the matching

circuit and balun is common to both modes, it was concluded that this would give an indication of a correlation of matching impedance between the two types of motes. It is observed that the return loss is lower for the high EVM mote and that the return loss is better at higher frequencies due to the tuning being centered high in frequency. From these results it was ascertained that all the high EVM motes were tuned to a higher frequency compared with low EVM Motes.

Even though this is a measure of Rx S11, this may indicate the path to ground is different between each mote type and that the impedance difference must be somewhere common to both Tx and Rx possibly the connection from the transceiver ground puck to the PCB.

Fig. 7. S11 for motes 30 and 35

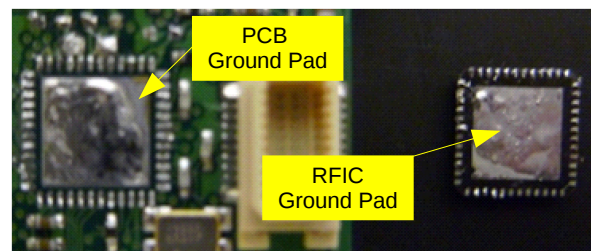
A number of high and low EVM parts were removed from the PCB and an example of each type is shown in figures 8 and 9 below.

Fig. 8. Low EVM PCB and RFIC

From Figure 8 above although the solder connection is not perfect it has good solder wetting over 70% of its surface area. Also noteworthy was that it took over 5 minutes to remove the part from the board, using a fine nozzle heat gun.

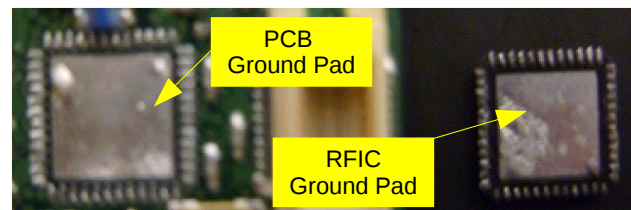
Fig. 9. High EVM PCB and RFIC

This part in Figure 9 above clearly had a very poor ground connection. It also only took a few seconds to remove from the PCB. Neither the ground puck on the IC or the ground plane on the PCB exhibited a shiny solder finish normally associated with a good joint. In this case the joint was obviously dry with ~5%

exhibiting a good contact to ground. This would mean that the device connection to ground would differ significantly from its model used in design. Thus we see a shift in frequency of the S11 response from optimum and poor linearity.

It is also shown that monitoring of output power alone may not reveal grounding issues with the RFIC and that the EVM can be as poor 50% in these circumstance thus degrading BER and throughput. Evaluation of the linearity and waveform quality parameters should be undertaken to ensure the integrity of the build. Further analysis and measurements are required to confirm the hypothesis presented in this paper.
