6th Transport Research Arena April 18-21, 2016

Novel efficient technologies in Europe for axle bearing condition monitoring – the MAXBE project

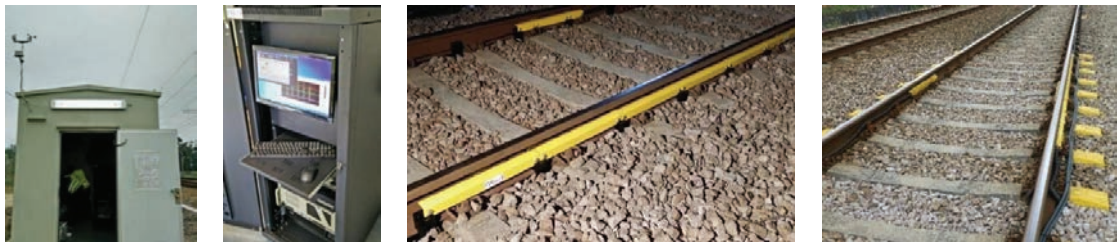
In Fig. 4, the acquisition system, the data processor unit and the communication system installed in a cabinet in the side of the track is shown, as well as the installation of the sensors in the track.

Fig. 4. Wayside system in Portugal: data processor unit and system installation in the track.

The sensors are protected against the railway adverse environment, with dust, ballast, water and all the heavy maintenance activities performed in this type of infrastructure with a robust mechanical system. The cables connecting the sensors to the acquisition system are in underground ducts in order to ensure the safety and the durability of the system considering the maintenance activities.
