6th Transport Research Arena April 18-21, 2016

Novel efficient technologies in Europe for axle bearing condition monitoring – the MAXBE project

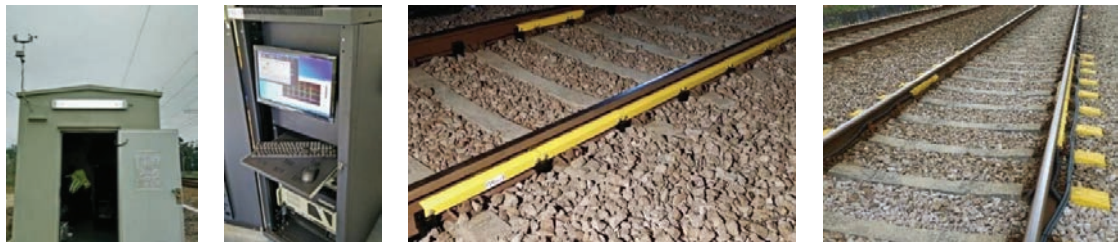
Fig. 4. Wayside system in Portugal: data processor unit and system installation in the track.

In Fig. 4, the acquisition system, the data processor unit and the communication system installed in a cabinet in the side of the track is shown, as well as the installation of the sensors in the track.

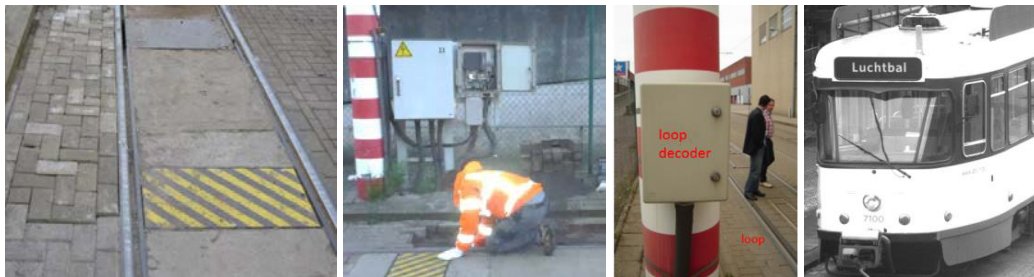
Fig. 6. Wayside axle bearing monitoring system for Light Rail Vehicle.

The complete system is composed of 8 high frequency accelerometers, mounted on the rail feet, field side. The accelerometers are connected to a processing unit, located in the vicinity of the accelerometer in a weatherproof casing. The accelerometers are specified for high frequency vibration measurement and have a sensitivity of 10 mV/g. A mechanical protection system is installed over the accelerometers for protection against moisture, dirt and EMC and isolating them from external vibration sources. Spacing between the accelerometers is 52 cm, approximately one fourth of the wheel circumference.

The processing unit is composed of signal conditioning cards, a data acquisition card and an embedded computer. The system also features a 3G connection to allow data upload to a centralized measurement database. The in-house built signal conditioning cards have been tuned for high frequency signals, measuring vibration signatures of up to 40 kHz.

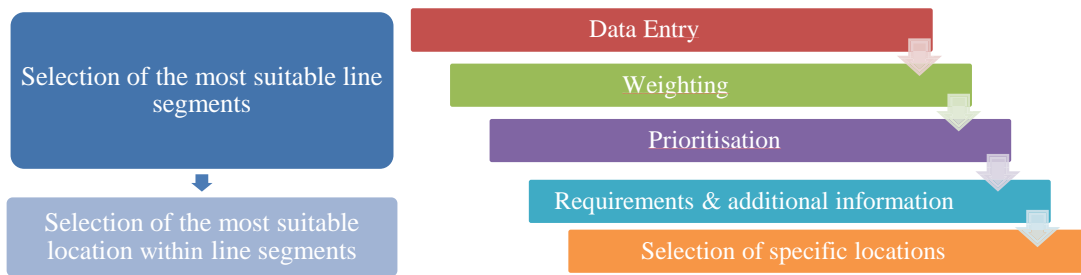
Fig. 9. Methodology of the software tool.

The tool is available in excel format programmed with Visual Basic and therefore is user-friendly, easy to implement and very flexible in order to be adapted to the end-users needs. At the end, the tool is able to suggest the most adequate places to install a wayside monitoring system, by weighting the several risk assessment indicators defined in the software tool (MAXBE, 2015d).
