Pakrashi, V., O'Connor A.J., Basu B., 2006. Damage Calibration of a Beam using Wavelet Analysis and Image Processing. In: Bridge Engineering Research in Ireland (BEI), *Third Symposium on Bridge and Infrastructure Research in Ireland*. Dublin, Ireland.

# Damage Calibration of a Beam Using Wavelet Analysis and Image Processing

Vikram Pakrashi, Alan O' Connor and Biswajit Basu

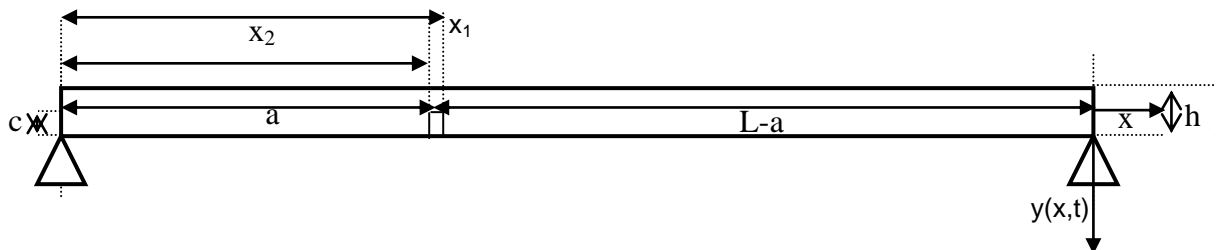
A simply supported Euler Bernoulli beam with an open crack is modelled as two uncracked sub-beams connected through a rotational spring at the location of crack in the lumped crack formulation. The length of the beam is  $L$  with the damage located at a distance of 'a' from the left hand support of the beam. The crack depth is taken as  $c$  and the overall depth of the beam is  $h$ . The general arrangement of such a beam with an open crack is shown in Figure 1. The free vibration equation for both the beams on either side of the crack can be written as

Figure 1. General Arrangement of a Simply Supported Beam with an Open Crack.

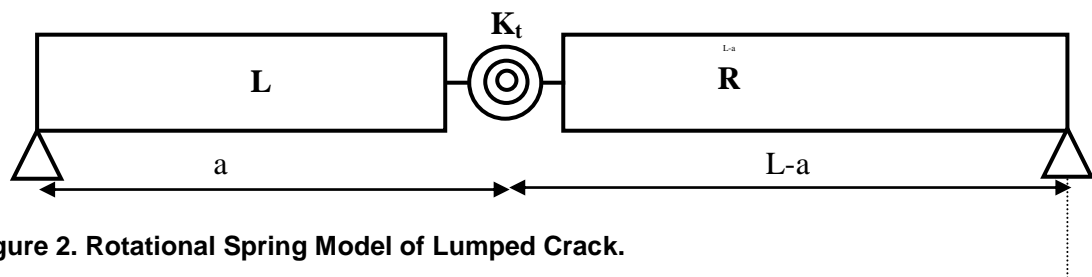
It is assumed that the effects of the crack are applicable in the immediate neighbourhood of the crack location and is represented by a rotational spring of equivalent local stiffness of  $K_t$  as shown in Figure 2.

Figure 2. Rotational Spring Model of Lumped Crack.

where the natural frequency of the cracked beam is  $\omega$ . Both displacement and moment at the two supports of the beam are zero. The continuity in displacement, moment and shear are assumed at the location of crack. A slope discontinuity is present at the crack location. The slope condition is modelled as

$$\Phi_R'(a) - \Phi_L'(a) = \theta L \Phi_R''(a) \quad (2.4)$$

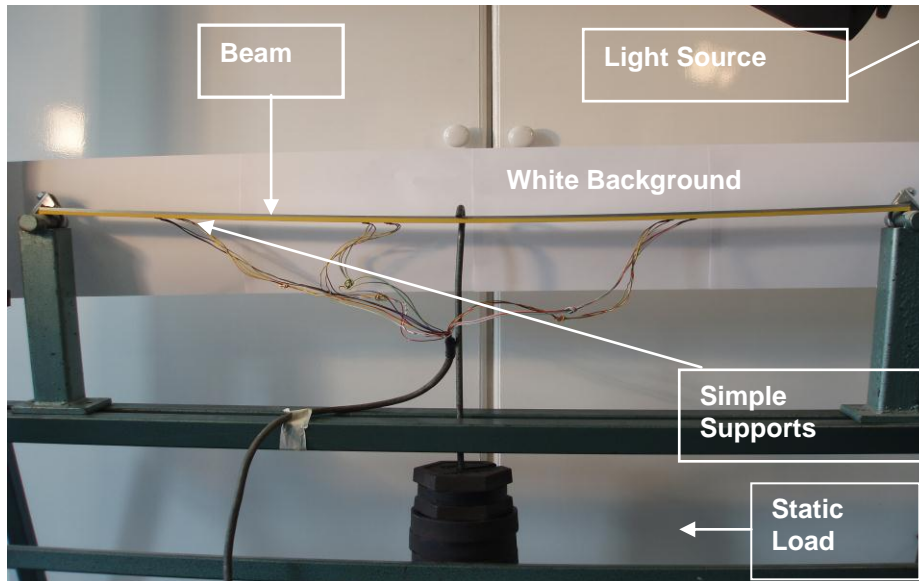
A simply supported aluminium beam of 1m length is employed for this purpose. The open crack is created by sawing a notch into the lower section of the beam of cross section 10mmx10mm. The location of the damage is situated at 0.3m from the left hand support of the beam. The beam is vibrated freely and is also subjected to a static weight ( $P=9$  kg) at the centre. The general arrangement of the experiment is given in Figure 3. The initial excitation of the beam is provided by deflecting the beam manually about its static displaced position and then releasing it to vibrate freely. The CDR of the damage is taken as 0.5.

The free vibration of the beam is recorded by an Olympus  $\mu$  800 digital camera. An appropriate deflected shape has been chosen by running the video using commercial software named Ulead Video Studio 6 and freezing a single frame, a method similar to that followed by Hartman and Gilchrist [14]. The frame is converted and saved as a bitmap image. The images are 240x320 pixels in size. The recording has been done in the presence of

**Figure 3. Experimental Setup for the Damage Detection of an Aluminium Beam Using Wavelet Analysis on Damaged Deflected Shape.**

controlled lighting and a white background to minimize ambient disturbances in the image. It should be noted here that a very high resolution image does not necessarily guarantee low noise in an image. Often the general imperfections of the underside of the beam are accentuated in high resolution images resulting in large file-space, increased computational time and false alarms.

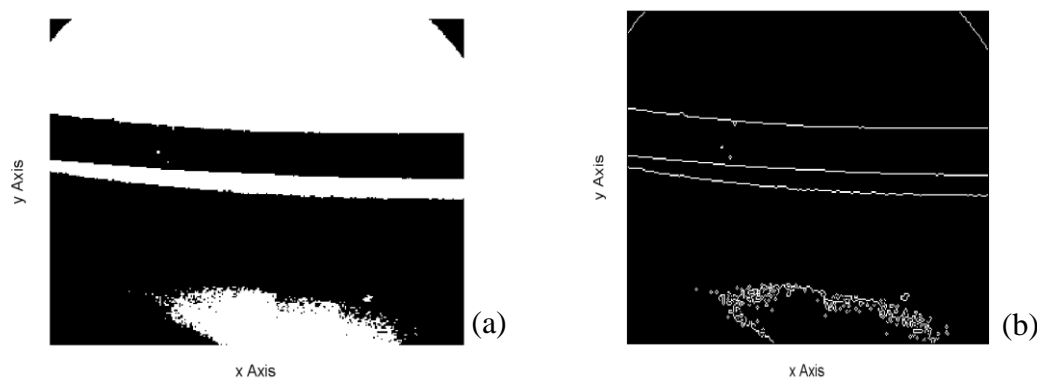
The saved image of the deflected shape is essentially a rectangular grid of pixels and the centre of a pixel occupies the integer co-ordinates in the grid so produced. The interior of each pixel can be further subdivided into a continuous spatial coordinate system by considering that the local origin for each pixel lies at the top left hand corner of the pixel, and not at the centre. Each pixel is associated with a vector of number describing its hue-saturation value. The gray-level threshold of the image is computed by minimizing the interclass variances of the black and white pixels using Otsu's method using MATLAB 7.0 signal processing toolbox. Pixels below the threshold assume a value zero and turn black, while the other pixels turn white. This enables to convert a complex matrix from the original image to a simpler binary black and white image. This transformation is important when the feature of interest is in contrast with its surroundings in the image. The damaged beam was tested to achieve such a contrast for the underside of the beam with its background. Figure 4-a shows a thresholded binary image representing the partial deflected shape of a beam with an open crack ( $\delta=0.5$ ) of 2mm width at a certain instant of time during the free vibration.

**Figure 4. Binary Image and Edge detection of a Damaged Partial Modeshape with  $\delta=0.5$ .**

The black and white binary images are converted by thresholding and the edges of the images were found using the Sobel method (Sarfraz [15]) incorporating the MATLAB 7.0 signal processing toolbox. The Sobel method scans a binary image and returns the approximation to the derivative of the two-dimensional data. The edges are returned (Figure 4-b) as the points where the gradient of the image are locally maximum. This identified image contains noise and a number of definite features, which are not a part of the deflected underside of the beam. These spurious edges are present for all practical applications and thus the image needs to be post processed to identify the damaged deflected shape. A visual idea about the spurious feature can be helpful to pre-process the picture to make the computational effort of the pattern recognition scheme easier and the scanning region comparatively smaller. The lower edge of the beam has been extracted from Figure 4-b by an intelligent pattern recognition scheme. A scheme of the computer aided deflected shape recognition is as follows:

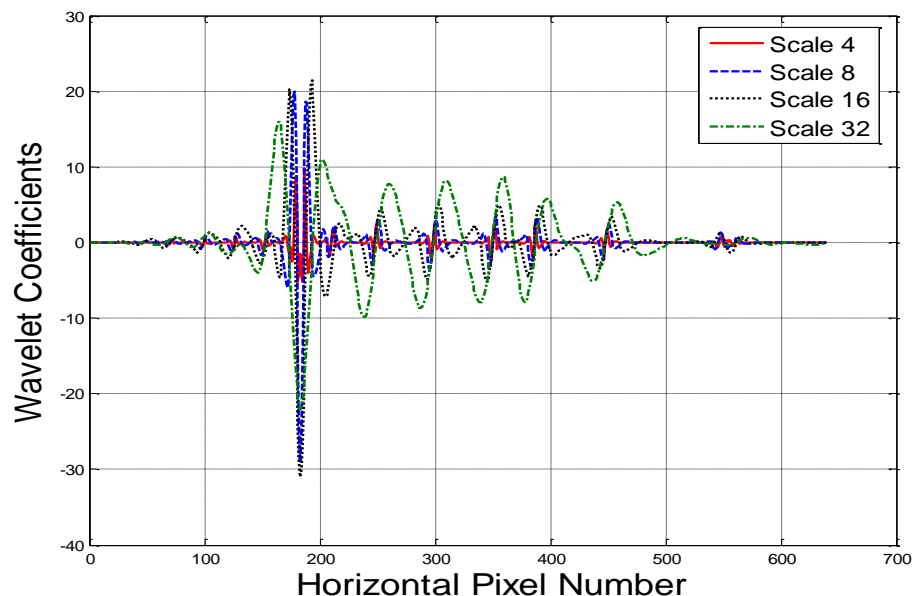
A wavelet analysis using Coif4 basis function and Hanning window is performed on the estimate of the deflected partial modeshape [16] and the result of the analysis is illustrated in Figure 5. It is observed that a definite local maximum is present in the analysed shape propagating at a range of scales consistently. The horizontal axis of the observed value is pre-calibrated against the beam length and the damage is seen to be detected around the neighbourhood of 0.3m from the left hand side of the beam.

**Figure 5. Experimental Identification of Damage Location.**

A wavelet based damage detection scheme is experimentally validated on a simply supported aluminium beam with an open crack using a video camera based intelligent pattern recognition technique. The presence and the location of the damaged have been successfully identified. This image analysis based detection is found to be a novel, easy and an inexpensive method for damage detection. The proposed scheme is seen to have a potential for unmanned online structural health monitoring process.
