Pakrashi, V., O'Connor A.J., Basu B., 2006. Damage Calibration of a Beam using Wavelet Analysis and Image Processing. In: Bridge Engineering Research in Ireland (BEI), *Third Symposium on Bridge and Infrastructure Research in Ireland*. Dublin, Ireland.

# Damage Calibration of a Beam Using Wavelet Analysis and Image Processing

Vikram Pakrashi, Alan O' Connor and Biswajit Basu

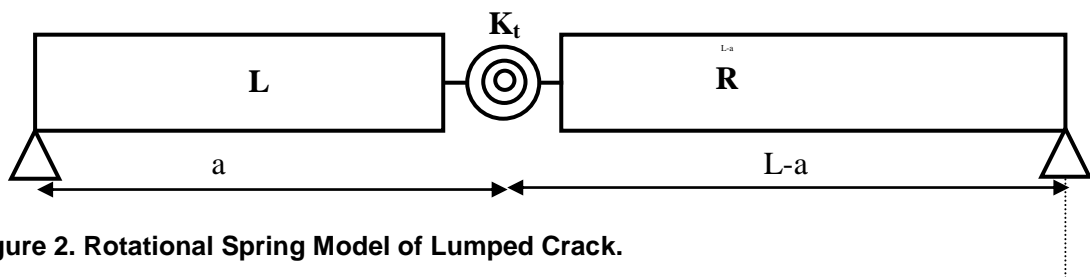
Figure 2. Rotational Spring Model of Lumped Crack.

It is assumed that the effects of the crack are applicable in the immediate neighbourhood of the crack location and is represented by a rotational spring of equivalent local stiffness of  $K_t$  as shown in Figure 2.

where the natural frequency of the cracked beam is  $\omega$ . Both displacement and moment at the two supports of the beam are zero. The continuity in displacement, moment and shear are assumed at the location of crack. A slope discontinuity is present at the crack location. The slope condition is modelled as

$$\Phi_R'(a) - \Phi_L'(a) = \theta L \Phi_R''(a) \quad (2.4)$$

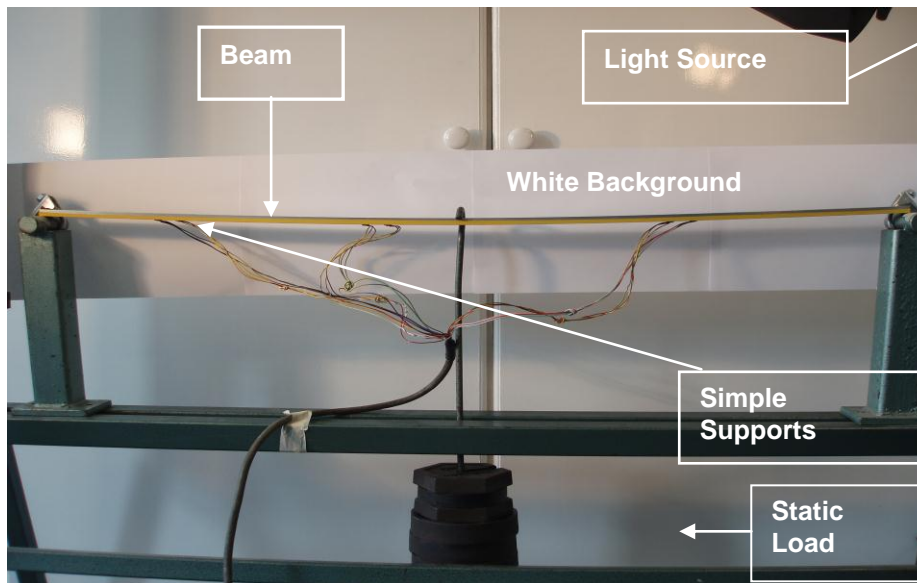
**Figure 3. Experimental Setup for the Damage Detection of an Aluminium Beam Using Wavelet Analysis on Damaged Deflected Shape.**

A simply supported aluminium beam of 1m length is employed for this purpose. The open crack is created by sawing a notch into the lower section of the beam of cross section 10mmx10mm. The location of the damage is situated at 0.3m from the left hand support of the beam. The beam is vibrated freely and is also subjected to a static weight ( $P=9$  kg) at the centre. The general arrangement of the experiment is given in Figure 3. The initial excitation of the beam is provided by deflecting the beam manually about its static displaced position and then releasing it to vibrate freely. The CDR of the damage is taken as 0.5.

The free vibration of the beam is recorded by an Olympus  $\mu$  800 digital camera. An appropriate deflected shape has been chosen by running the video using commercial software named Ulead Video Studio 6 and freezing a single frame, a method similar to that followed by Hartman and Gilchrist [14]. The frame is converted and saved as a bitmap image. The images are 240x320 pixels in size. The recording has been done in the presence of

controlled lighting and a white background to minimize ambient disturbances in the image. It should be noted here that a very high resolution image does not necessarily guarantee low noise in an image. Often the general imperfections of the underside of the beam are accentuated in high resolution images resulting in large file-space, increased computational time and false alarms.

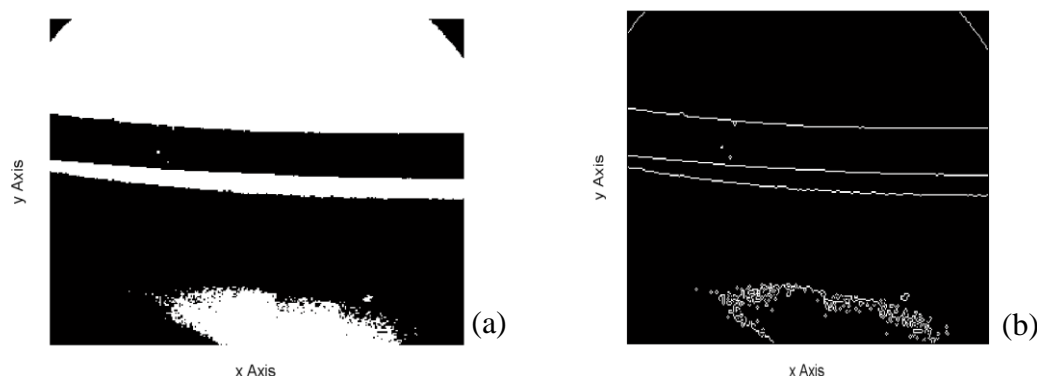
**Figure 4. Binary Image and Edge detection of a Damaged Partial Modeshape with  $\delta=0.5$ .**

The saved image of the deflected shape is essentially a rectangular grid of pixels and the centre of a pixel occupies the integer co-ordinates in the grid so produced. The interior of each pixel can be further subdivided into a continuous spatial coordinate system by considering that the local origin for each pixel lies at the top left hand corner of the pixel, and not at the centre. Each pixel is associated with a vector of number describing its hue-saturation value. The gray-level threshold of the image is computed by minimizing the interclass variances of the black and white pixels using Otsu's method using MATLAB 7.0 signal processing toolbox. Pixels below the threshold assume a value zero and turn black, while the other pixels turn white. This enables to convert a complex matrix from the original image to a simpler binary black and white image. This transformation is important when the feature of interest is in contrast with its surroundings in the image. The damaged beam was tested to achieve such a contrast for the underside of the beam with its background. Figure 4-a shows a thresholded binary image representing the partial deflected shape of a beam with an open crack ( $\delta=0.5$ ) of 2mm width at a certain instant of time during the free vibration.

The black and white binary images are converted by thresholding and the edges of the images were found using the Sobel method (Sarfraz [15]) incorporating the MATLAB 7.0 signal processing toolbox. The Sobel method scans a binary image and returns the approximation to the derivative of the two-dimensional data. The edges are returned (Figure 4-b) as the points where the gradient of the image are locally maximum. This identified image contains noise and a number of definite features, which are not a part of the deflected underside of the beam. These spurious edges are present for all practical applications and thus the image needs to be post processed to identify the damaged deflected shape. A visual idea about the spurious feature can be helpful to pre-process the picture to make the computational effort of the pattern recognition scheme easier and the scanning region comparatively smaller. The lower edge of the beam has been extracted from Figure 4-b by an intelligent pattern recognition scheme. A scheme of the computer aided deflected shape recognition is as follows:

1. Acquire a video recording of the free vibration of the damaged beam.
2. Import it to the computer and run it using Ulead Video 6.
3. Select and freeze and appropriate frame representing the deflected shape from the video and convert it to a bitmap image.
4. Load the bitmap image in Matlab 7.0 workspace and convert the coloured image to a binary image.
5. Identify the edges of the binary image.
6. Given a co-ordinate pair of the vicinity of the lower edge of the beam, incorporate a vertical column by column search to recognise a pattern of a certain number of pixel coordinates with value 1 in between two large bands of zero. A pixel is considered to be discretised in space arbitrarily keeping the pixel value constant within a single pixel.
7. Identify the lower edge of the beam from the search.
8. Employ wavelet based damage identification on the measured deflected shape.

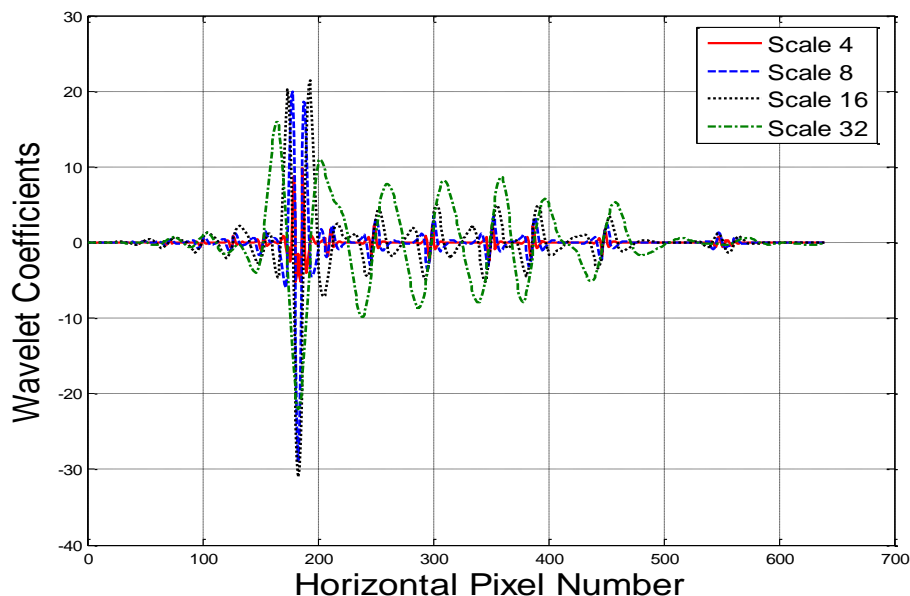
**Figure 5. Experimental Identification of Damage Location.**

A wavelet analysis using Coif4 basis function and Hanning window is performed on the estimate of the deflected partial modeshape [16] and the result of the analysis is illustrated in Figure 5. It is observed that a definite local maximum is present in the analysed shape propagating at a range of scales consistently. The horizontal axis of the observed value is pre-calibrated against the beam length and the damage is seen to be detected around the neighbourhood of 0.3m from the left hand side of the beam.

A wavelet based damage detection scheme is experimentally validated on a simply supported aluminium beam with an open crack using a video camera based intelligent pattern recognition technique. The presence and the location of the damaged have been successfully identified. This image analysis based detection is found to be a novel, easy and an inexpensive method for damage detection. The proposed scheme is seen to have a potential for unmanned online structural health monitoring process.
